Report: TAB Report
Function: Test, Adjust, & Balance
Date: 01/22/2025
Completed By: National TAB

01-13-25 WAWA #6611 FARMVILLE, VA

Project: 01-13-25 WAWA #6611 FARMVILLE, VA

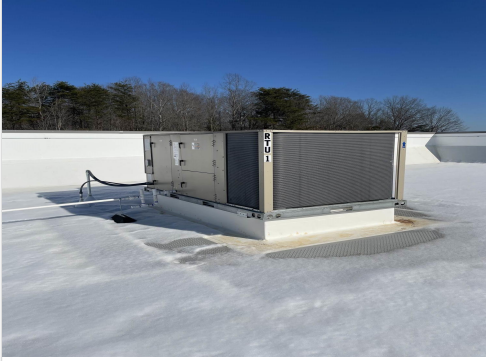
Unit Data - PHOTO LOG

Asset: RTU1

Unit Data		
	Design	Actual
MFG	LENNOX ENLIGHT	LENNOX ENLIGHT
Serial Num	-	5624D03499
Model Num	LCT092H4E	LCT092H4E
Type	RTU	RTU
Configuration	VERTICAL	VERTICAL
Num OA Filters 1	-	2
OA Filter Size 1	-	24"X15.5"
Num Final Filter 1	-	4
Final Filter Size 1	-	20"X25"X2"

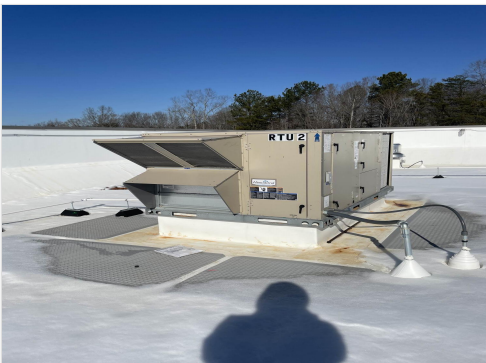
Unit Data - PHOTO LOG

Asset: RTU2

Unit Data		
	Design	Actual
MFG	LENNOX ENLIGHT	LENNOX ENLIGHT
Serial Num	-	5624A03690
Model Num	LCT150H4E	LCT150H4E
Type	RTU	RTU
Configuration	VERTICAL	VERTICAL
Num OA Filters 1	-	2
OA Filter Size 1	-	24"X15"5
Num Final Filter 1	-	4
Final Filter Size 1	-	20"X25"X2

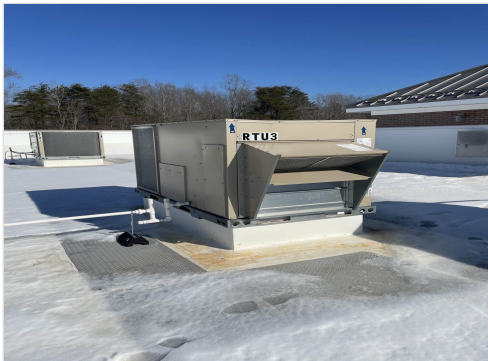
Unit Data - PHOTO LOG

Asset: RTU3

Unit Data		
	Design	Actual
MFG	LENNOX ENLIGHT	LENNOX ENLIGHT
Serial Num	-	5624C07753
Model Num	LCT060H4E	LCT060H4E
Type	RTU	RTU
Configuration	VERTICAL	VERTICAL
Num OA Filters 1	-	1
OA Filter Size 1	-	30"X15"
Num Final Filter 1	-	4
Final Filter Size 1	-	20"X20"X2"

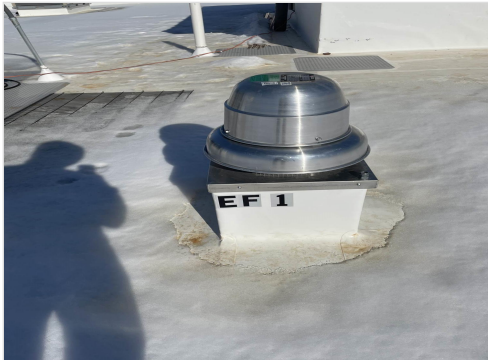
Unit Data - PHOTO LOG

Asset: EF1

Unit Data		
	Design	Actual
MFG	PENNBARRY	COOK
Model Num	DX10S	100C10DL
Serial Num	-	224SL3097200/0004101
Type	CENTRIFUGAL	CENTRIFUGAL
Configuration	VERTICAL	VERTICAL

- . Set point marked on dial

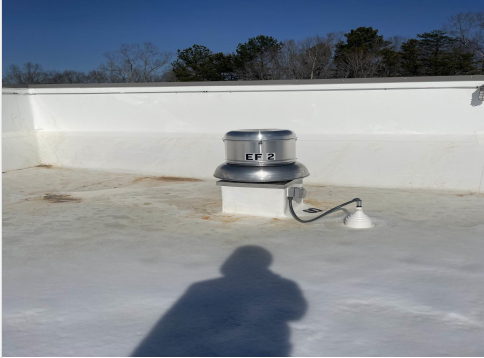
Unit Data - PHOTO LOG

Asset: EF2

Unit Data		
	Design	Actual
MFG	PENNBARRY	COOK
Model Num	DX13R	120C15D
Serial Num	-	224LP30972-01/0000701
Type	DOWNBLAST	DOWNBLAST
Configuration	VERTICAL	VERTICAL

. Set point marked on dial
