**Report: TAB REPORT**  
**Function: Test, Adjust, & Balance**  
**Date: 10/08/2024**  
**Completed By: National TAB**

**PROJECT**  
**09-30-24 CAVA SAGINAW, TX (OLD**  
**DECATUR)**

Project: 09-30-24 CAVA SAGINAW, TX (OLD DECATUR)

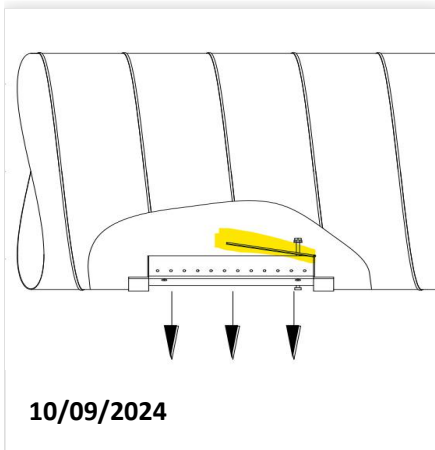
Project Issue File Details

**Issue Name :** RTU-1 DINING ROOM DIFFUSERS  
**Description :** Total flow for RTU-1 is balanced, but individual diffusers cannot all be balanced. The dampers on the spiral duct are installed as spec'd but are scoop type dampers which do not cover the entire face of the grille. Closing them does not significantly change airflow. Not anticipated to be any comfort issues since it's an open dining room.  
**Created By :** National TAB                      **Assigned To :** National TAB - Will Turnbough  
**Status :** Open  
**Priority :** Low    **Asset Tag :** RTU1  
**Originated Date :** 10/08/2024 - Bayley Morvant - National TAB

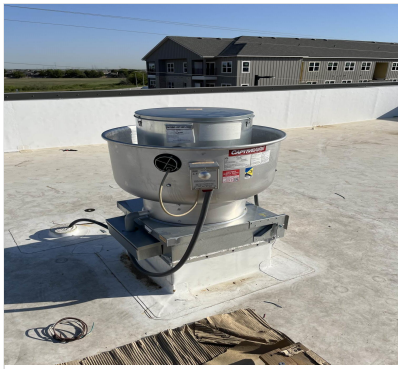
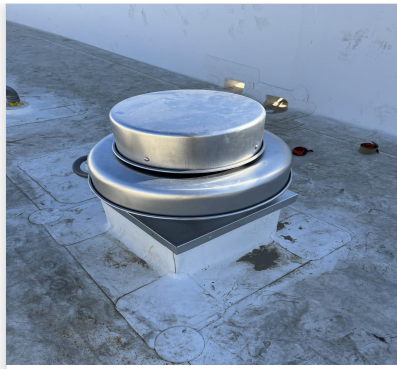
INCLUDES EF-2
