**Report: Renew
Date: 11/22/2021**

**PROJECT
FREDDY'S - SHILOH, IL - RENEW 3FH (4)**

3320 GREEN MOUNT CROSSING DRIVE
SHILOH, IL 62269

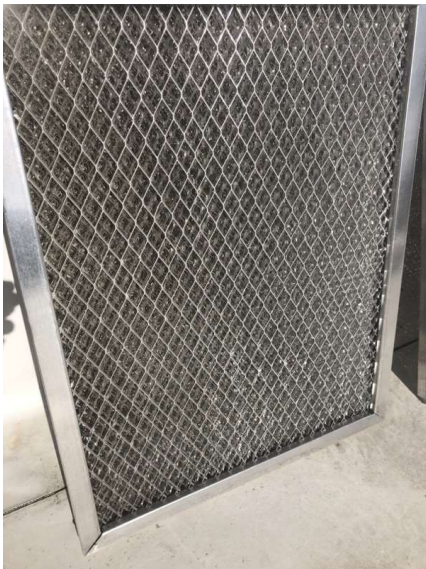
MAU
Clean outside air filters

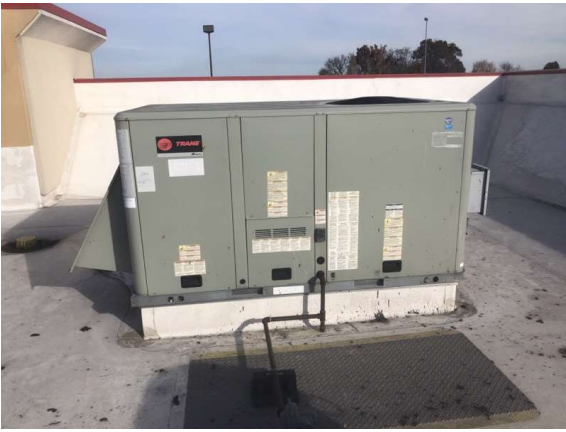
RTU-1
Dining

RECOMMENDATION (CLEAN/REPAIR/REPLACE/INFO)	
INFO	RTU-1 (Dining) fire is failing to light. Unit won't go into heat. A service provider needs to resolve the issue.

Notes: [1] HEAT NOT OPERATIONAL. UNIT ATTEMPTS TO GO INTO HEATING STAGE THROUGH JUMP AND THERMOSTAT, DOES NOT IGNITE GAS. SERVICE SUGGESTED.

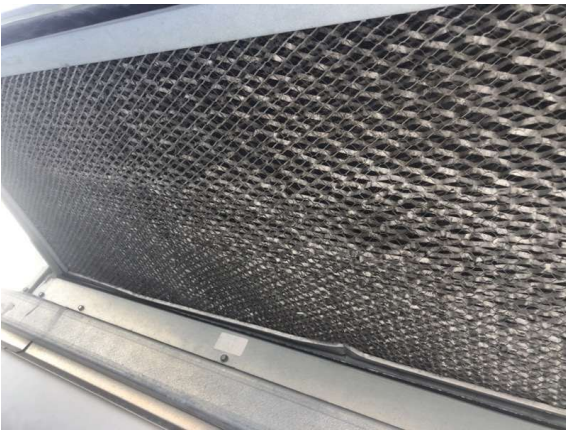
RTU-1
Dirty outside air filters

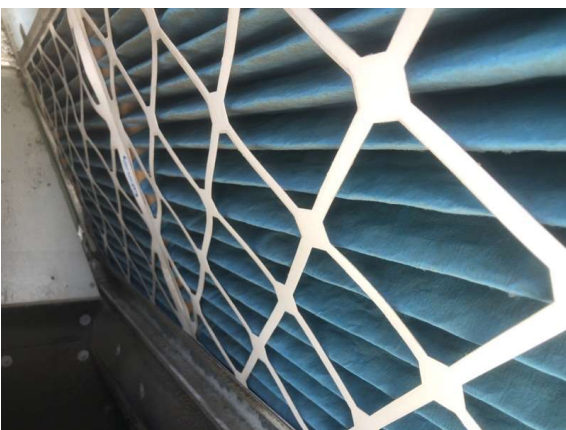
RTU-1
Dirty evaporator filters

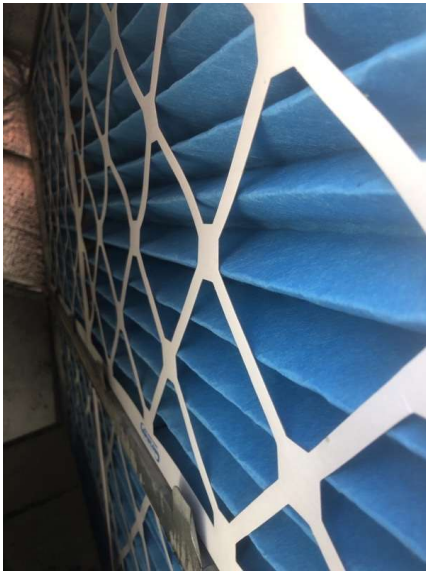
RTU-1
Clean evaporator filters

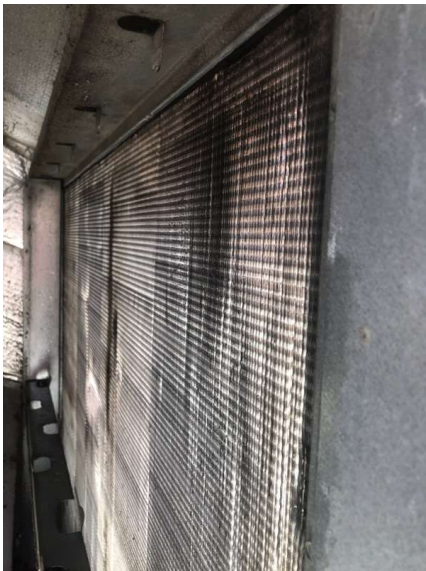
RTU-1
Dirty evaporator coil

RTUs: There evaporator coil was rinsed off and cleaned. During warmer months a self-cleaning chemical is sprayed on the evaporator. The outside air filters were rinsed off to remove any dirty, so the unit stays at the designated outside air set point. Based on static pressures, amps, and fan rpm it shows that the total supply has not changed since the last test and balance.

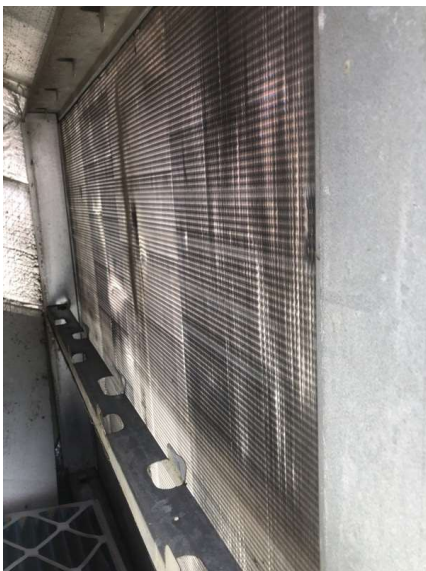
RTU-1
Clean evaporator coil

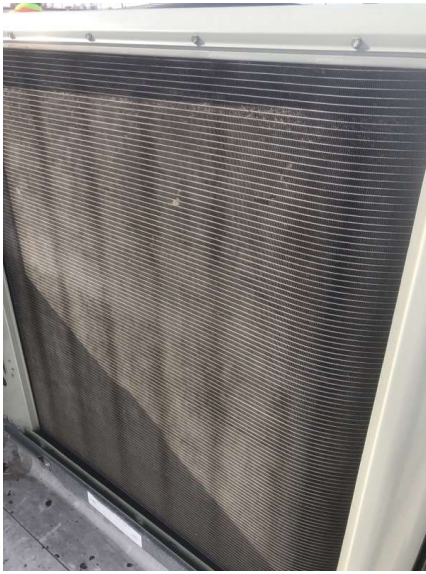
RTU-1
Dirty condenser

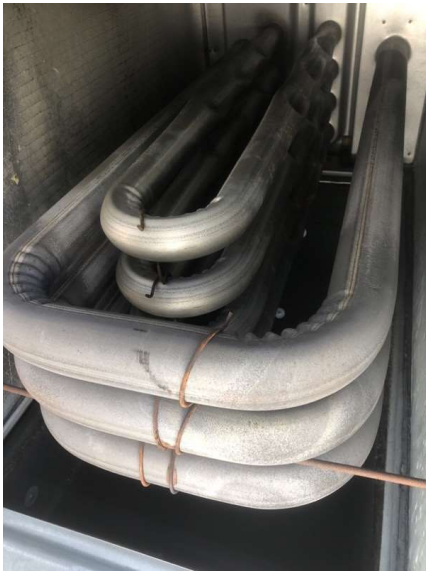
RTU-1
Burner Tube inspection

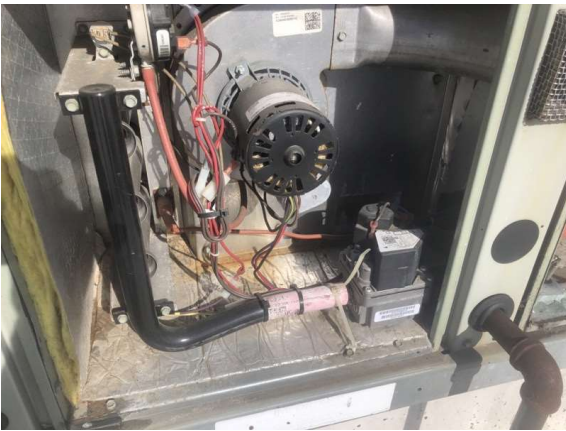
RTU-1
Heating compartment cleaned

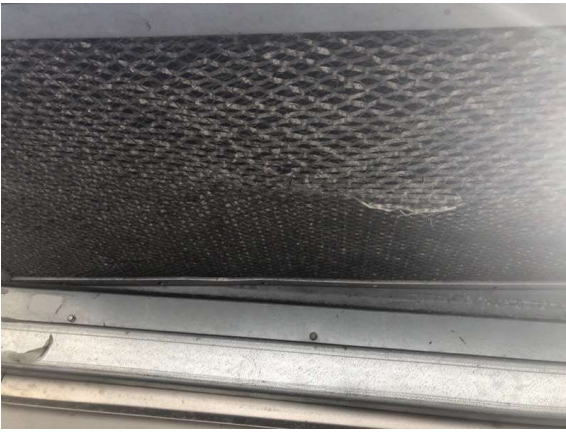
RTU-2
Dirty outside air filters

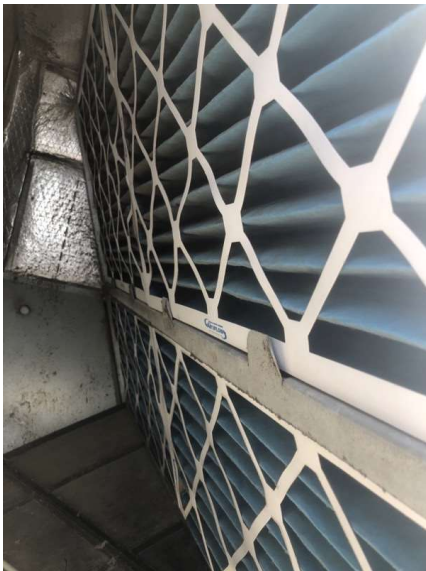
RTU-2
Dirty evaporator filters

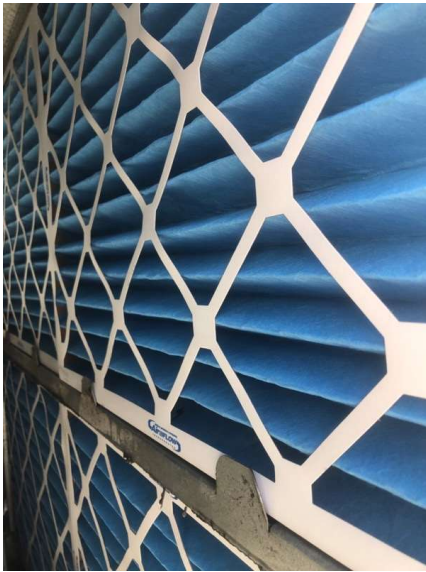
RTU-2
Clean evaporator filters

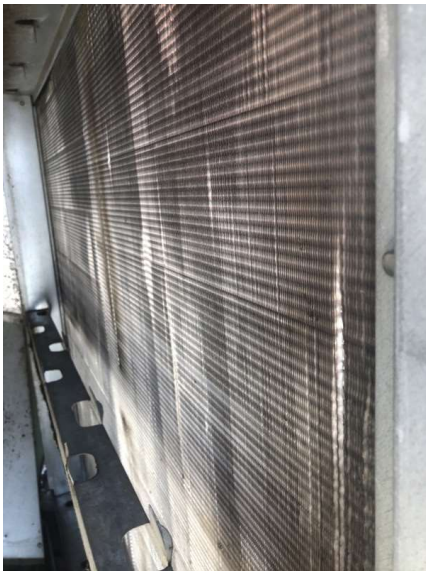
RTU-2
Dirty evaporator coil

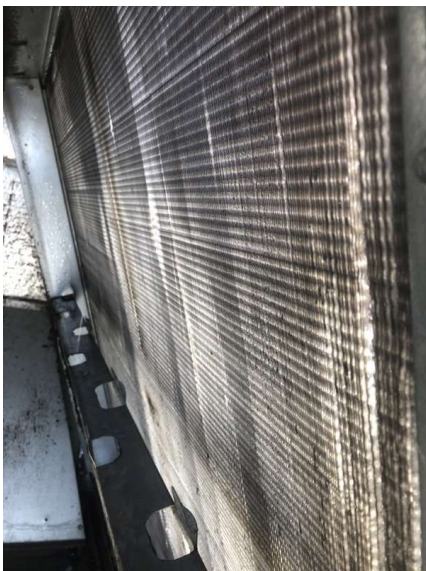
RTU-2
Clean evaporator coil

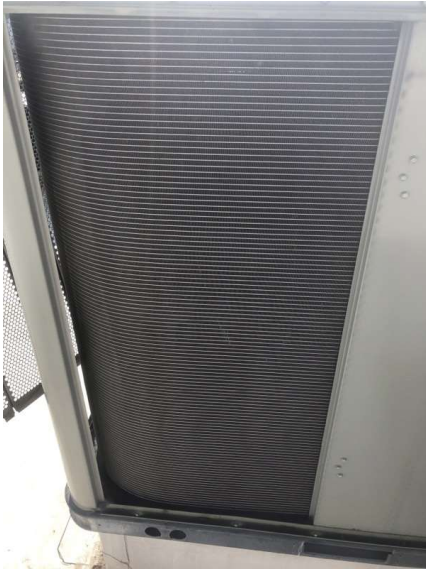
RTU-2
Dirt condenser coil

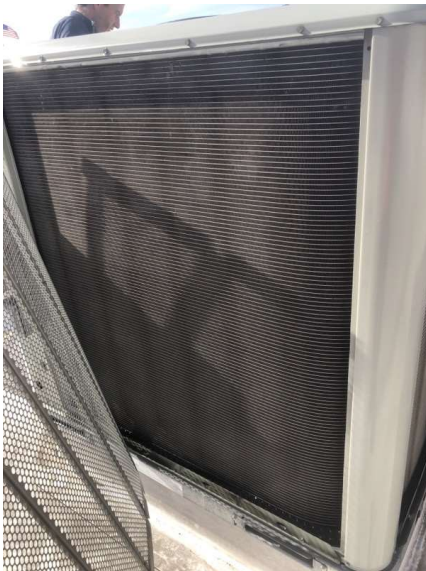
RTU-2
Clean condenser coil

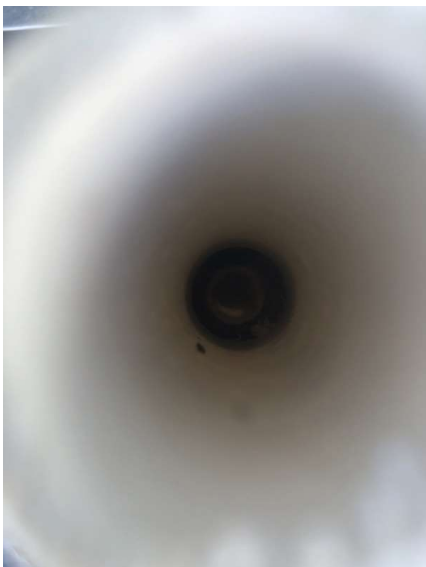
RTU-2
Condensate drain flushed clean

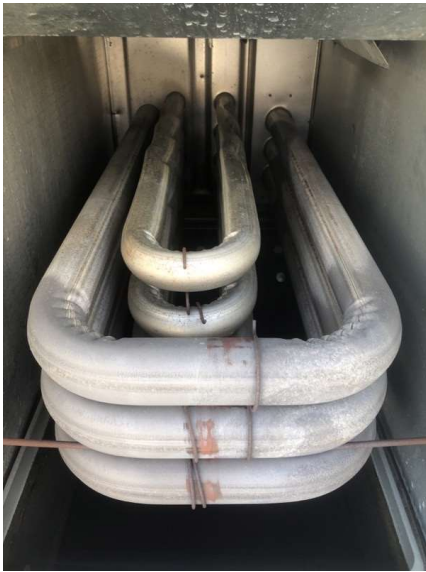
RTU-2
Burner Tube inspection

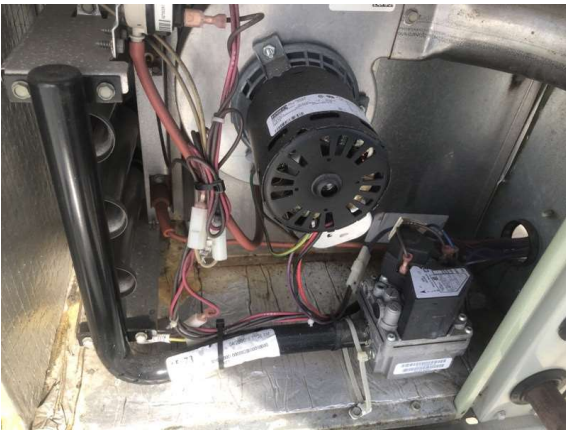
RTU-2
Heating compartment

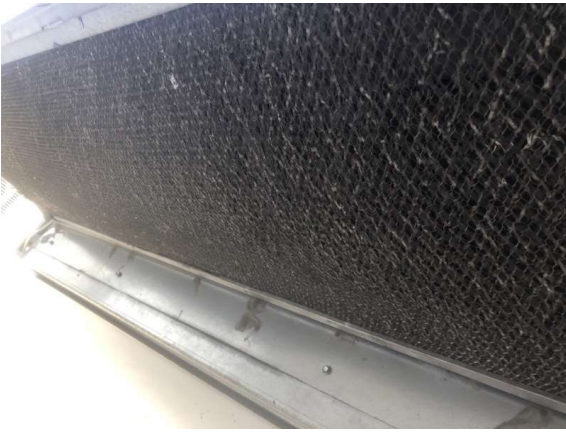
RTU-3
Dirty outside air filters

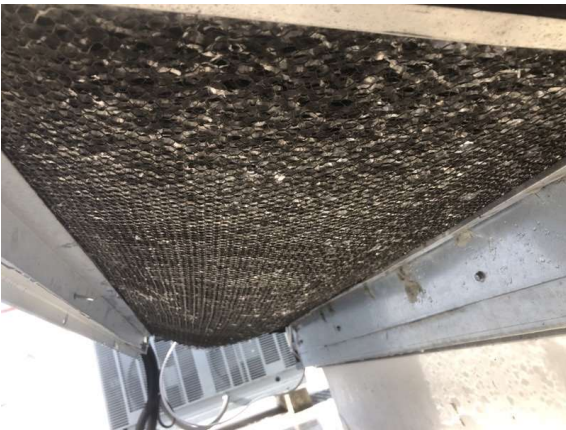
RTU-3
Clean outside air filters

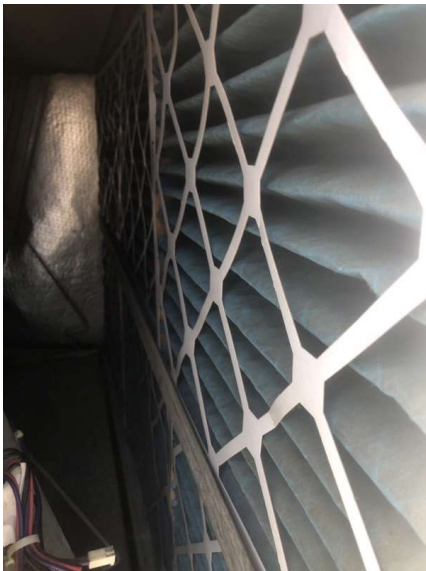
RTU-3
Dirty evaporator filters

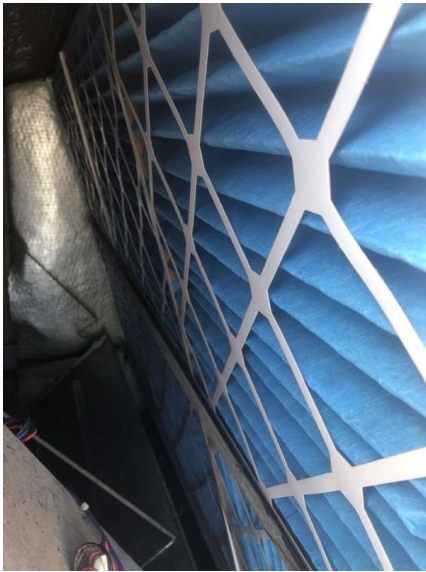
RTU-3
Clean evaporator filters

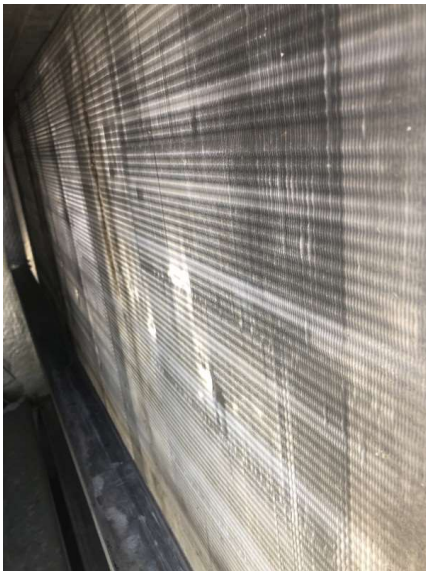
RTU-3
Dirty evaporator coil

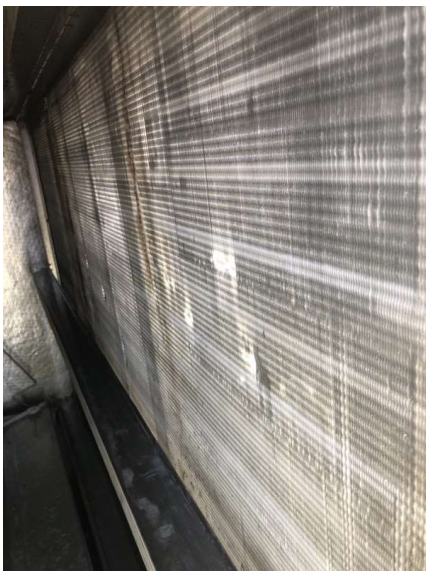
RTU-3
Clean evaporator coil

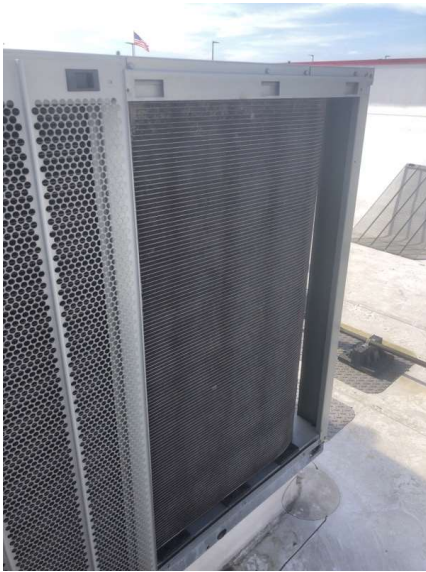
RTU-3
Dirty condenser coil

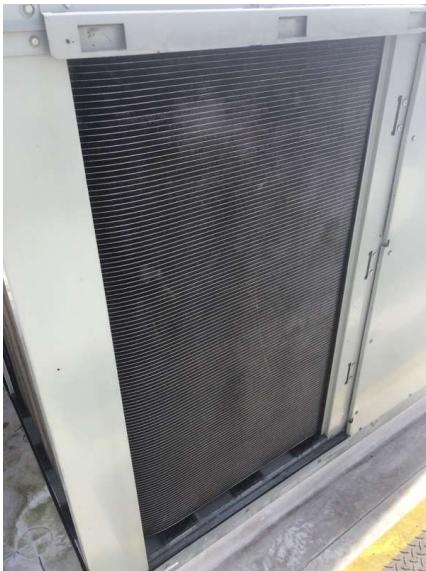
RTU-3
Clean condenser coil

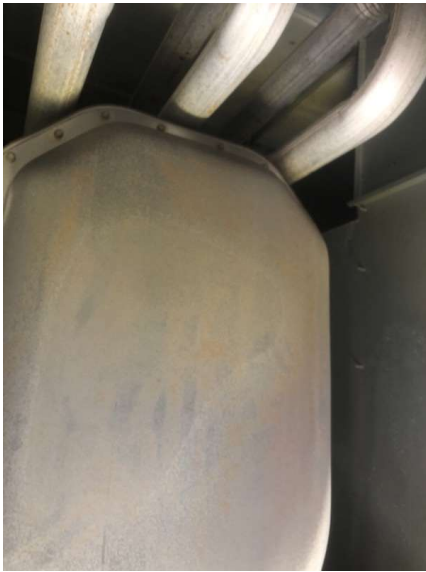
RTU-3
Burner tube inspection

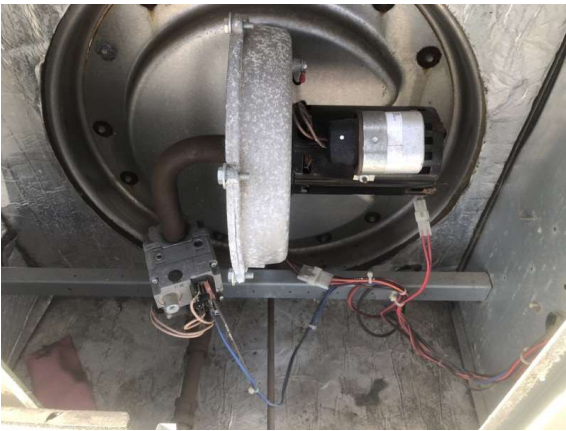
RTU-3
Heating compartment

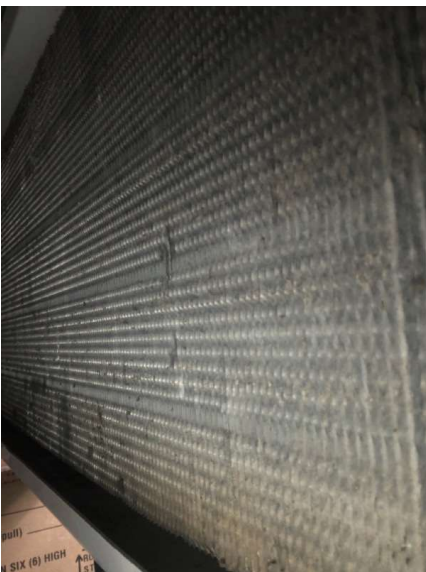
Walk-in Cooler
Dirty evaporator

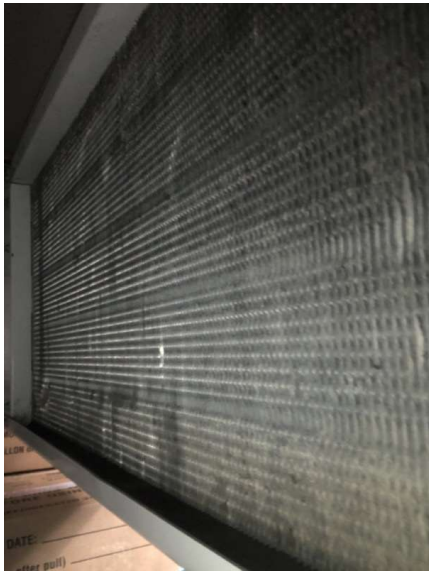
Walk-in Cooler
Clean evaporator

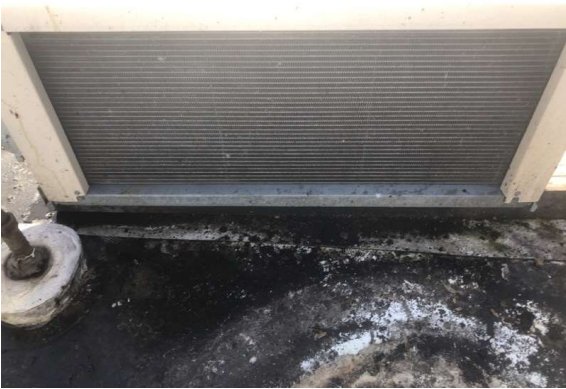
Walk-in Cooler
Dirty condenser

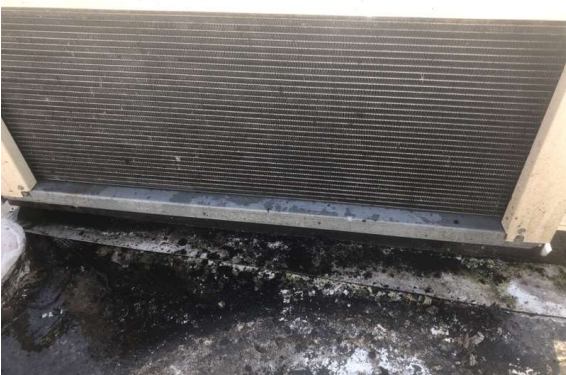
Walk-in Cooler
Clean condenser

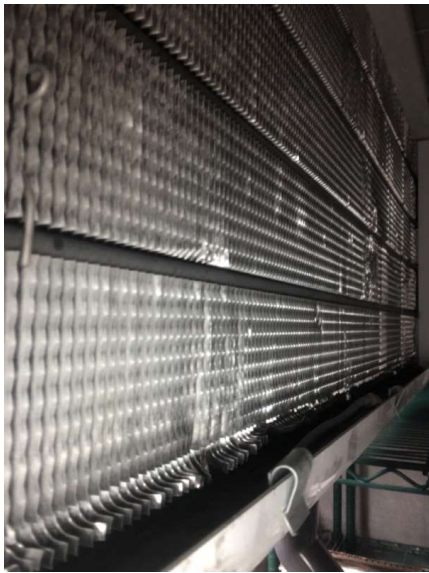
Walk-in Freezer
Clean evaporator

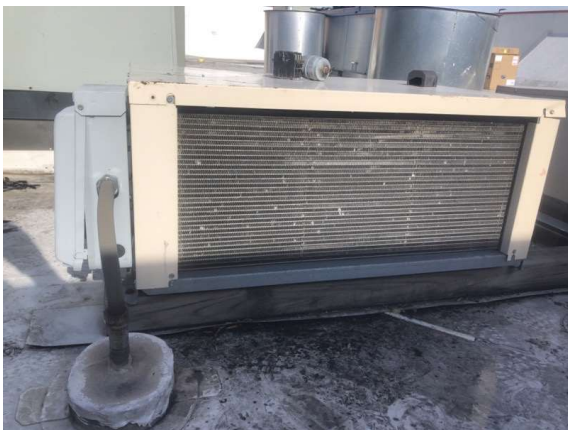
Walk-in Freezer
Dirty condenser

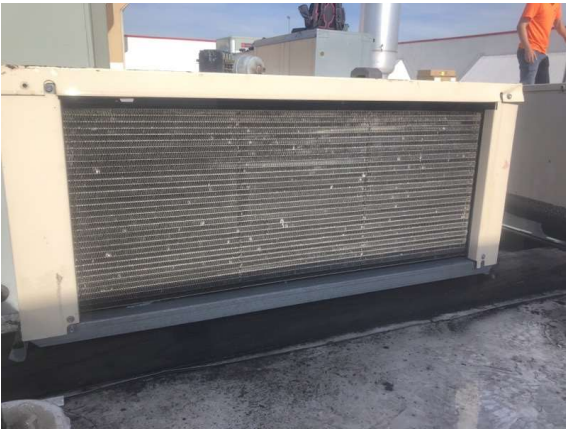
Walk-in Freezer
Clean condenser

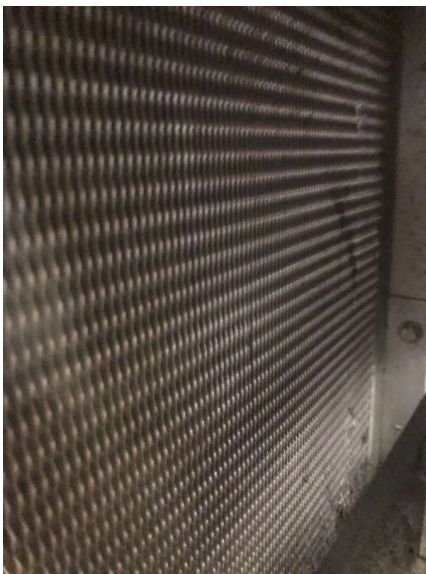
Meat Cooler 1
Clean condenser

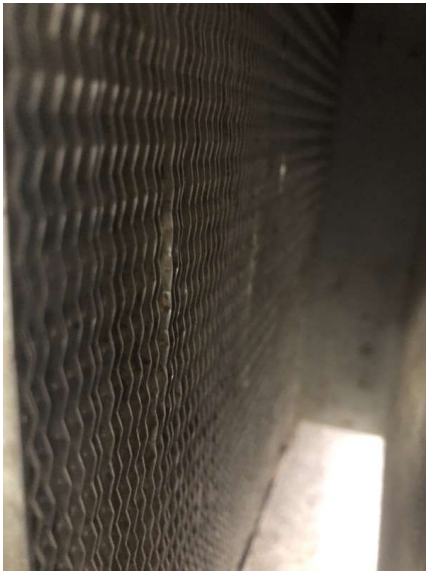
Meat Cooler 2
Dirty condenser

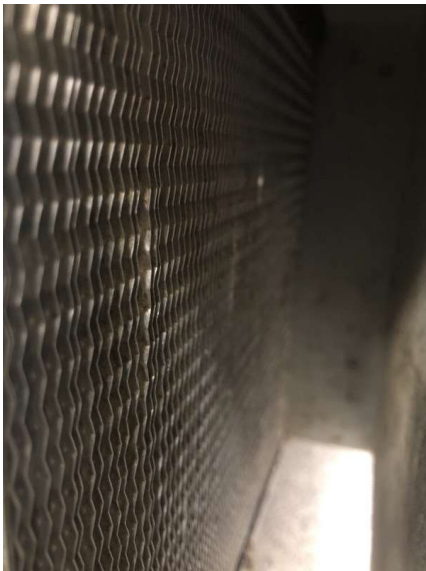
Meat Cooler 2
Clean condenser

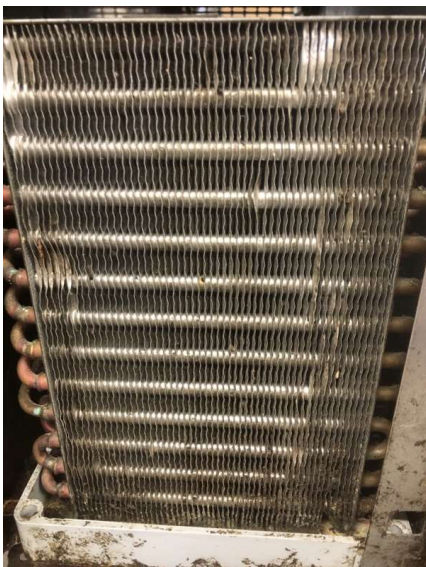
Prep Table 1
Dirty condenser

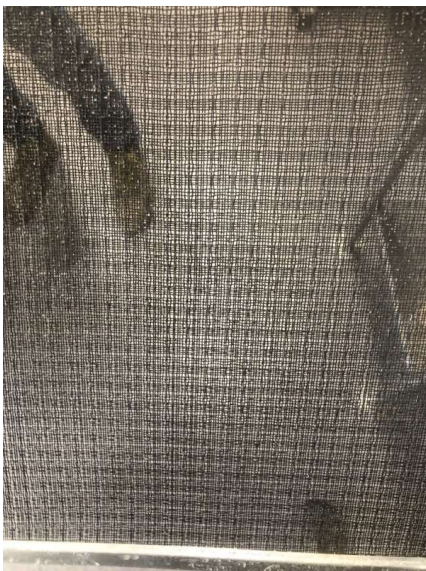
Fryer Freezer
Clean condenser

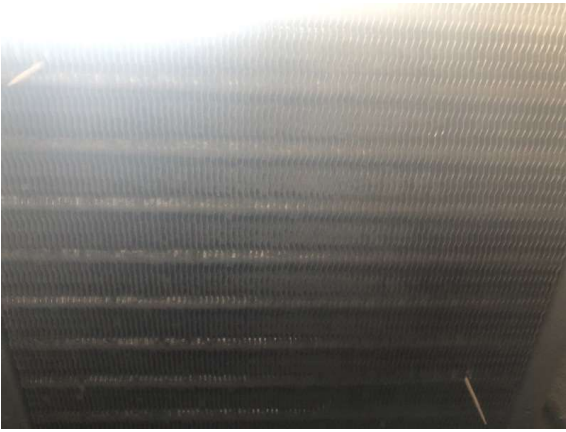
Sundae Prep
Dirty condenser

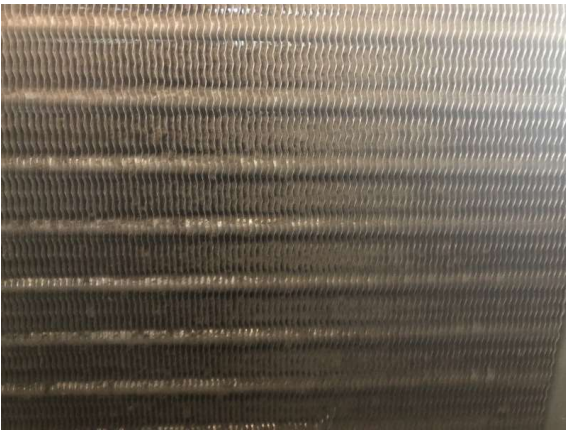
Sundae Prep
Clean condenser

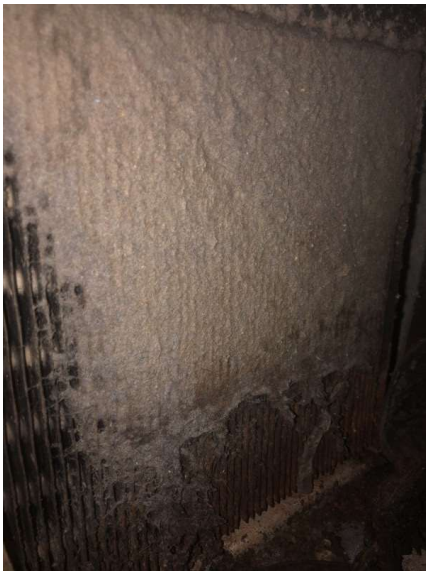
Toppings
Dirty condenser

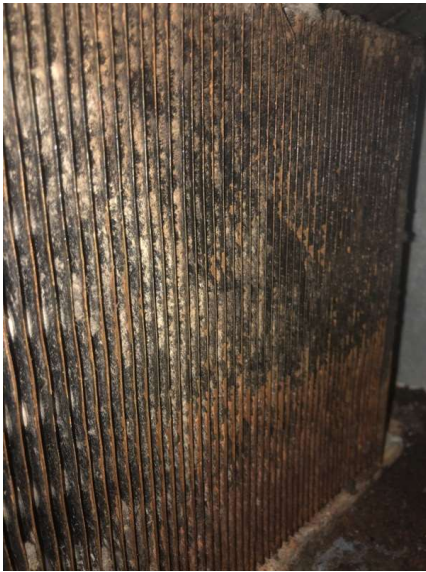
Toppings
Clean condenser

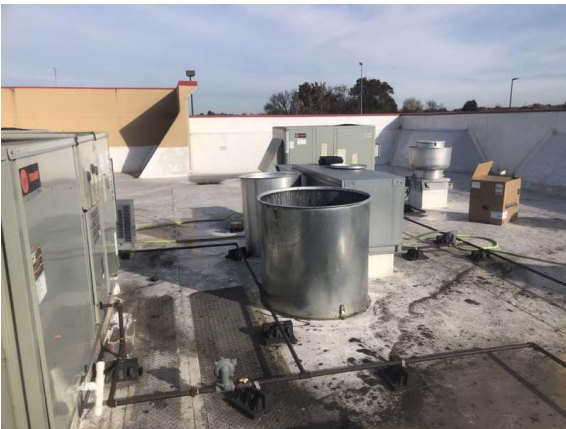
ISSUE: Wind Band Extensions
Wind band extensions found off of fans. NTAB placed back on fans.

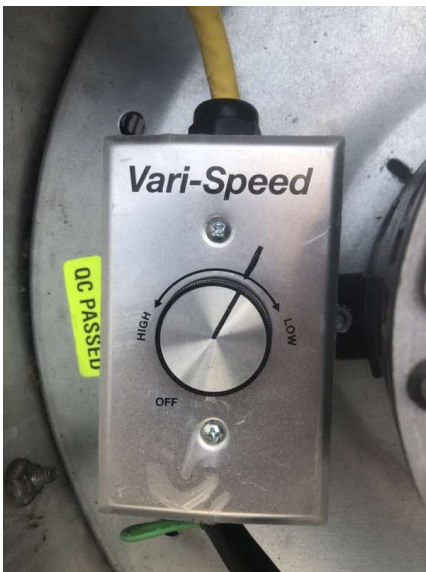
KEF-3
Fan Balanced, Setpoint marked

Notes: [LAST VISIT][1] FAN IS STILL NOT OPERATIONAL. MOTOR IS BAD. NOTIFIED REGIONAL MANAGER.
[1] SPEED CONTROLLER REPAIRED. MARKED SPEED CONTROLLER, BALANCED TO DESIGN.

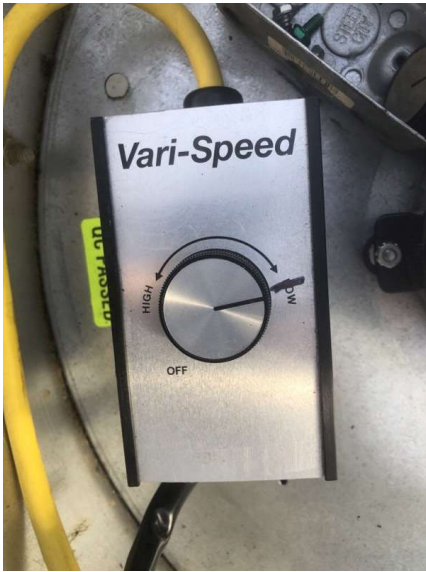
KEF-2
Speed controller marked
