Report: TAB REPORT
Function: Test, Adjust, & Balance
Date: 01/06/2023

**01-02-23 WALGREENS #4619 - SEBASTIAN,
FL**

Project: 01-02-23 WALGREENS #4619 - SEBASTIAN, FL

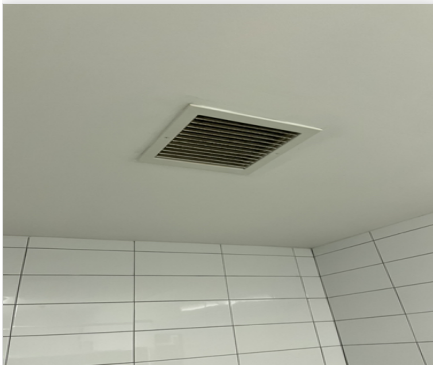
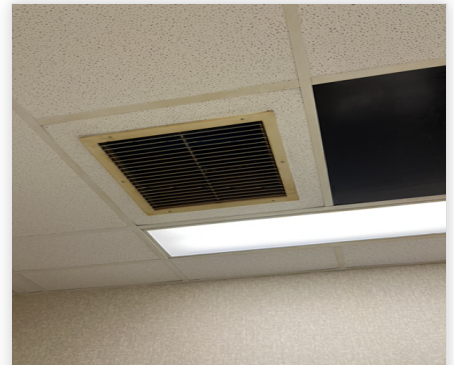
Issue Name : EF#3, 4, & 5 all have low flow.

Description : EF3 is at 241 cfm out of designed 300. EF4 is at 264 out a designed 300. EF5 is at 435 cfm out of a designed 750. Could not reach fans to speed up into design.
