**National TAB  
1329 E. KEMPER ROAD  
SUITE 4210  
CINCINNATI, OH 45246**

**Report: TAB REPORT  
Function: Test, Adjust, & Balance  
Date: 01/06/2023**

**01-02-23 WALGREENS #4619 - SEBASTIAN,  
FL**

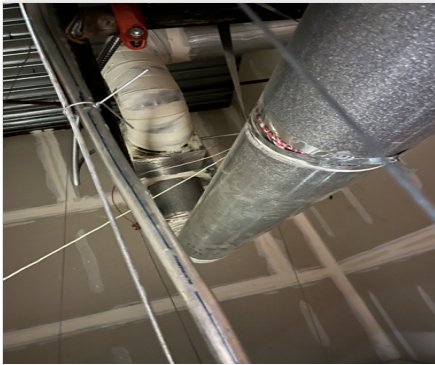
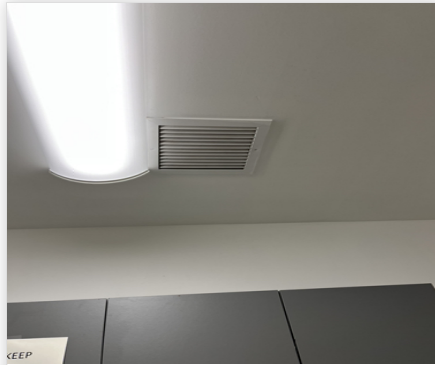
**Issue Name :** EF#1 & EF#2 currently are not functioning

**Description :** No airflow measured.

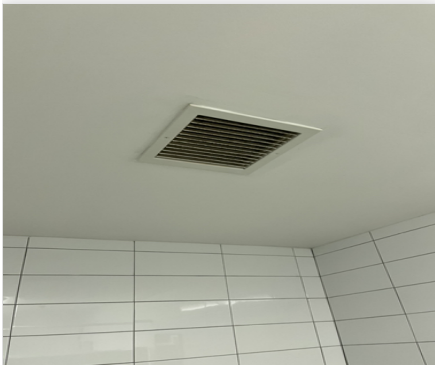
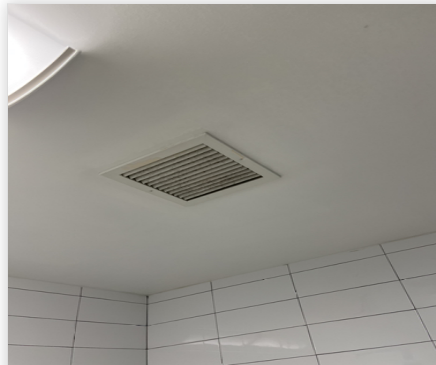
**Issue Name :** EF#3 & 4 are below design.

**Description :** EF3 is at 241 cfm out of designed 300. EF4 is at 264 out a designed 300. Could not reach fans to see if airflow could be sped up to design. Would require a roughly a 12' ladder and removing ceiling grid to access.

Fan rotation is correct	Pass
Pulleys are aligned and belts are tensioned properly	NA
Speed controller installed and functional (direct drive)	NA
Fan is secured to the curb	Pass
Back draft damper is installed and functional	Pass
No exterior damage to the fan	Pass
No unusual noise or vibration	Pass
Controls are functional	Pass
Additional Comments:	INLINE EXHAUST FANS ARE TOO HIGH TO REACH.

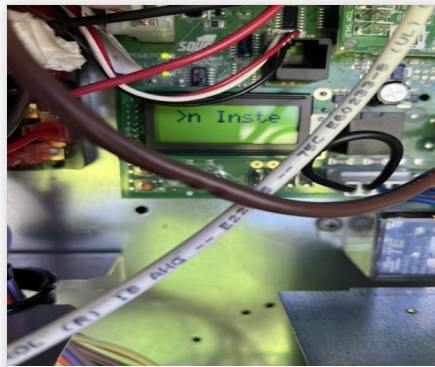
**Issue Name :** RTU#5 has alarm that indicates it is using return temp sensor instead of space temp sensor.

**Description :** Alarm shown on HMI screen. Needs to be resolved for unit to accurately read temperature.

RTU5 IS USING RETURN TEMPERATURE SENSOR INSTEAD OF SPACE TEMPERATURE SENSOR.

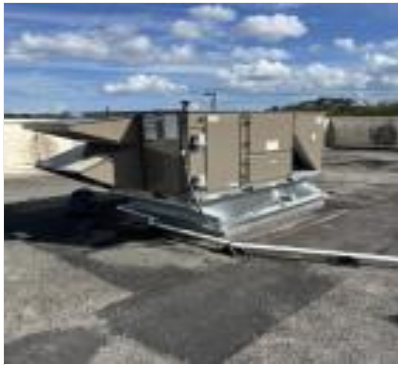
**RTU3.jpeg**

Verify all required equipment has been replaced per TA and BOM.	Pass
All units are installed in the proper locations	Pass
Units are labeled correctly	Fail
Asset tag installed	Pass
Roof is clear of debris.	Pass
Maintenance access for all unit access panels is acceptable and panels open freely.	Pass
Cabinet and general installation is complete.	Pass
Unit is secure to curb and level horizontally and vertically.	Pass
Access doors close tightly with no leaks	Pass
Condensate and gas piping is properly supported.	Pass
Costgaurd is installed per scope of work and piping unions are cemented.	
Additional Comments	RTU'S 3 AND 4 ARE LABELED BACKWARDS ON THE ROOF.
