Report: TAB REPORT
Function: Test, Adjust, & Balance
Date: 01/06/2023

**01-02-23 WALGREENS #4619 - SEBASTIAN,
FL**

Project: 01-02-23 WALGREENS #4619 - SEBASTIAN, FL

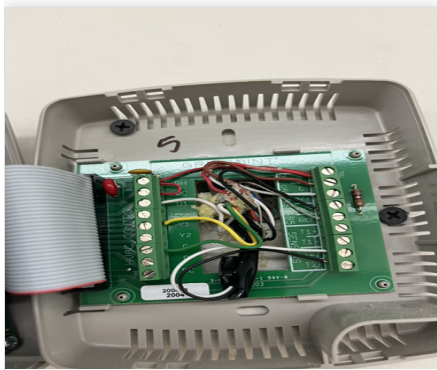
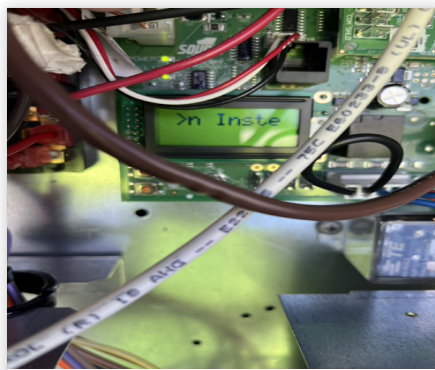
Issue Name : RTU#5 has alarm that indicates it is using return temp sensor instead of space temp sensor.

Description : Alarm shown on HMI screen. Needs to be resolved for unit to accurately read temperature.

RTU5 IS USING RETURN TEMPERATURE SENSOR INSTEAD OF SPACE TEMPERATURE SENSOR.
