Report: TAB Report
Function: Test, Adjust, & Balance
Date: 11/11/2025
Completed By: National TAB

PROJECT
11-17-25 QT #1149 GREENVILLE, SC

Project: 11-17-25 QT #1149 GREENVILLE, SC

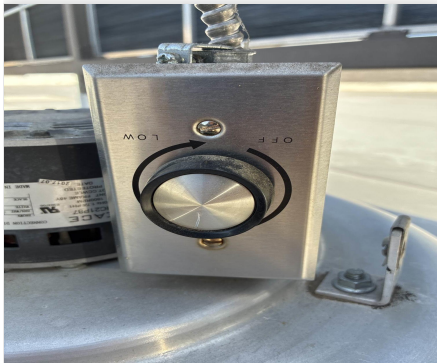
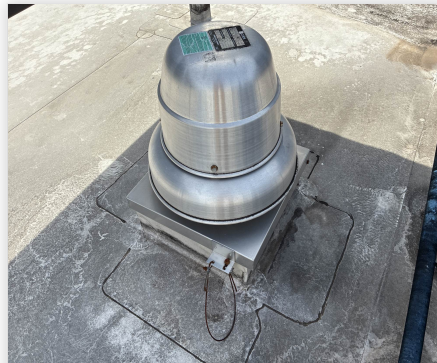
Issue Name : EF-1 Excessive Airflow
Description : EF-1 is at the lowest speed setting and is exhausting more air than it needs to.
Created By : National TAB **Assigned To :** National TAB - Dan Hertenstein
Status : Open
Priority : InfoOnly **Asset Tag :** EF1
Originated Date : 11/19/2025 - Alex Bauer - National TAB

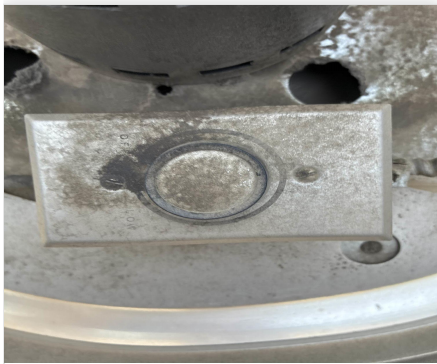
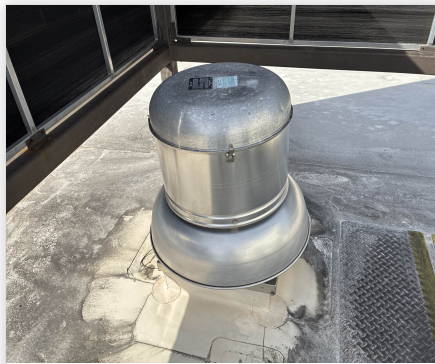
Issue Name : EF-2 Low Flow
Description : EF-2 is at the highest speed setting and is not exhausting enough air.
Created By : National TAB **Assigned To :** National TAB - Dan Hertenstein
Status : Open
Priority : Low **Asset Tag :** EF2
Originated Date : 11/19/2025 - Alex Bauer - National TAB

[1] FAN SPEED MAXIMIZED, UNABLE TO REACH DESIGN AIRFLOW.

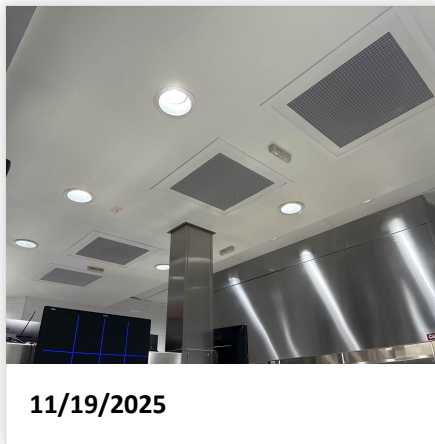
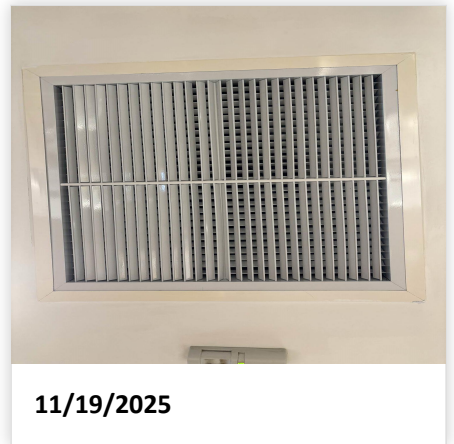
Issue Name : Incorrect Kitchen Diffusers
Description : The kitchen diffusers 3-1 through 3-4 are not the Titus S1 diffuser with the controllable damper.
Created By : National TAB **Assigned To :** National TAB - Dan Hertenstein
Status : Open
Priority : Low **Asset Tag :** RT-3
Originated Date : 11/19/2025 - Alex Bauer - National TAB

CHILLER	REGISTER	DIFFUSER				
MANUFACTURER	MODEL	SERVICE	FACE SIZE	BACK SIZE	DESCRIPTION	NOTES
1	1116	330L	36X48	18 X 18	3/4" 30" SLAVE REGISTER CHILLER AL. W/TE	12
5	1116	3025	36X48	22 X 22	DOUBLE REGISTER CHILLER AL. W/TE	13

NOTES
 1. REVIEW FOR CHILLER AL. DIFFUSERS AND REGISTER BOARD FOR 11/19/25

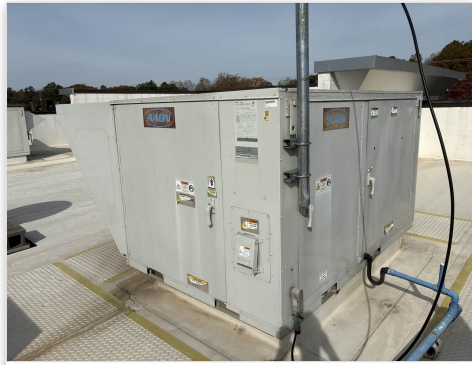
Unit Data - PHOTO LOG

Notes:
RTU-1 is actually RTU-2 on the site. Facilibuild is incorrect.

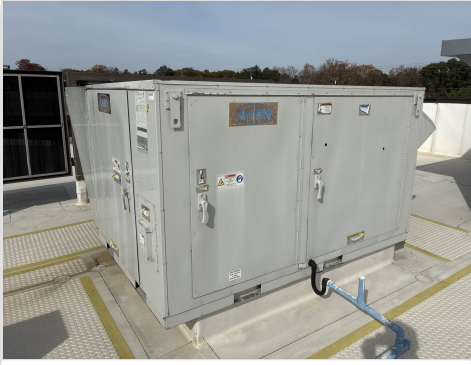
Unit Data - PHOTO LOG

Notes:
RTU-2 is actually RTU-3 on the site. Facilibuild is incorrect.

OA for the hood off was set manually. The gap is 0.125" (1/8").

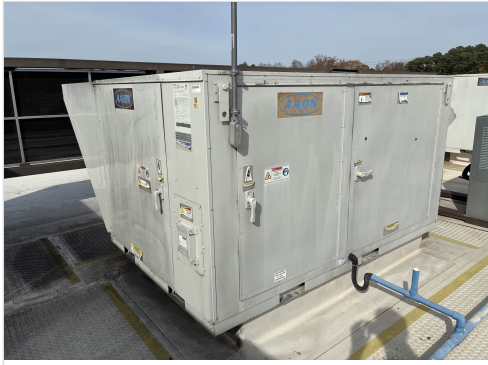
Unit Data - PHOTO LOG

RTU-3 is actually RTU-1 on the site. Facilibuild is incorrect.

[1] INCORRECT KITCHEN DIFFUSERS

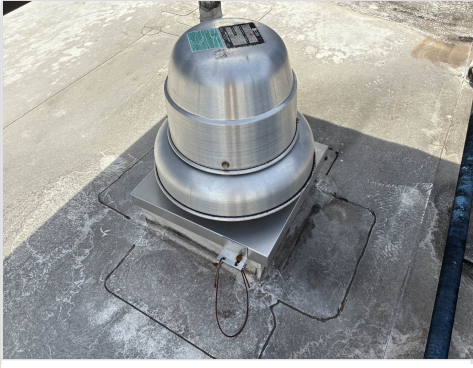
Unit Data - PHOTO LOG

Test Data		
	Design	Actual
CFM	225	311
Fan RPM	-	DD
Fan Rotation	-	CCW
Motor RPM	-	DD
System SetPt	-	LOW
RL Voltage	-	NA
RL Amperage	-	NA
Total ESP	-	0.36"
Fan Inlet SP	-	-0.36"
Fan Discharge SP	-	ATMO

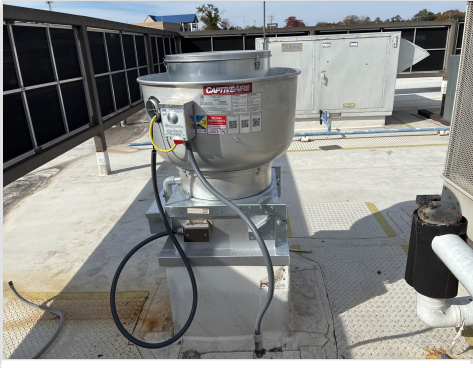
Unit Data - PHOTO LOG

Test Data		
	Design	Actual
CFM	1350	1310
Fan RPM	-	DD
Fan Rotation	-	CCW
Motor RPM	-	DD
System SetPt	-	54.8 Hz
RL Voltage	-	NA
RL Amperage	-	NA
Total ESP	-	0.73"
Fan Inlet SP	-	-0.73"
Fan Discharge SP	-	ATMO
