Report: TAB Report
Function: Test, Adjust, & Balance
Date: 11/11/2025
Completed By: National TAB

PROJECT
11-17-25 QT #1149 GREENVILLE, SC

Project: 11-17-25 QT #1149 GREENVILLE, SC

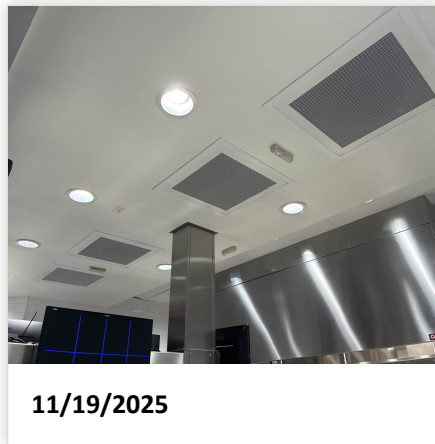
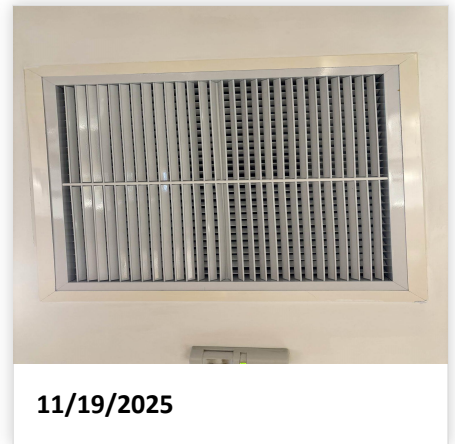
Issue Name : Incorrect Kitchen Diffusers
Description : The kitchen diffusers 3-1 through 3-4 are not the Titus S1 diffuser with the controllable damper.
Created By : National TAB **Assigned To :** National TAB - Dan Hertenstein
Status : Open
Priority : Low **Asset Tag :** RT-3
Originated Date : 11/19/2025 - Alex Bauer - National TAB

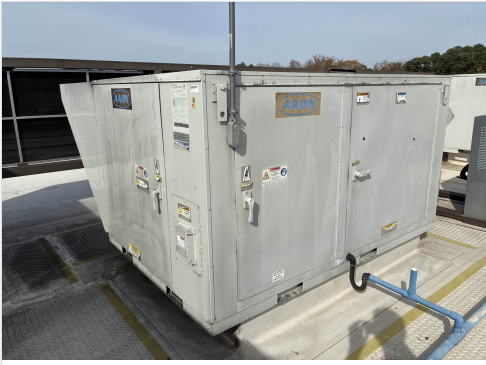
Unit Data - PHOTO LOG

Unit Data	
	Actual
MFG	AAON
Serial Num	201711-ANEK16486
Model Num	RN-013-8-0-EA0A-152
Num OA Filters 1	1
OA Filter Size 1	22.5X44.5
Num Final Filter 1	2
Final Filter Size 1	19.5X46.5

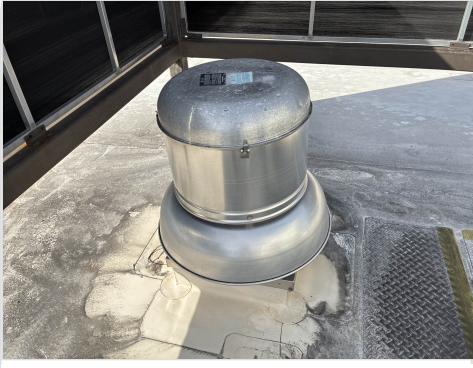
Unit Data - PHOTO LOG

Unit Data		
	Design	Actual
MFG	NA	COOK
Model Num	NA	120 ACE 120C13D
Serial Num	-	044SH27681- 00/0002101
Type	-	VERTICAL
Configuration	-	UPBLAST

Test Data		
	Design	Actual
CFM	525	203
Fan RPM	-	DD
Fan Rotation	-	CCW
Motor RPM	-	DD
System SetPt	-	MAX
RL Voltage	-	NA
RL Amperage	-	NA
Total ESP	-	0.19"
Fan Inlet SP	-	-0.19"
Fan Discharge SP	-	ATMO
