Report: TAB Report
Function: Test, Adjust, & Balance
Date: 11/11/2025
Completed By: National TAB

PROJECT
11-17-25 QT #1149 GREENVILLE, SC

Project: 11-17-25 QT #1149 GREENVILLE, SC

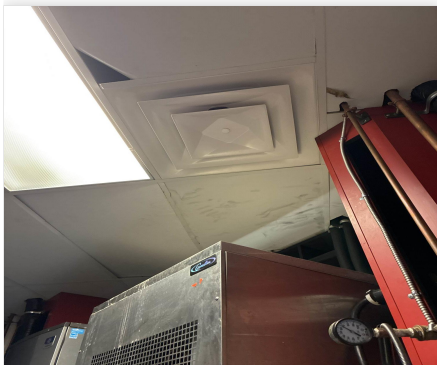
Issue Name : Diffuser Not Readable
Description : Diffuser 2-10 has a machine blocking it and cannot be read.
Created By : National TAB **Assigned To :** National TAB - Dan Hertenstein
Status : Open
Priority : InfoOnly **Asset Tag :** SGRD10
Originated Date : 11/19/2025 - Alex Bauer - National TAB

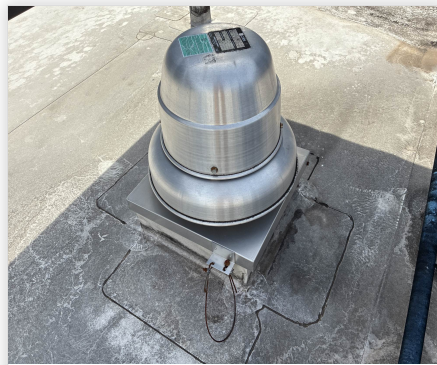
Issue Name : EF-1 Excessive Airflow
Description : EF-1 is at the lowest speed setting and is exhausting more air than it needs to.
Created By : National TAB **Assigned To :** National TAB - Dan Hertenstein
Status : Open
Priority : InfoOnly **Asset Tag :** EF1
Originated Date : 11/19/2025 - Alex Bauer - National TAB

Test Data		
	Design	Actual
CFM	225	311
Fan RPM	-	DD
Fan Rotation	-	CCW
Motor RPM	-	DD
System SetPt	-	LOW
RL Voltage	-	NA
RL Amperage	-	NA
Total ESP	-	0.36"
Fan Inlet SP	-	-0.36"
Fan Discharge SP	-	ATMO
