**Report: PopUp Evaluation**  
**Function: Test, Adjust, & Balance**  
**Date: 03/19/2025**  
**Completed By: National TAB**

## 03-17-25 POPUP EVAL COLUMBUS NY, NY

388 COLUMBUS AVE

## FIELD ENGINEER REPORT

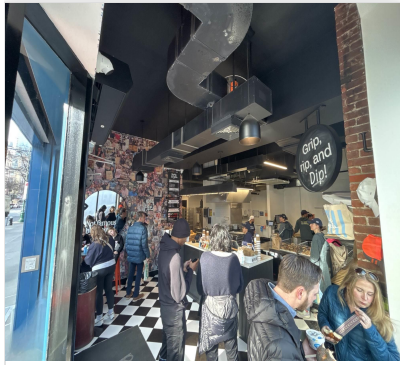
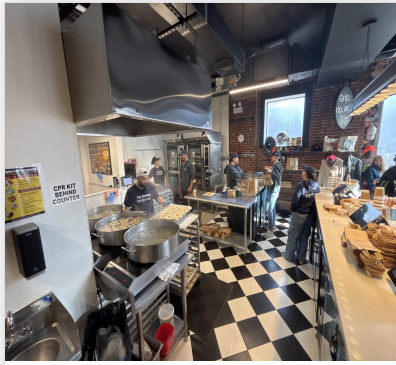
picture of the oven area & boiling pot area

- Bagels are boiled before baking. Boiling pots run continuously all day long, generating constant steam. A significant portion of this steam escapes the hood.
- Ovens continuously radiate heat. Viewing window surface is more than 100F. When the oven doors open, a stream of steam exits in addition to exchanging hot air with the oven interior.
- Videos of cooking steam on Microsoft Teams

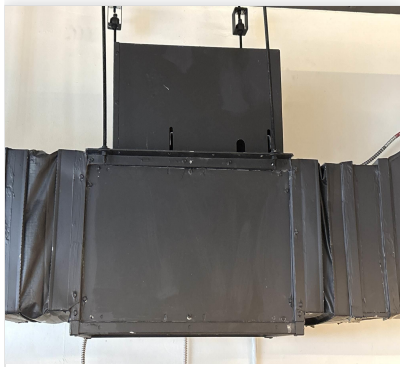
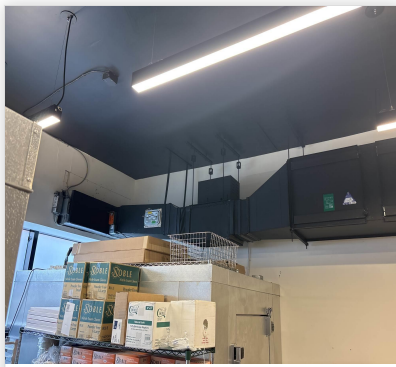
**Picture of Outside air Fan**

- Traverse 14x10 300 cfm
- Fan suction -0.223"
- Fan discharge 0.28"
- Based on drilling observation, I think the duct is very dirty

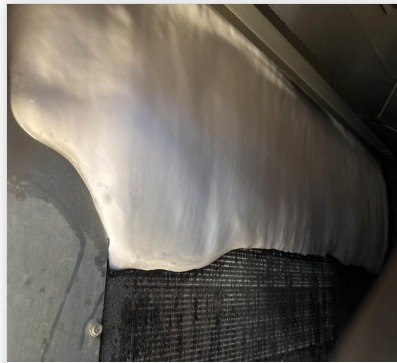
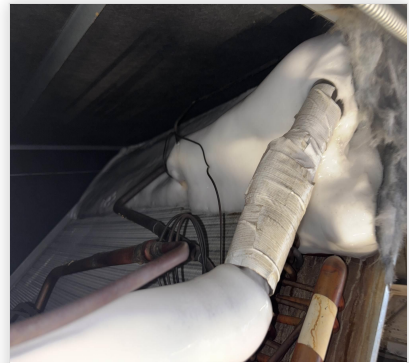
**Add any pictures of any deficiencies or other visual items.**

- Very hot in the summer. When it is 90-100F outdoors, they will leave the doors open to cool the store.
- Bakers request a consideration to blow conditioned air into the oven area.
- Significant ice buildup on refrigerant lines.
- Ductwork and AHU refrigerant line drip water depending on the humidity. On a good day it will just drip 2-3x an hour. On a bad day, they will drip continuously as if the roof was leaking during a rain shower. There is a drip tray underneath the AHU to catch water and need to lay towels on the floor and work surfaces in other locations.

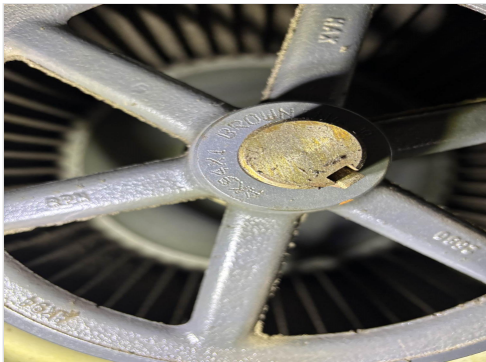
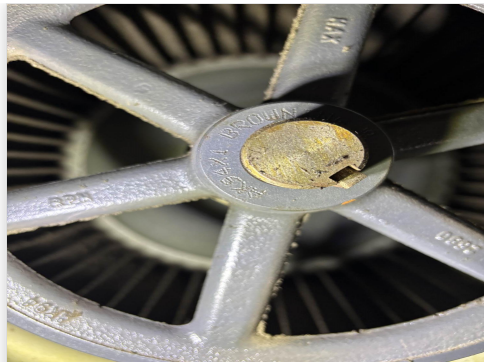
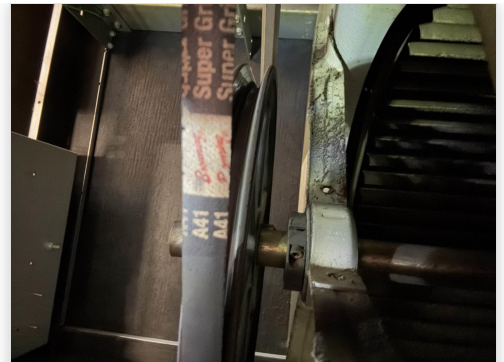
## Motor Data - PHOTO LOG

Currently, fan pulley is AK94X1 with an A41 belt. Centerline distance is 10.5" and motor pulley 4.5"

Too tight to adjust motor pulley. Can swap fan pulley.

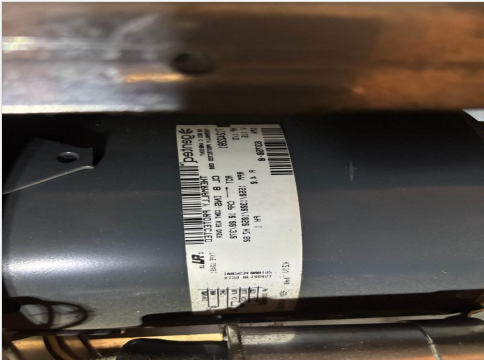
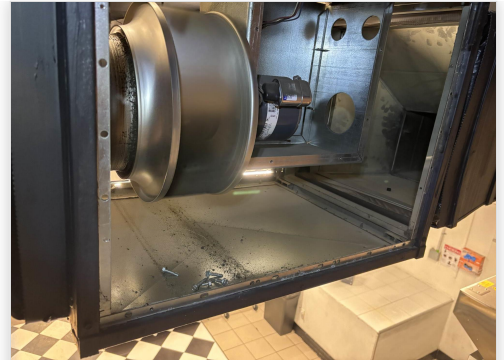
### Motor Data - PHOTO LOG

Notes:  
Unit data not accessible. Possibly painted over.

After closing dining grilles OA increased to 764 CFM.
