Field Engineer: Ryan Smith
JOB: Pop up Bagels Evaluation
338 Columbus Ave, New York, NY 10023

FIELD ENGINEER REPORT

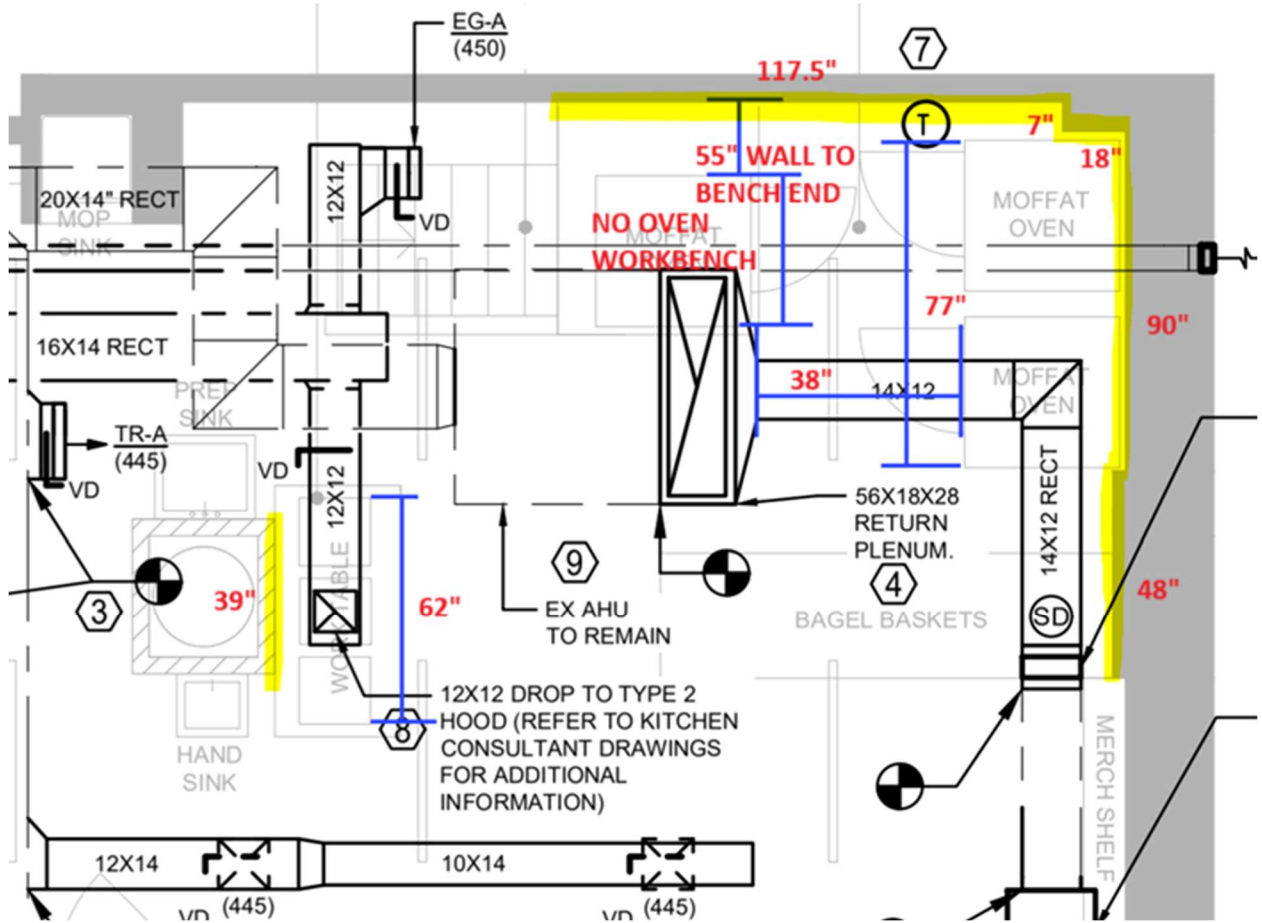
- Hard ceiling height is 152"
- AHU:
 - AHU bottom to floor is 114"
 - Bottom of OA duct to floor 123"
 - OA duct is 14"X10"
 - Bottom of supply duct to floor is 123"
 - Supply duct is 24"X18" exterior, internal insulation decreases interior to 22"X16"
- EXH:
 - Boiling pots hood is 48"X60"
 - Oven and hood branches to floor are 100"
 - Oven and hood branches are 12"X10"
 - Main trunkline to floor is 99" which increases to 109" which increases to 114" at outlet
 - Mina trunkline is 16"X14"
- Bathroom exhaust duct to floor is 142" above ovens. The duct then lowers to 114" to go through louver
- See picture below for more store dimensions
