**Report: TAB REPORT**  
**Function: Test, Adjust, & Balance**  
**Date: 01/09/2023**

## 02-27-23 WALGREENS #3840 - BURIEN, WA

14656 AMBAUM BLVD SW

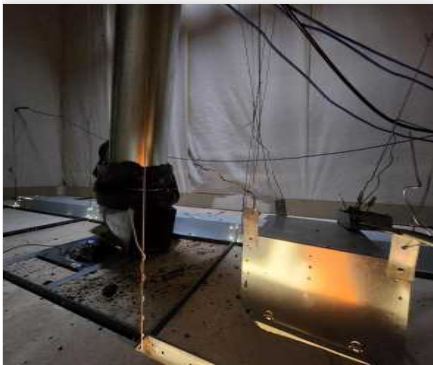
ef5.jpg

**Issue Name :** EF-5 is not attached to ductwork.

**Description :** EF-5 is not attached to any ductwork and the ductwork that is installed is not attached to the roof. Speed controller is also not installed.

- **04/28/2023** National TAB - Will Turnbough
  - Per Chase's email on 4/11. The duct is now connected.

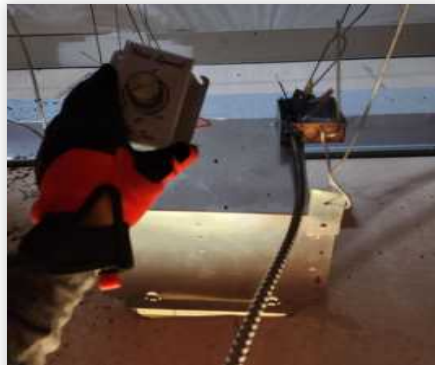
ef5speedcontroller.jp...

- The speed controller is now installed but not functional. It is not responding to adjustment. Airflow is 153 CFM out of 300 CFM design. Since speed controller not functional it is likely operating at highest speed. The fan label says it is rated for 150 CFM. Ductwork not connected at the fan.
