**Report: TAB REPORT**  
**Function: Test, Adjust, & Balance**  
**Date: 01/09/2023**

## 02-27-23 WALGREENS #3840 - BURIEN, WA

# National TAB

## Table Of Contents

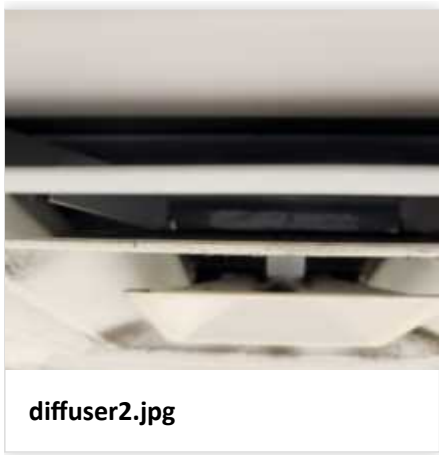
**Issue Name :** Diffuser 2 on RTU-5 (Pharmacy)

**Description :** Lever for the OBD on diffuser 2 in the pharmacy is missing. Unable to damper diffuser. As a result diffuser 4 is low.

Asset	Notes
SGRD2	OBD MISSING LEVER TO ADJUST DAMPER. UNABLE TO PUSH AIR TO DIFFUSER 4 AS A RESULT.
SGRD5	EXTRA DIFFUSER NOT SHOWN ON PLANS. READ AS IS.

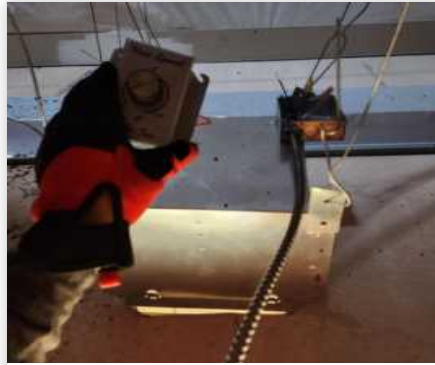
ef5speedcontroller.jp...

**Issue Name :** EF-5 is not attached to ductwork.  
**Description :** EF-5 is not attached to any ductwork and the ductwork that is installed is not attached to the roof. Speed controller is also not installed.  
**Created By :** National TAB **Assigned To :** National TAB - Will Turnbough  
**Status :** Open  
**Originated Date :** 01/05/2023 - Zack Eismin - National TAB

Fan rotation is correct	Pass
Pulleys are aligned and belts are tensioned properly	N/A
Speed controller installed and functional (direct drive)	NO
Fan is secured to the curb	Pass
Back draft damper is installed and functional	Pass
No exterior damage to the fan	Pass
No unusual noise or vibration	Pass
Controls are functional	Fail
