National TAB  
1329 E. KEMPER ROAD  
SUITE 4210  
CINCINNATI, OH 45246

**Report: TAB REPORT**  
**Function: Test, Adjust, & Balance**  
**Date: 01/09/2023**

**01-02-23 WALGREENS #3840 - BURIEN, WA**

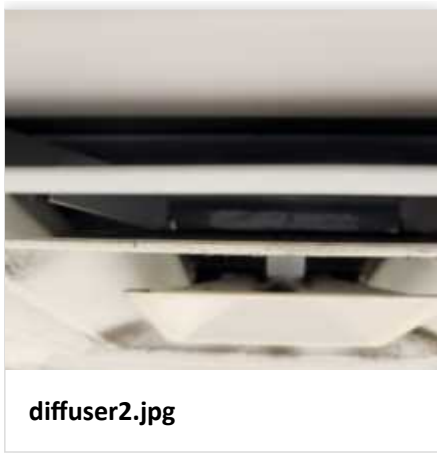
**Issue Name :** Diffuser 2 on RTU-5 (Pharmacy)

**Description :** Lever for the OBD on diffuser 2 in the pharmacy is missing. Unable to damper diffuser. As a result diffuser 4 is low.

Asset	Notes
SGRD2	OBD MISSING LEVER TO ADJUST DAMPER. UNABLE TO PUSH AIR TO DIFFUSER 4 AS A RESULT.
SGRD5	EXTRA DIFFUSER NOT SHOWN ON PLANS. READ AS IS.
