Report: TAB REPORT
Function: Test, Adjust, & Balance
Date: 01/09/2023

02-27-23 WALGREENS #3840 - BURIEN, WA

Project: 02-27-23 WALGREENS #3840 - BURIEN, WA

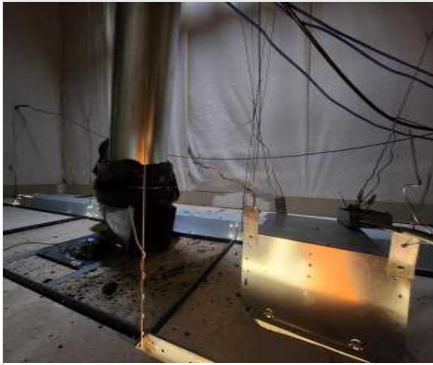
ef5.jpg

Issue Name : EF-5 is not attached to ductwork.

Description : EF-5 is not attached to any ductwork and the ductwork that is installed is not attached to the roof. Speed controller is also not installed.
