**Report: TAB REPORT**  
**Function: Test, Adjust, & Balance**  
**Date: 01/09/2023**

## 04-05-23 WALGREENS #3840 - BURIEN, WA

Project: 04-05-23 WALGREENS #3840 - BURIEN, WA

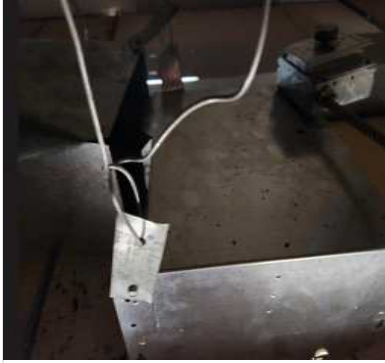
ef5.jpg

- The speed controller is now installed but not functional. It is not responding to adjustment. Airflow is 153 CFM out of 300 CFM design. Since speed controller not functional it is likely operating at highest speed. The fan label says it is rated for 150 CFM. Ductwork not connected at the fan.
