Report: PRELIM
Function: Test, Adjust, & Balance
Date: 02/02/2024

PROJECT
Valvoline (Bellevue, WI)

Project: Valvoline (Bellevue, WI)

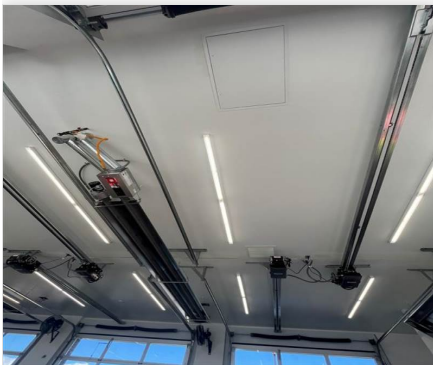
Access
02/02/2024

Issue Name : EF-2 / EF-3 Accessibility
Description : EF-2 and EF-3 in-line fans are mounted high above shop floor behind hard ceiling in attic space. A ladder or lift is needed to access ceiling hatch, and then it is necessary to crawl through insulation in 2ft high space. Not accessible.

Notes:
[1] INLINE FAN IS INSTALLED IN ATTIC SPACE BEHIND HARD CEILING. NOT ACCESSIBLE.

[1] INLINE FAN MOUNTED IN ATTIC SPACE ABOVE HARD CEILING. NOT EASILY ACCESSIBLE. COULD NOT READ AMPERAGE AND VOLTS SAFELY. LIGHT SWITCH DISCONNECT.

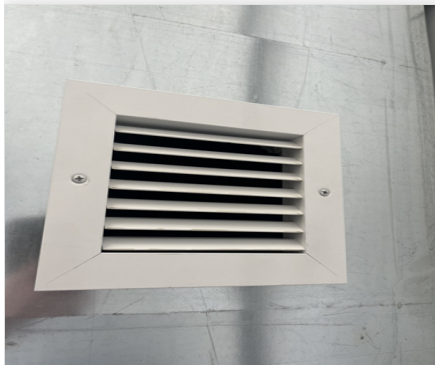
1-1NoDamper
02/02/2024

Issue Name : Return Dampers Missing
Description : Return dampers are not installed on returns 1-1 and 1-2. As a result, return airflow cannot be properly balanced. Recommend return dampers are installed.
Created By : National TAB **Assigned To :** National TAB - Michael McDonnell
Status : Open
Priority : **Asset Tag :**
Originated Date : 02/02/2024 - Michael McDonnell - National TAB

Asset	Notes	Date	Written By
Furnace1-EGRD1	[1] NO DAMPER INSTALLED	02/02/2024	Michael McDonnell
Furnace1-EGRD2	[1] NO DAMPER INSTALLED	02/02/2024	Michael McDonnell

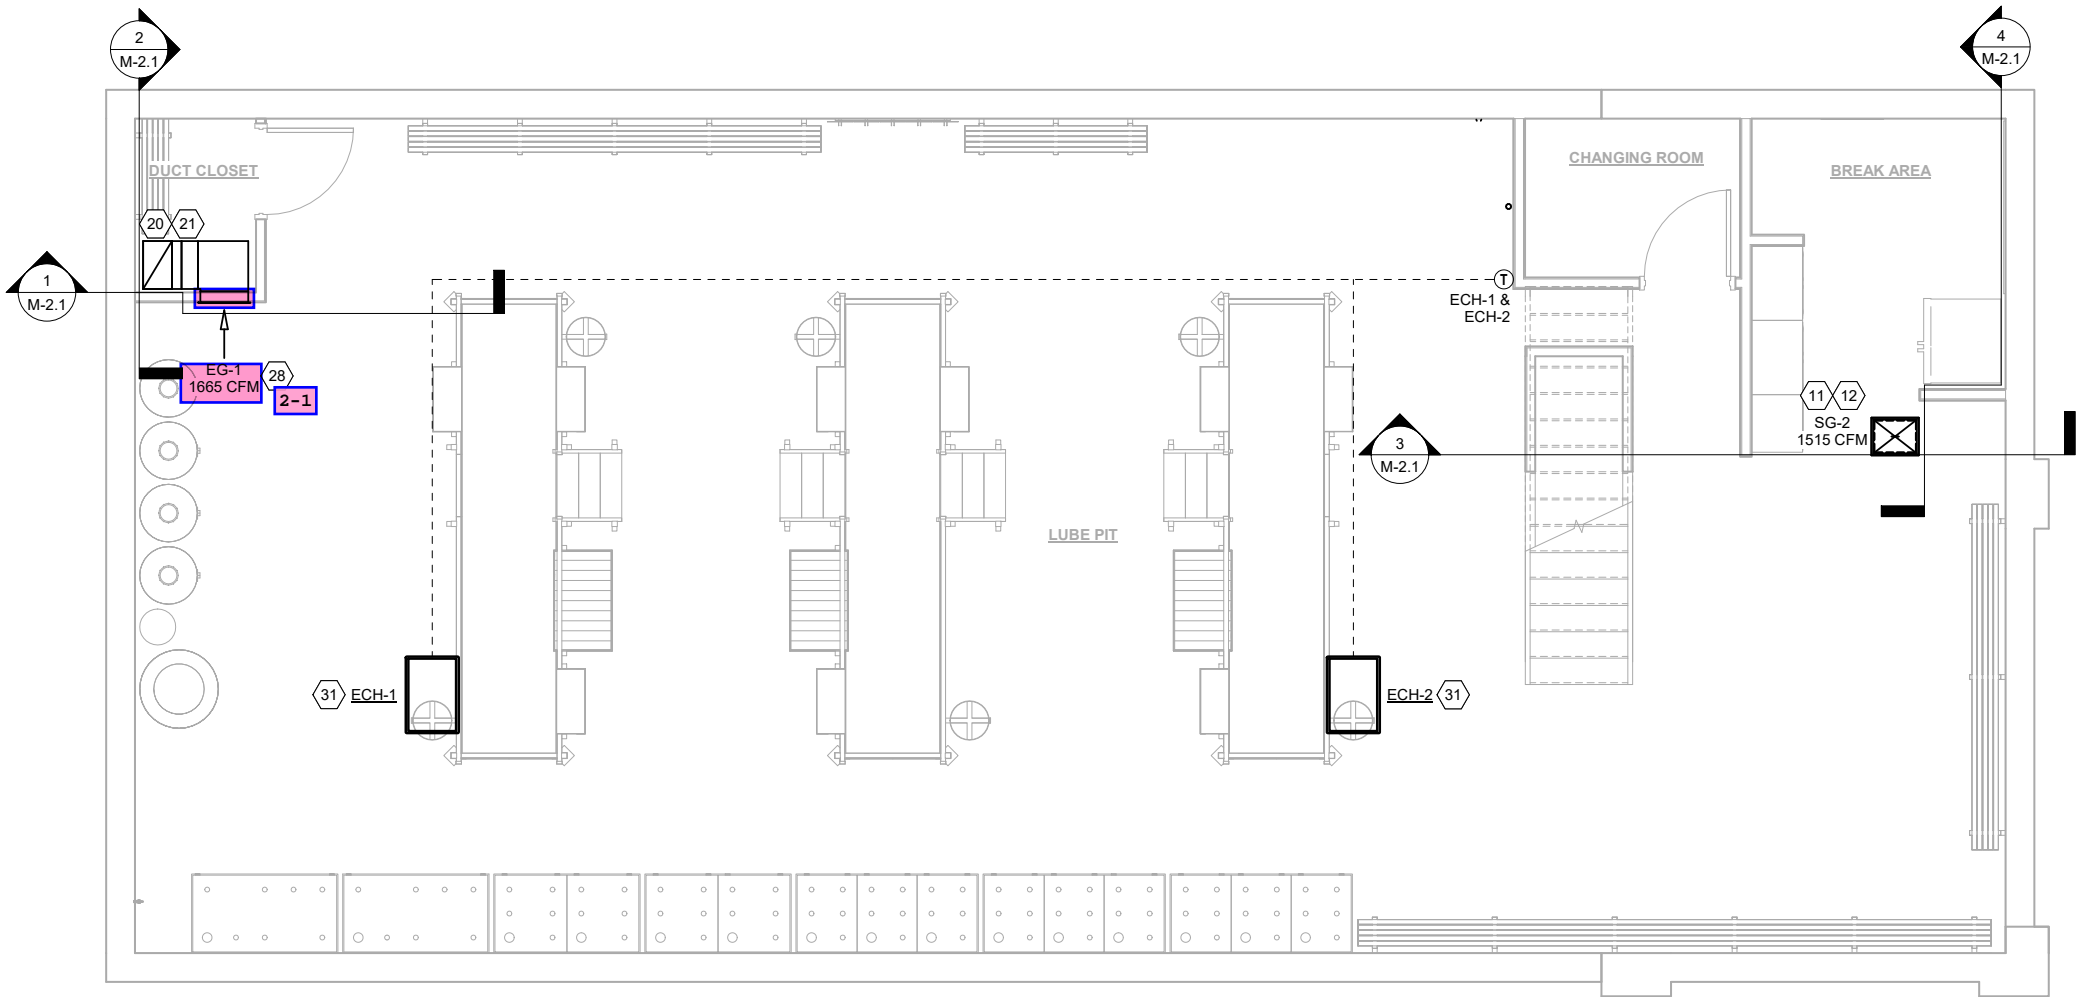
2 LOWER LEVEL MECHANICAL PLAN
 M-1.1 Scale: 1/4" = 1'-0"

Asset							
Asset Name	Location	Type	Size	DESIGN CFM	CFM(1)	FINAL CFM	% to design
Furnace1-SGRD1	MECH	SG1	6	100	91	94	94.0
Furnace1-SGRD2	UTILITY	SD1	10	400	468	418	104.5
Furnace1-SGRD3	OFFICE	SD2	6	125	105	126	100.8
Furnace1-SGRD4	RR	SD2	6	75	132	74	98.7
Furnace1-SGRD5	WAITING	SD1	10	400	374	382	95.5
Total				1100	1170	1094	99.45%

Asset								
Asset Name	Type	Size	DESIGN CFM	AK	CFM(1)	CFM(2)	FINAL CFM	% to design
Furnace1-EGRD1	RG4	6	100	0.19	228	228	228	228.0
Furnace1-EGRD2	RG3	10	375	1.0	518	518	518	138.1
Furnace1-EGRD3	RG2	6	125	1.0	46	46	46	36.8
Furnace1-EGRD4	RG1	12	375	1.0	157	157	157	41.9
Total			975		949	949	949	97.33%
