**Report: TAB Report**  
**Function: Test, Adjust, & Balance**  
**Date: 05/06/2025**  
**Completed By: National TAB**

**PROJECT**  
**04-21-25 CHUY'S DALLAS, TX**

Project: 04-21-25 CHUY'S DALLAS, TX

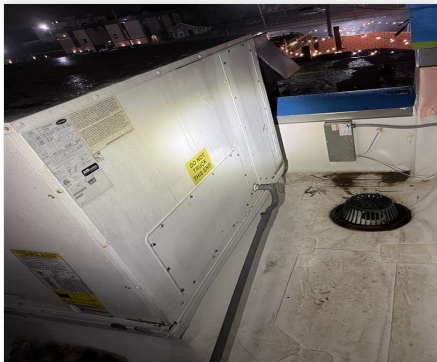
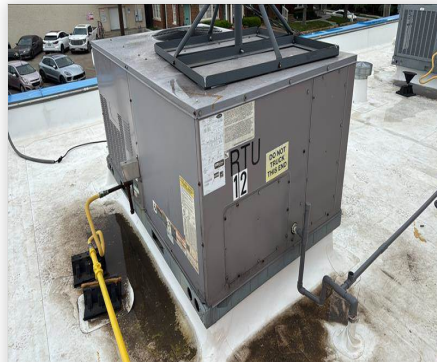
**Issue Name :** EXISTING RTU'S W/ NO OUTSIDE AIR INTAKE  
**Description :** (EX)RTU-9 AND (EX)RTU-12 DO NOT HAVE AN OUTSIDE AIR INTAKE INSTALLED ON UNITS ON THE ROOF. THIS WILL NEGITIVELY AFFECT BUILDING PRESSURE, AND WILL NEED TO BE MADE UP BY OTHER UNITS TO COMPENSATE.

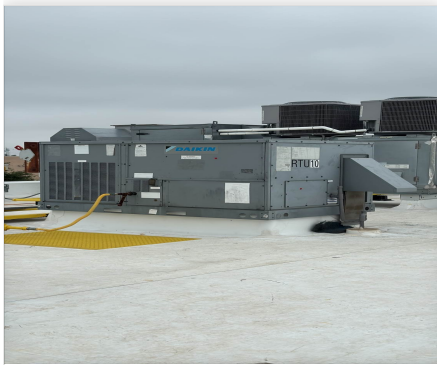
**Issue Name :** RTU-10 LOW TOTAL AIRFLOW  
**Description :** RTU-10 HAS A DIRECT DRIVE MOTOR THAT IS OPERATING AT THE HIGHEST POSSIBLE SPEED. UNIT IS AT 81% OF DESIGN.  
**Created By :** National TAB                      **Assigned To :** National TAB - Dan Hertenstein  
**Status :** Open  
**Priority :** Urgent                                      **Asset Tag :**  
**Originated Date :** 05/02/2025 - Bayley Morvant - National TAB

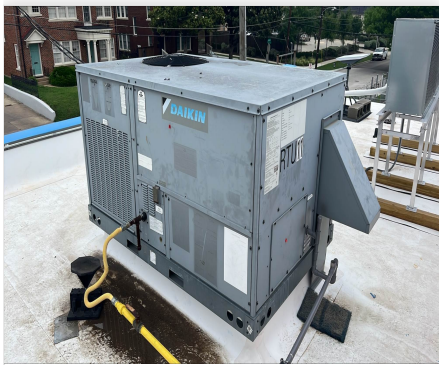
**Issue Name :** RTU-11 LOW TOTAL AIRFLOW  
**Description :** RTU-11 HAS A DIRECT DRIVE MOTOR THAT IS OPERATING AT THE HIGHEST POSSIBLE SPEED. UNIT IS AT 63% OF DESIGN.  
**Created By :** National TAB                      **Assigned To :** National TAB - Dan Hertenstein  
**Status :** Open  
**Priority :** Urgent                                      **Asset Tag :**  
**Originated Date :** 05/02/2025 - Bayley Morvant - National TAB

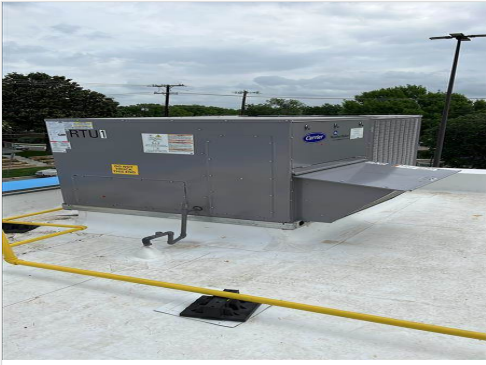
Asset: RTU1

Test Data		
	Design	Actual
SF CFM	4000	4101
SF RPM	-	DIRECT DRIVE
RA CFM	3200	3239
OA CFM	800	862
RL Voltage	208	208
RL Amperage	6.4	5.8
SF Rotation	-	CCW
SF System SetPt	-	SETTING C 50%
RA Damper Position	-	72% OPEN
Min OA Damper Position	-	28% OPEN
Min OA Damper Type	-	OPOSED BLADE
OA Enthalpy Setpt	-	53

Notes:  
UNIT HAS TWO EXTRA SUPPLY DIFFUSERS IN KITCHEN AREA. IN ORDER TO KEEP TOTAL CFM AT DESIGN, ORIGINAL CFM DIFFUSER DESIGNS WERE ADJUSTED.

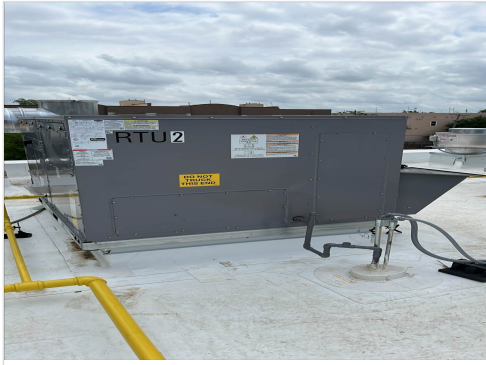
Asset: RTU2

Test Data		
	Design	Actual
SF CFM	4000	3729
SF RPM	-	DIRECT DRIVE
RA CFM	3200	2914
OA CFM	800	815
RL Voltage	208	206
RL Amperage	6.4	5.2
SF Rotation	-	CCW
SF System SetPt	-	SETTING C 50%
RA Damper Position	-	72% OPEN
Min OA Damper Position	-	28% OPEN
Min OA Damper Type	-	OPOSED BLADE
OA Enthalpy Setpt	-	53

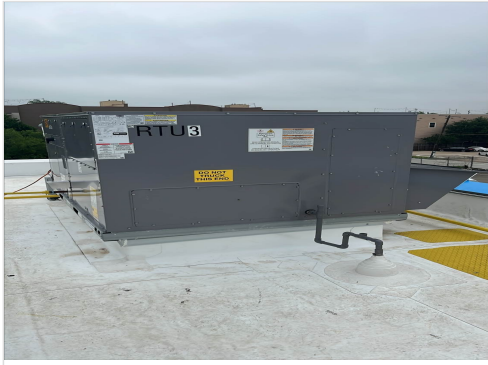
Asset: RTU3

Test Data		
	Design	Actual
SF CFM	4000	3676
SF RPM	-	DIRECT DRIVE
RA CFM	3200	2813
OA CFM	800	863
RL Voltage	208	211/211/211
RL Amperage	6.4	6.4/6.5/6.5
SF Rotation	-	CW
SF System SetPt	-	SETTING C 100%
RA Damper Position	-	65% OPEN
Min OA Damper Position	-	35% OPEN
Min OA Damper Type	-	OPOSED BLADE
OA Enthalpy Setpt	-	53

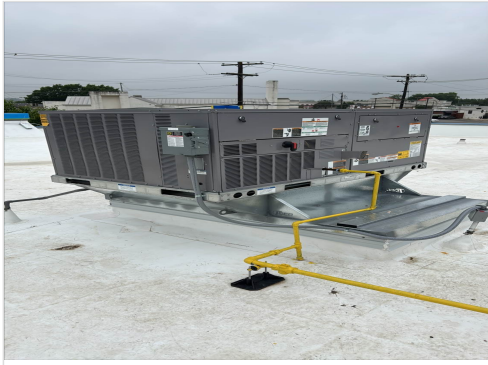
Asset: RTU4

Test Data		
	Design	Actual
SF CFM	2000	1949
SF RPM	-	DIRECT DRIVE
RA CFM	1600	1511
OA CFM	400	438
RL Voltage	-	212
RL Amperage	-	8.4
SF Rotation	-	CCW
SF System SetPt	-	SETTING C 80%
RA Damper Position	-	65% OPEN
Min OA Damper Position	-	35% OPEN
Min OA Damper Type	-	OPOSED BLADE
OA Enthalpy Setpt	-	53
