**Report: TAB Report**  
**Function: Test, Adjust, & Balance**  
**Date: 05/06/2025**  
**Completed By: National TAB**

**PROJECT**  
**04-21-25 CHUY'S DALLAS, TX**

Chuys Restaurants

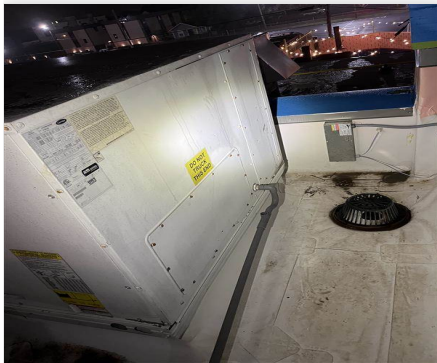
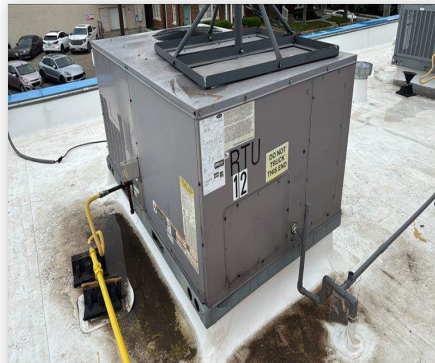
**Issue Name :** EXISTING RTU'S W/ NO OUTSIDE AIR INTAKE  
**Description :** (EX)RTU-9 AND (EX)RTU-12 DO NOT HAVE AN OUTSIDE AIR INTAKE INSTALLED ON UNITS ON THE ROOF. OA HAD TO BE INCREASED TO OTHER UNITS TO ENSURE NEUTRAL BUILDING PRESSURE.

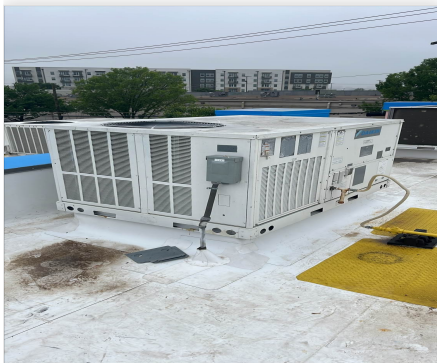
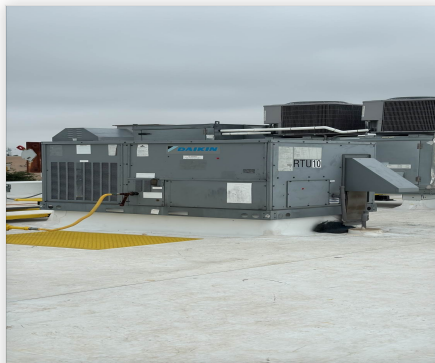
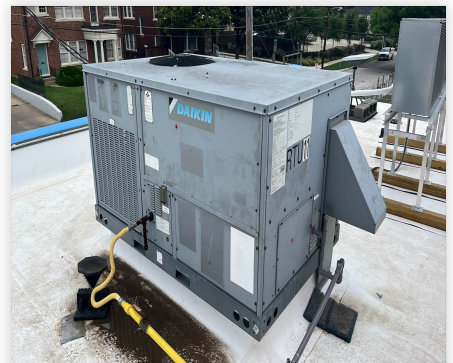
**Issue Name :** MULTIPLE RTU LOW OUTSIDE AIR  
**Description :** RTU-8, RTU-10 and RTU-11 all have low outside air with outside air dampers at 100% open. All three of these units have a small outside air intake that is 8.5"x12" and a manual slide damper.  
**Created By :** National TAB                      **Assigned To :** National TAB - Dan Hertenstein  
**Status :** Open  
**Priority :** InfoOnly                                      **Asset Tag :**  
**Originated Date :** 05/02/2025 - Bayley Morvant - National TAB

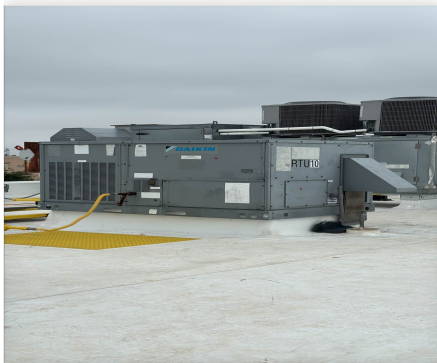
**Issue Name :** RTU-10 LOW TOTAL AIRFLOW  
**Description :** RTU-10 HAS A DIRECT DRIVE MOTOR THAT IS OPERATING AT THE HIGHEST POSSIBLE SPEED. UNIT IS AT 81% OF DESIGN. IT IS OPERATING AT 341 CFM/TON AND SHOULD NOT CAUSE ANY PERFORMANCE ISSUES.  
**Created By :** National TAB                      **Assigned To :** National TAB - Dan Hertenstein  
**Status :** Open  
**Priority :** InfoOnly                                      **Asset Tag :**  
**Originated Date :** 05/02/2025 - Bayley Morvant - National TAB

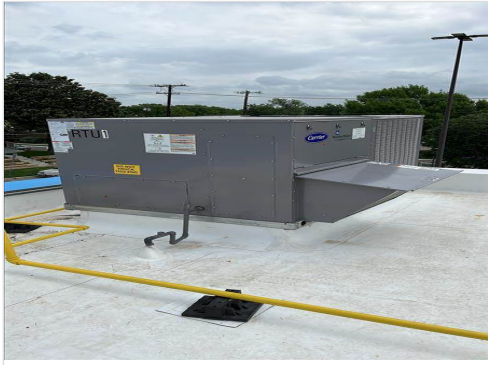
Notes:  
 UNIT HAS TWO EXTRA SUPPLY DIFFUSERS IN KITCHEN AREA. IN ORDER TO KEEP TOTAL CFM AT DESIGN, ORIGINAL CFM DIFFUSER DESIGNS WERE ADJUSTED.
