Report: TAB Report
Function: Test, Adjust, & Balance
Date: 07/29/2025
Completed By: National TAB

07-28-25 WAWA #5470 JACKSONVILLE, FL

Project: 07-28-25 WAWA #5470 JACKSONVILLE, FL

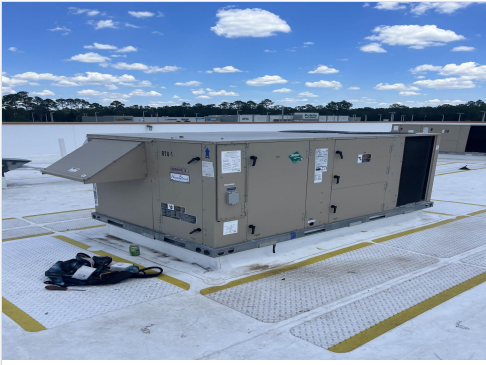
Unit Data - PHOTO LOG

Asset: RTU1

AREA: CORE

Unit Data		
	Design	Actual
MFG	LENNOX ENLIGHT	LENNOX
Serial Num	-	5624L02672
Model Num	LCT102H4E	LCT102H4EG2Y
Type	RTU	RTU
Configuration	VERTICAL	VERTICAL
Num OA Filters 1	-	1
OA Filter Size 1	-	23X14
Num Final Filter 1	-	4
Final Filter Size 1	-	20X25X2
