**Report: TAB Report**  
**Function: Test, Adjust, & Balance**  
**Date: 07/29/2025**  
**Completed By: National TAB**

## 07-28-25 WAWA #5470 JACKSONVILLE, FL

Project: 07-28-25 WAWA #5470 JACKSONVILLE, FL

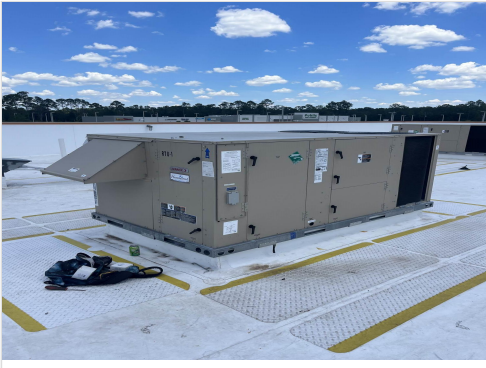
## Unit Data - PHOTO LOG

Asset: RTU1

AREA: CORE

Unit Data		
	Design	Actual
MFG	LENNOX ENLIGHT	LENNOX
Serial Num	-	5624L02672
Model Num	LCT102H4E	LCT102H4EG2Y
Type	RTU	RTU
Configuration	VERTICAL	VERTICAL
Num OA Filters 1	-	1
OA Filter Size 1	-	23X14
Num Final Filter 1	-	4
Final Filter Size 1	-	20X25X2

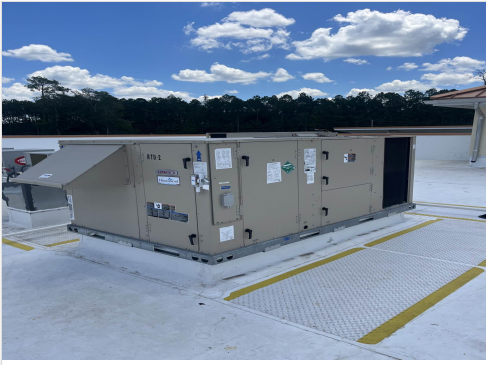
## Unit Data - PHOTO LOG

Asset: RTU2

AREA:DELI

Unit Data		
	Design	Actual
MFG	LENNOX ENLIGHT	LENNOX
Serial Num	-	5624L02674
Model Num	LCT150H4E	LCT150H4EN2Y
Type	RTU	RTU
Configuration	VERTICAL	VERTICAL
Num OA Filters 1	-	1
OA Filter Size 1	-	23X14
Num Final Filter 1	-	4
Final Filter Size 1	-	20X25X2

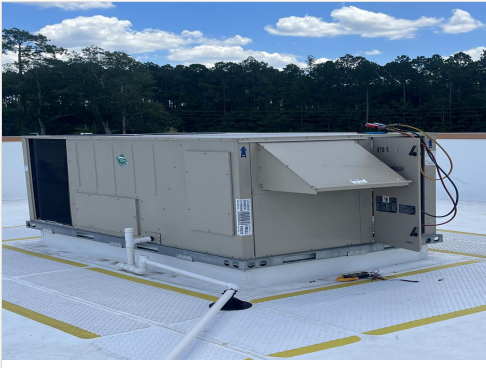
## Unit Data - PHOTO LOG

Asset: RTU3

AREA:RETAIL

Unit Data		
	Design	Actual
MFG	LENNOX ENLIGHT	LENNOX ENLIGHT
Serial Num	-	5624K00726
Model Num	LCT092H4E	LCT092H4EG1Y
Type	RTU	RTU
Configuration	VERTICAL	VERTICAL
Num OA Filters 1	-	1
OA Filter Size 1	-	23X14
Num Final Filter 1	-	4
Final Filter Size 1	-	20X25X2

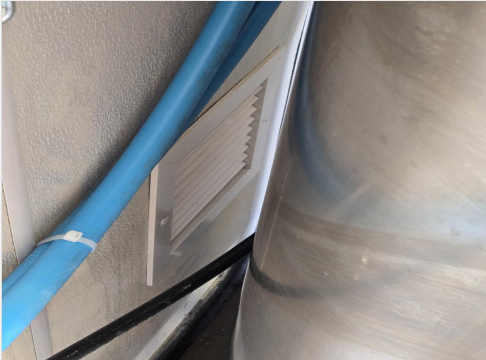
### Unit Data - PHOTO LOG

Asset: EF2

AREA:WALK IN REFRIGERATOR

Unit Data		
	Design	Actual
MFG	GREENHECK	GREENHECK
Model Num	CSP-B110	CSP-B110
Serial Num	-	N/A
Type	INLINE	INLINE
Configuration	HORIZONTAL	HORIZONTAL

Notes:  
UNABLE TO ACCESS MOTOR TO GET MOTOR DATA / TEST DATA. IT IS INSIDE A HARD WALL.
