**National TAB  
1329 E. KEMPER ROAD  
SUITE 4210  
CINCINNATI, OH 45246**

**Report: TAB REPORT  
Function: Test, Adjust, & Balance  
Date: 03/05/2023**

## **01-23-23 CULVERS - RICHLAND CENTER, WI (REVIVE)**

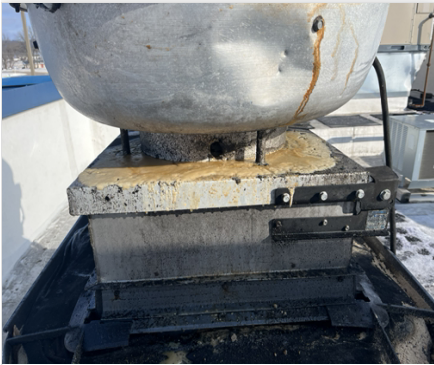
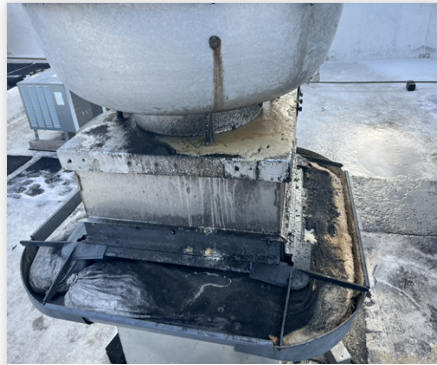
PRV-2.jpeg

**Issue Name :** PRV-2 and PRV-3 (hood fans) need cleaning.

**Description :** Both hood exhaust fans have significant grease and dirt build up. Recommend Fans are cleaned.

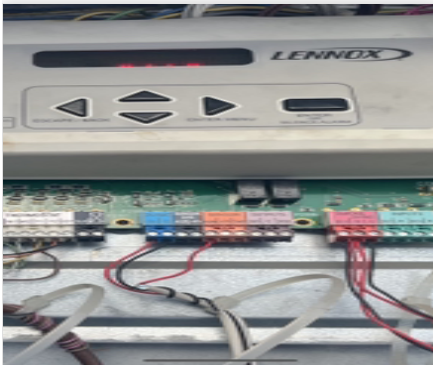
Wiring.jpeg

**Issue Name :** RTU Humidity sensor wiring

**Description :** Drain wires for humidity sensor are not connected. Recommend drain wires are connected per humidity sensor wiring schematic attached.

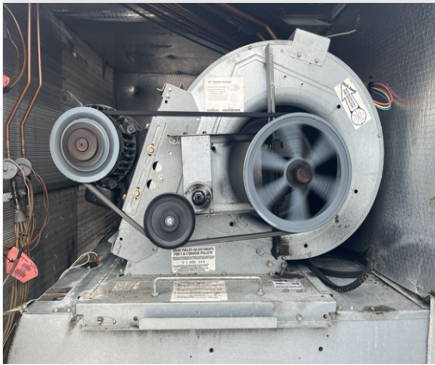
Tensionpulley.jpeg

**Issue Name :** RTU-2 (Kitchen) Tension Pulley

**Description :** Belt tension pulley on RTU-2 is creating a significant amount of noise. Recommend pulley is serviced or replaced to prevent drive failure.

Economizers are assembled and functional?	Yes, some play in actuator gears on RTU-2 (kitchen).
DCV Max damper opening position is set to minimum?	Yes
Free cooling enthalpy set point set for lowest setting (Typically "D")	Yes
Motors are all operating below the FLA rating?	Yes
Are belts tight?	Yes
If direct drive unit is the speed controller working.	NA
Is gas piping installed and valves turned on?	Yes
Unit free of noticeable noise and vibration	Some tension pulley noise on RTU-2, see issue.

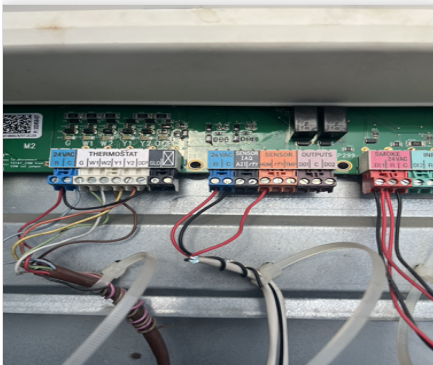
RTU-2.jpeg

**Issue Name :** RTUs jumpered for occupancy.

**Description :** Both RTU-1 and RTU-2 are jumpered for occupancy (wire from R to OCP). When OCP is energized, the outside air damper opens. Recommend the jumper is removed and a wire is run from OCP to each RTUs thermostat. This will allow the outside damper to modulate based on scheduled occupancy at the thermostat.

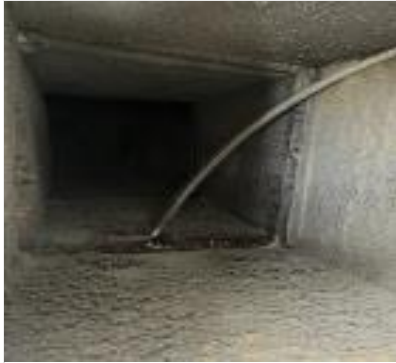
PRV-1.jpeg

For restroom fan(s) is the back draft damper installed and can it fully open?

No backdraft damper installed.
