Report: TAB REPORT
Function: Test, Adjust, & Balance
Date: 11/11/2024
Completed By: National TAB

**11-04-24 UCHIKO - AUSTIN, TX (REFRESH
TAB)**

4200 NORTH LAMAR BLVD SERVICE RD

HAI Hospitality

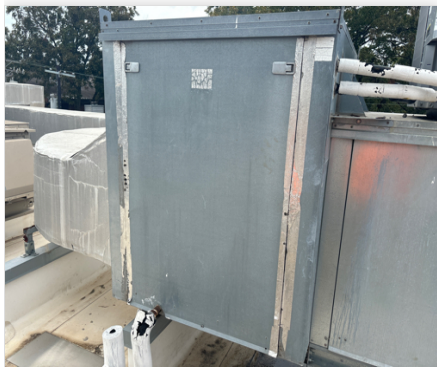
Issue Name : MUA-1 Leakage
Description : Major leakage observed at MUA-1 discharge panel. Recommend sealing. Silver tape re-installed by NTAB during testing for more accurate readings.
Created By : National TAB **Assigned To :** National TAB - Oscar Ventura
Status : Open
Priority : Medium **Asset Tag :**
Originated Date : 11/04/2024 - Wesley John - National TAB

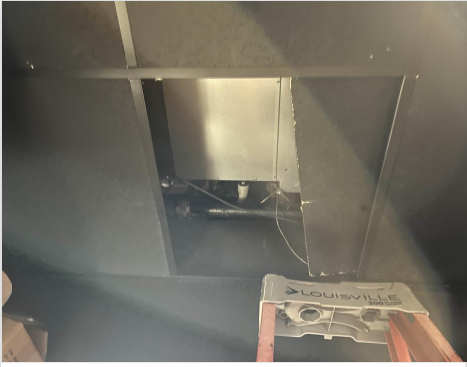
AHU_3_1188807109

Test Data		
	Design	Actual
SF CFM	1000	1054
SF RPM	-	(1)
RA CFM	-	(1)
OA CFM	-	(1)
RL Voltage	-	208
RL Amperage	-	(1)
SF Rotation	-	(1)
SF System SetPt	-	(1)
RA Damper Position	-	(1)
Min OA Damper Position	-	(1)
Min OA Damper Type	-	(1)

(1). UNIT NOT ACCESSIBLE FOR TESTING.

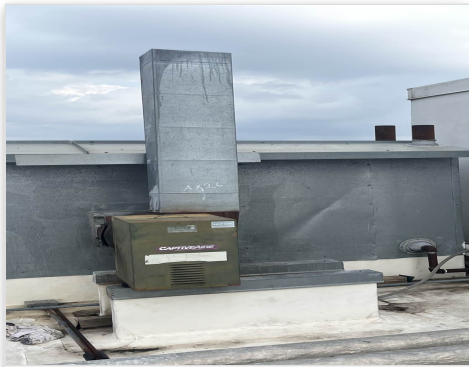
KEF_1_855637545

Test Data		
	Design	Actual
CFM	1100	1252
Fan RPM	-	2630
Fan Rotation	-	CCW
Motor RPM	-	1720
System SetPt	-	3 TURNS
RL Voltage	-	208
RL Amperage	-	6.1
Total ESP	-	2.2"
Fan Inlet SP	-	-2.2"
Fan Discharge SP	-	ATM

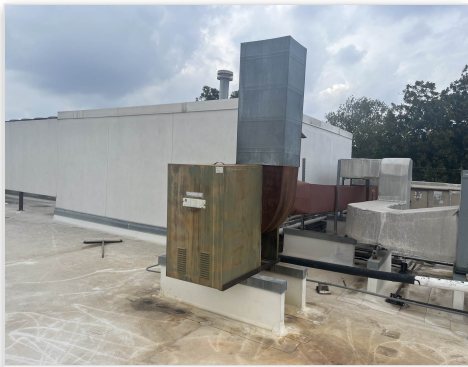
KEF_2_1304084446

Test Data		
	Design	Actual
CFM	4130	4493
Fan RPM	-	1365
Fan Rotation	-	CCW
Motor RPM	-	1774
System SetPt	-	5 TURNS
RL Voltage	-	208/209/208
RL Amperage	-	7.9/8.2/8.4
Total ESP	-	[1]
Fan Inlet SP	-	[1]
Fan Discharge SP	-	ATM

After testing, the building pressure was measured at -0.021" W.C. The initial building pressure was -0.025". The change in measurements was achieved by bringing down the air flow for KEF-2 to within tolerance. The hoods served by KEF-2 are still performing well.

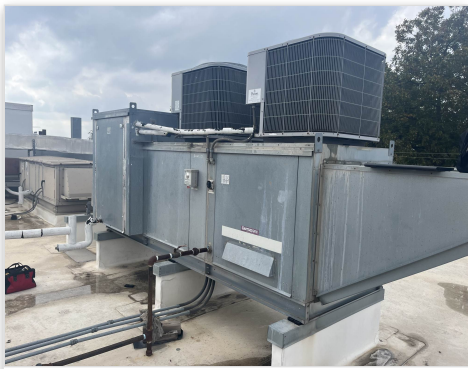
MAU_1_487108293

Issue Name : MUA-1 Air Flow
Description : MUA-1 air flow was measured at 3792 CFM out of 5760 design (66%). This is likely due to restrictions at the air devices. There is not much room in the ceiling space. Could not investigate very well. Discharge pressure was measured at 1.78" which is high and supports downstream restriction.
Created By : National TAB **Assigned To :** National TAB - Oscar Ventura
Status : Open
Priority : Urgent **Asset Tag :**
Originated Date : 11/11/2024 - Wesley John - National TAB

Gas Heat		
	Design	Actual
Heater Operates (y/n)	-	NA
Flame Status (pass/fail)	-	NA
Inlet Air Temp SetPt	-	55
Discharge Air Temp SetPt	-	60
Air Flow Switch SP Actual	-	0.21"

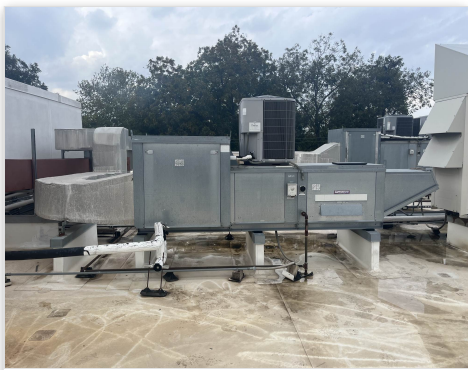
MAU_2_183840507

Issue Name : MUA-2 Air Flow
Description : MUA-2 air flow was measured at 64% of design air flow. Fan speed maximized. Unit is likely undersized and designed for too small of a static pressure. 0.40" measured at unit. There are (4) 90 degree turns between the unit and the air devices in the space. The unit is likely unable to overcome these restrictions.
Created By : National TAB **Assigned To :** National TAB - Oscar Ventura
Status : Open
Priority : Urgent **Asset Tag :**
Originated Date : 11/11/2024 - Wesley John - National TAB

Gas Heat		
	Design	Actual
Heater Operates (y/n)	-	N/A
Flame Status (pass/fail)	-	N/A
Inlet Air Temp SetPt	-	55.0 F
Discharge Air Temp SetPt	-	60.0 F
Air Flow Switch SP Actual	-	0.18"
