Report: TAB REPORT
Function: Test, Adjust, & Balance
Date: 01/22/2026
Completed By: National TAB

01-19-26 Culvers - Dundee, MI (DOAS, TAB)

Project: 01-19-26 Culvers - Dundee, MI (DOAS, TAB)

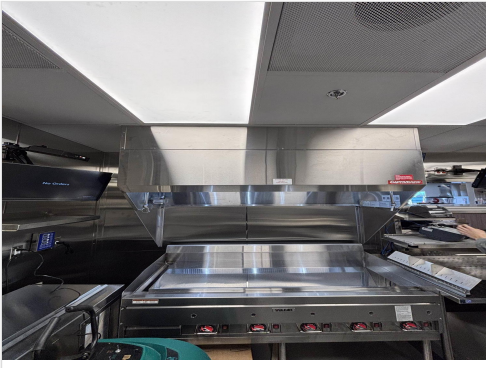
Unit Data - PHOTO LOG

Asset: HD-2

AREA:GRIDDLE HOOD

Unit Data		
	Design	Actual
MFG	CAPTIVEAIRE	CAPTIVEAIRE
Model Num	3347BD-2	3347BD-2
Job / Serial Num	-	7511080
Type	TYPE I CANOPY	TYPE I CANOPY
Hood length	66"	66"
Hood Width	33"	33"
