Report: TAB REPORT
Function: Test, Adjust, & Balance
Date: 01/22/2026
Completed By: National TAB

01-19-26 Culvers - Dundee, MI (DOAS, TAB)

16495 Tecumseh Street

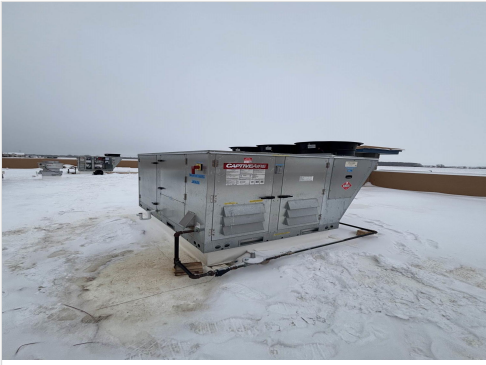
Unit Data - PHOTO LOG

Asset: RTU-1

Test Data		
	Design	Actual
SF CFM	6300	6466
RA CFM	4700	4788
OA CFM	1600	1678
RL Voltage	-	188 VFD
RL Amperage	-	23.2 VFD
SF Rotation	-	CCW CORRECT
SF System SetPt	-	56 HZ
RA Damper Position	-	MECHANICALLY LINKED
Min OA Damper Position	-	3.8 VDC
Min OA Damper Type	-	ECONOMIZER

Ceiling diffuser used in vestibule instead of ECH. Set to typical Culver's vestibule total of 150 CFM

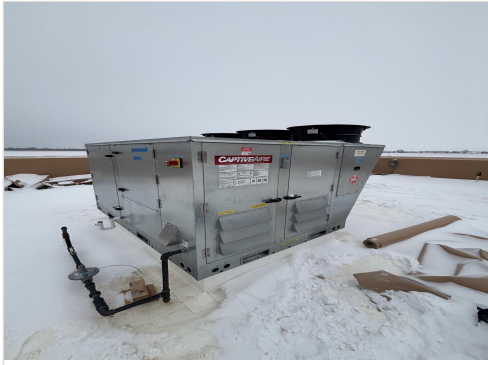
Unit Data - PHOTO LOG

Asset: RTU-2

Test Data		
	Design	Actual
SF CFM	6300	6193
RA CFM	3900	3726
OA CFM	2400	2467
RL Voltage	-	188 VFD
RL Amperage	-	24.0 VFD
SF Rotation	-	CCW CORRECT
SF System SetPt	-	56 HZ
RA Damper Position	-	MECHANICALLY LINKED
Min OA Damper Position	-	4.2 VDC
Min OA Damper Type	-	ECONOMIZER

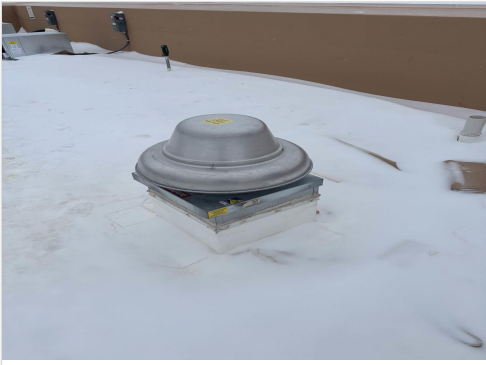
Unit Data - PHOTO LOG

Asset: PRV-1

Test Data		
	Design	Actual
CFM	300	294
Fan RPM	-	720
Fan Rotation	-	CCW CORRECT
Motor RPM	-	720
System SetPt	-	40%
RL Voltage	-	INACCESSIBLE
RL Amperage	-	INACCESSIBLE
Total ESP	0.50"	0.04"
Fan Inlet SP	-	-0.04"
Fan Discharge SP	-	ATM

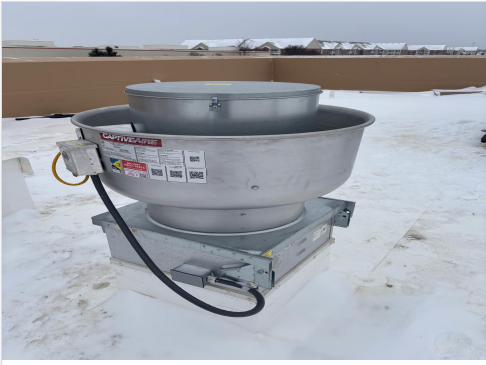
Unit Data - PHOTO LOG

Asset: PRV-2

Test Data		
	Design	Actual
CFM	1500	1555
Fan RPM	-	1080
Fan Rotation	-	CCW CORRECT
Motor RPM	-	1080
System SetPt	-	56%
RL Voltage	-	122
RL Amperage	-	3.8
Total ESP	1.412"	0.99"
Fan Inlet SP	-	-0.99"
Fan Discharge SP	-	ATM

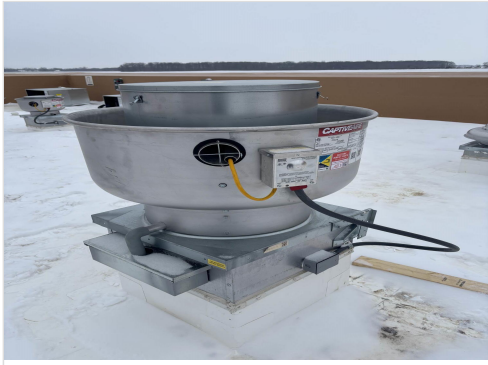
Unit Data - PHOTO LOG

Asset: PRV-3

Test Data		
	Design	Actual
CFM	1500	1535
Fan RPM	-	1134
Fan Rotation	-	CCW CORRECT
Motor RPM	-	1134
System SetPt	-	59%
RL Voltage	-	123
RL Amperage	-	4.6
Total ESP	1.25"	1.16"
Fan Inlet SP	-	-1.16"
Fan Discharge SP	-	ATM

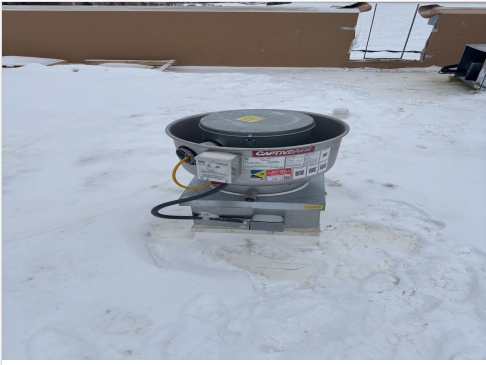
Unit Data - PHOTO LOG

Asset: PRV-4

Test Data		
	Design	Actual
CFM	350	379
Fan RPM	-	823
Fan Rotation	-	CCW CORRECT
Motor RPM	-	822
System SetPt	-	44%
RL Voltage	-	123
RL Amperage	-	0.35
Total ESP	0.25"	0.12"
Fan Inlet SP	-	-0.12"
Fan Discharge SP	-	ATM

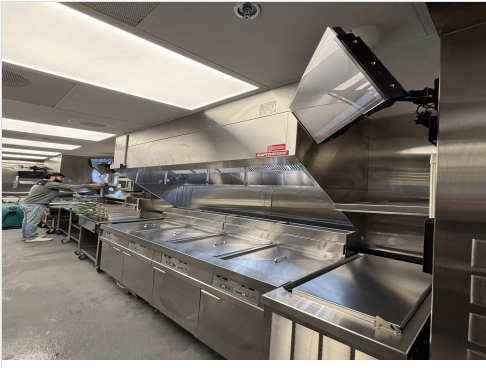
Unit Data - PHOTO LOG

Asset: HD-1

Test Data Exhaust		
	Design	Actual
Filter Type	CAPTRATE SOLO FILTER	CAPTRATE SOLO FILTER
Filter Size 1	16X16	16x16
Filter Qty 1	5	5
Filter AK factor size 1	1.62	1.62
Filter Total AK Area	8.1	8.1
Filter1 FPM	-	184
Filter2 FPM	-	186
Filter3 FPM	-	201
Filter4 FPM	-	203
Filter5 FPM	-	187
Filter Ave FPM(corr)	-	192
CFM	1500	1555

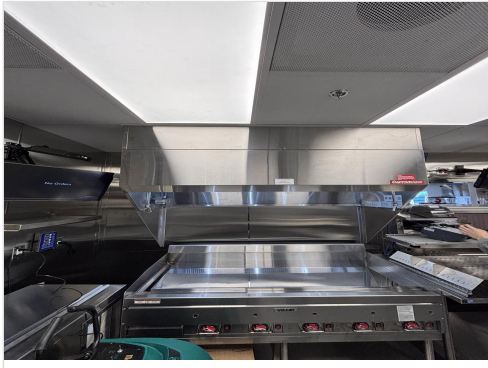
Unit Data - PHOTO LOG

Asset: HD-2

Test Data Exhaust		
	Design	Actual
Filter Type	CAPTRATE SOLO FILTER	CAPTRATE SOLO FILTER
Filter Size 1	16X16	16x16
Filter Qty 1	4	4
Filter AK factor size 1	1.62	1.62
Filter Total AK Area	6.48	6.48
Filter1 FPM	-	237
Filter2 FPM	-	233
Filter3 FPM	-	233
Filter4 FPM	-	245
Filter Ave FPM(corr)	-	237
CFM	1500	1535

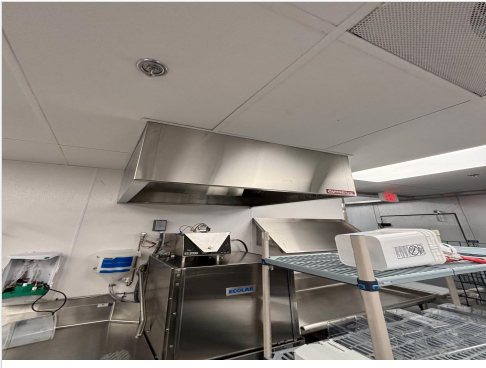
Unit Data - PHOTO LOG

Asset: HD-3

Test Data		
	Design	Actual
Exhaust CFM	350	379
