**Report: TAB**

**Function: Test, Adjust, & Balance**

**Date: 12/09/2024**

**12-09-24 CHIPOTLE #5255 AUBURN, AL  
(AUBURN MALL)**

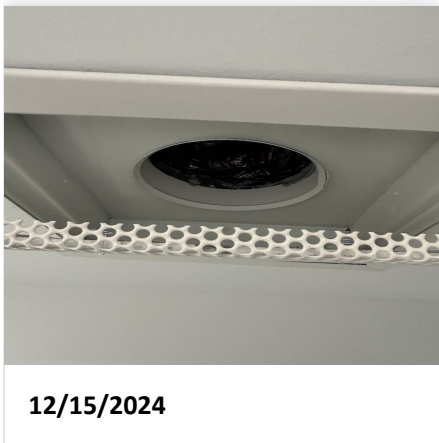
Project Issue File Details

**Issue Name :** Diffuser 2-1 - No Damper Installed  
**Description :** Supply diffuser 2-1 (restroom) is outputting 121 CFM (242% design) and cannot be adjusted as there is no face-accessible damper installed. This high flow is causing the restroom to have slightly positive pressure. Recommend installing OBD's.  
**Created By :** National TAB                      **Assigned To :** National TAB - Will Turnbough  
**Status :** Open  
**Priority :** High                                      **Asset Tag :** RTU 2-SGRD1  
**Originated Date :** 12/15/2024 - Mark Johnson - National TAB

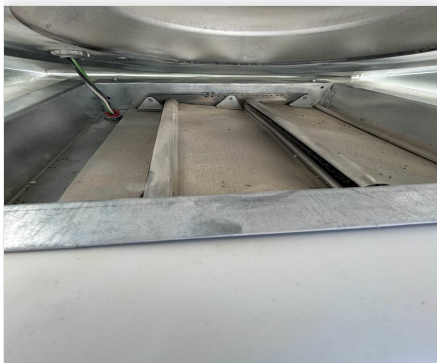
Project Issue File Details

**Issue Name :** EF-2 - Backdraft Damper  
**Description :** The backdraft damper for EF-2 is installed too close to the base of the fan, preventing it from opening fully. Recommend moving backdraft damper per mechanical plans.  
**Created By :** National TAB                      **Assigned To :** National TAB - Will Turnbough  
**Status :** Open  
**Priority :** Low                                      **Asset Tag :** EF2  
**Originated Date :** 12/16/2024 - Mark Johnson - National TAB

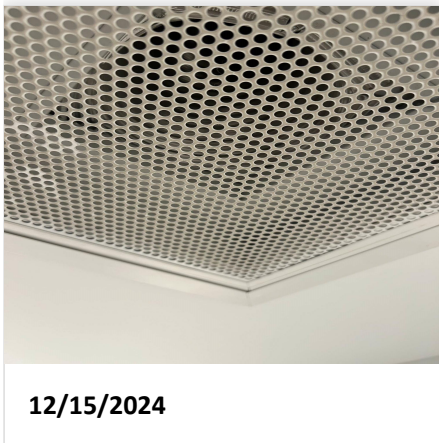
Project Issue File Details

**Issue Name :** Restroom Exhaust - No Dampers Installed  
**Description :** No face-accessible dampers are installed to balance the individual restroom exhaust grilles. EF-2 is within design total (143 CFM), but the exhaust is split disproportionately between the two restrooms (103 CFM and 40 CFM). Recommend installing dampers and inspecting duct for possible restriction.

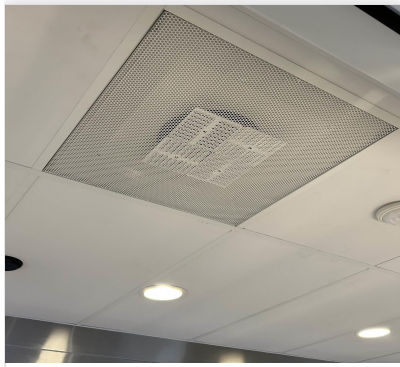
**Deflector plates are removed from 1x1 diffusers on the serve line (double check that this is specified on the diffuser schedule first)** N/A

Not specified for removal

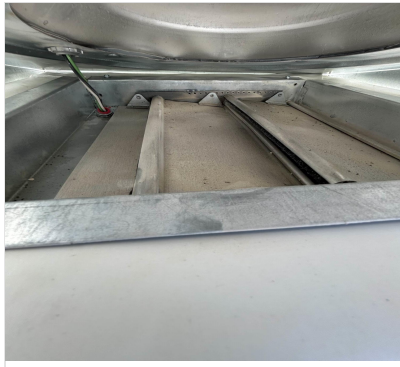
For restroom fan(s) is the back draft damper installed and can it fully open?

No

Cannot fully open, too close to fan

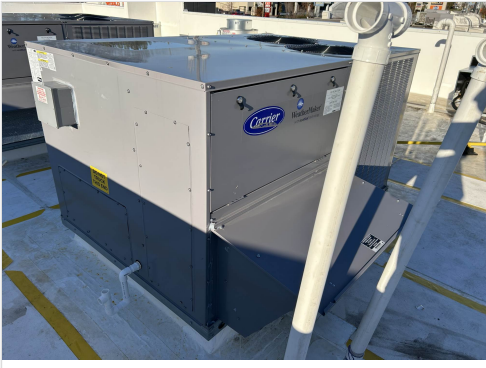
## Unit Data - PHOTO LOG

Unit Data		
	Design	Actual
MFG	CARRIER	CARRIER
Serial Num	-	0424P63006
Model Num	48FCFN12	48FCFN12D3M5A6W4F0
Type	RTU	RTU
Configuration	VERTICAL	VERTICAL
Num OA Filters 1	-	1
OA Filter Size 1	-	35x19
Num Final Filter 1	-	4
Final Filter Size 1	-	20x20x2

Notes:  
Line 1 wire (black) not accessible for amp reading

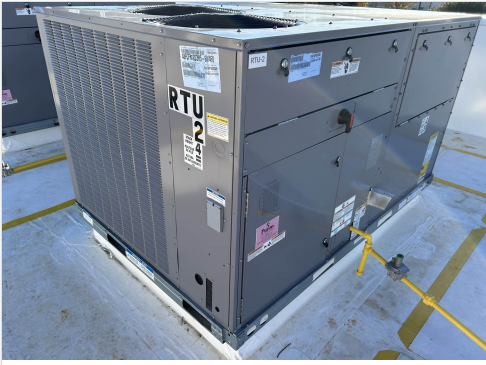
## Unit Data - PHOTO LOG

Unit Data		
	Design	Actual
MFG	CARRIER	CARRIER
Serial Num	-	0424P62830
Model Num	48FCFN12	48FCFN12D3M5A6W4F0
Type	RTU	RTU
Configuration	VERTICAL	VERTICAL
Num OA Filters 1	-	1
OA Filter Size 1	-	35x19
Num Final Filter 1	-	4
Final Filter Size 1	-	20x20x2

Notes:  
Lines 2 and 3 (yellow and blue) not accessible for amp readings

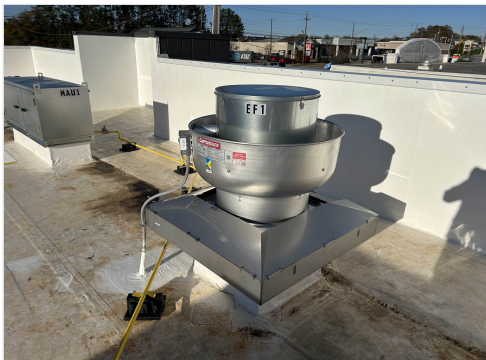
### Unit Data - PHOTO LOG

Unit Data		
	Design	Actual
MFG	CAPTIVE-AIRE	CAPTIVE-AIRE
Model Num	DU180HFA	DU180HFA
Serial Num	-	6726669
Type	DD	DD
Configuration	UPBLAST	UPBLAST

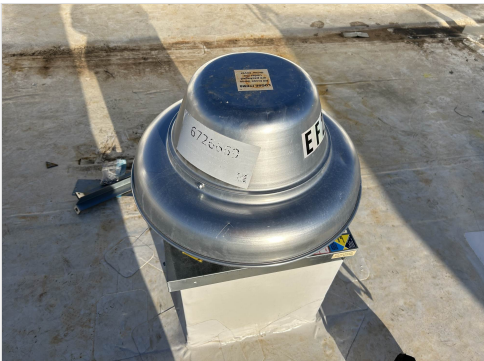
### Unit Data - PHOTO LOG

Unit Data		
	Design	Actual
MFG	CAPTIVE-AIRE	CAPTIVE-AIRE
Model Num	DR12HFA	DR12HFA
Serial Num	-	6726669
Type	DD	DD
Configuration	DOWNBLAST	DOWNBLAST

NO FACE ACCESSIBLE DAMPERS INSTALLED. POSSIBLE RESTRICTION IN DUCT ABOVE HARD CEILING, NOT ACCESSIBLE.

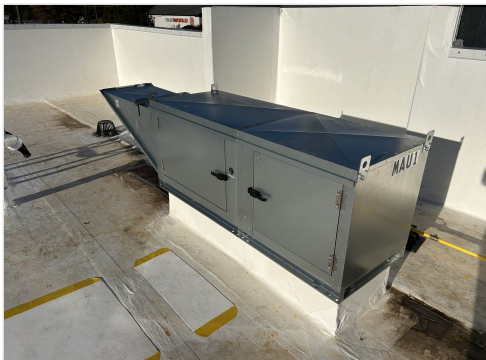
### Unit Data - PHOTO LOG

Unit Data		
	Design	Actual
MFG	CAPTIVE-AIRE	CAPTIVE-AIRE
Model Num	A1-D.250-15D	A1-D.250-15D
Serial Num	-	6726669
Type	MAU	MAU
Configuration	VERTICAL	VERTICAL

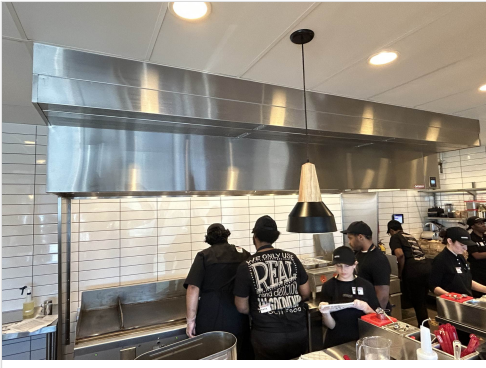
## Unit Data - PHOTO LOG

Unit Data		
	Design	Actual
MFG	CAPTIVE-AIRE	CAPTIVE-AIRE
Model Num	5424 ND-2-ACPSP-F	5424 ND-2-ACPSP-F
Job / Serial Num	-	6726669
Type	TYPE 1 CANOPY	TYPE I CANOPY
Hood length	153"	153"
Hood Width	54"	54"
Supply Plenum Type	-	ACPSP
Supply Plenum Width	9"	9"
Supply Plenum Length	165"	165"
