Report: Prelim Report
Function: Test, Adjust, & Balance
Date: 11/26/2024
Completed By: National TAB

PROJECT
11-25-24 PENN STATION ASHLAND, KY

Project: 11-25-24 PENN STATION ASHLAND, KY

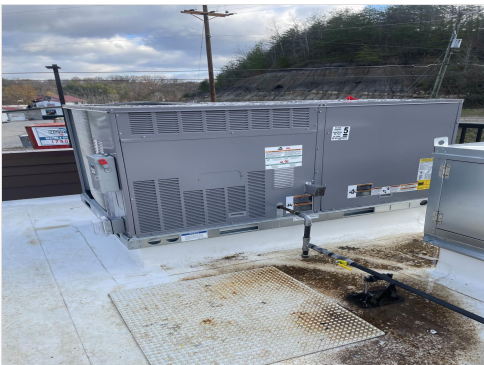
Asset: RTU2

AREA: KITCHEN

Test Data		
	Design	Actual
SF CFM	2400	2470
RA CFM	2040	2122
OA CFM	360	348
RL Voltage	-	216.2/215.4/217.5
RL Amperage	-	3.27/3.65/3.02
SF Rotation	-	CCW
SF System SetPt	-	8.6 VDC
Min OA Damper Position	-	3.6 VDC
Min OA Damper Type	-	MOTORIZED
OA Enthalpy Setpt	-	DEFAULT

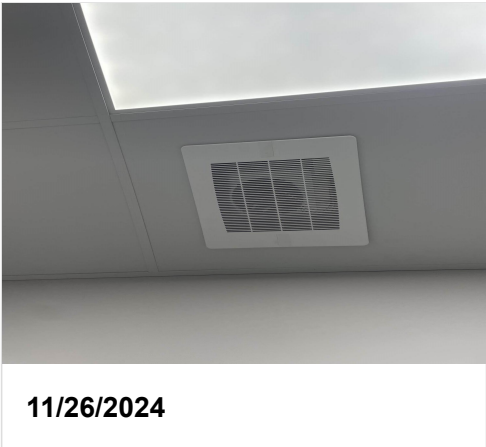
Asset: EF4

AREA:RESTROOM

Test Data		
	Design	Actual
CFM	75	73
Fan Rotation	-	CCW
System SetPt	-	FIXED SPEED
RL Amperage	-	0.39
Fan Discharge SP	-	ATM

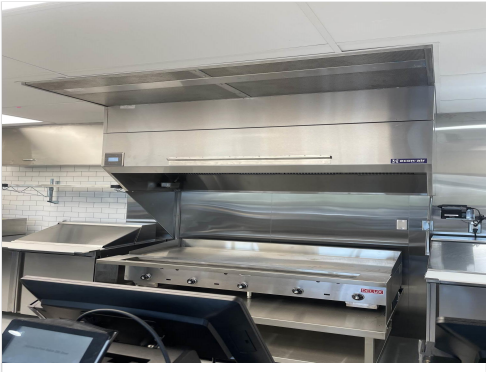
Asset: HD1

AREA:GRILL

Test Data Supply		
	Design	Actual
Total AK Area	7	7
Kv factor (Vel)	0.89	0.89
Num of Readings	-	6
Reading1 FPM	-	154
Reading2 FPM	-	147
Reading3 FPM	-	164
Reading4 FPM	-	176
Reading5 FPM	-	160
Reading6 FPM	-	174
Ave FPM(corr)	-	162
CFM	1000	1009

Test Data Exhaust		
	Design	Actual
Filter Type	CAPTRATE SOLO	CAPTRATE SOLO
Filter Size 1	16X16	16X16
Filter Qty 1	4	4
Filter AK factor size 1	1.62	1.62
Filter Total AK Area	6.48	6.48
Filter1 FPM	-	176
Filter2 FPM	-	173
Filter3 FPM	-	176
Filter4 FPM	-	174
Filter Ave FPM(corr)	-	174
CFM	1120	1127

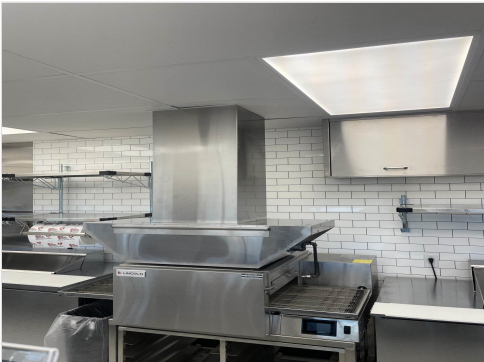
Asset: HD2

AREA:OVEN

Test Data Exhaust		
	Design	Actual
Filter Type	SS BAFFLE	SS BAFFLE
Filter Size 1	20X10	20X10
Filter Qty 1	2	2
Filter AK factor size 1	-	1.27
Filter Total AK Area	-	2.54
Filter1 FPM	-	227
Filter2 FPM	-	228
Filter Ave FPM(corr)	-	227
CFM	600	579
