**Report: Prelim Report**  
**Function: Test, Adjust, & Balance**  
**Date: 11/26/2024**  
**Completed By: National TAB**

**PROJECT**  
**11-25-24 PENN STATION ASHLAND, KY**

C&T DESIGN  
4025 PORT UNION RD.  
FAIRFIELD, OH 45014

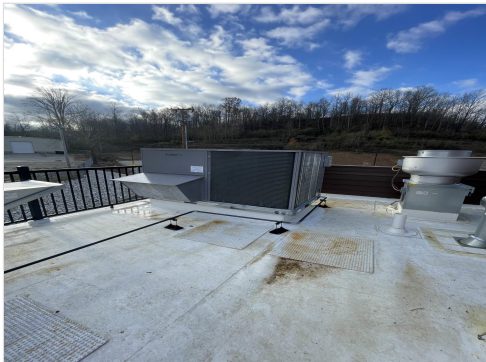
Asset: RTU1

Test Data		
	Design	Actual
SF CFM	4000	3957
RA CFM	3120	3039
OA CFM	880	918
RL Voltage	-	217.1/215.3/216.4
RL Amperage	-	5.08/4.51/4.57
SF Rotation	-	CCW
SF System SetPt	-	7.43 VDC
Min OA Damper Position	-	5.5 VDC
Min OA Damper Type	-	MOTORIZED
OA Enthalpy Setpt	-	DEFAULT

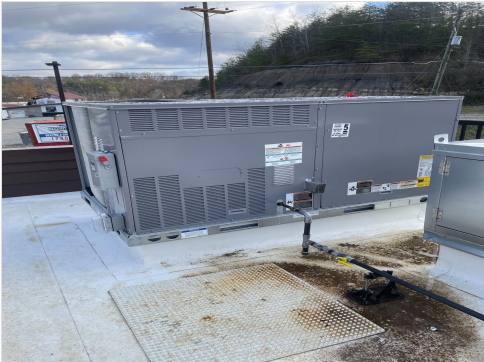
Asset: RTU2

Test Data		
	Design	Actual
SF CFM	2400	2470
RA CFM	2040	2122
OA CFM	360	348
RL Voltage	-	216.2/215.4/217.5
RL Amperage	-	3.27/3.65/3.02
SF Rotation	-	CCW
SF System SetPt	-	8.6 VDC
Min OA Damper Position	-	4.5 VDC
Min OA Damper Type	-	MOTORIZED
OA Enthalpy Setpt	-	DEFAULT

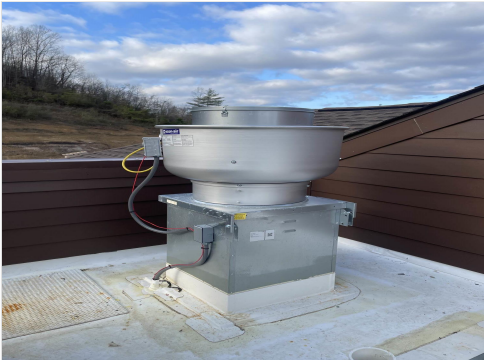
Asset: EF1

Test Data		
	Design	Actual
<b>CFM</b>	1120	1127
<b>Fan RPM</b>	1215	936
<b>Fan Rotation</b>	-	CCW
<b>Motor RPM</b>	-	936
<b>System SetPt</b>	-	52 %
<b>RL Voltage</b>	-	124.2
<b>RL Amperage</b>	-	3.08
<b>Total ESP</b>	1.150"	0.41"
<b>Fan Inlet SP</b>	-	-0.41"
<b>Fan Discharge SP</b>	-	ATM

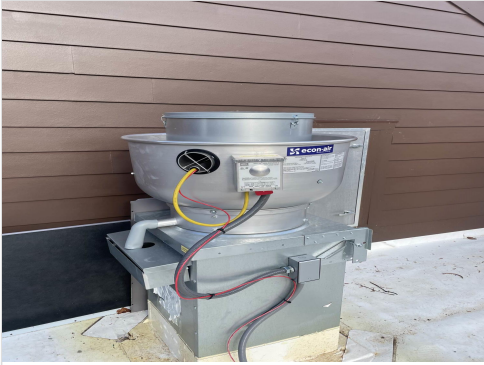
Asset: EF2

Test Data		
	Design	Actual
CFM	600	579
Fan RPM	1360	1242
Fan Rotation	-	CCW
Motor RPM	-	1242
System SetPt	-	69%
RL Voltage	-	125.6
RL Amperage	-	2.34
Total ESP	0.600"	0.31"
Fan Inlet SP	-	-0.31"
Fan Discharge SP	-	ATM

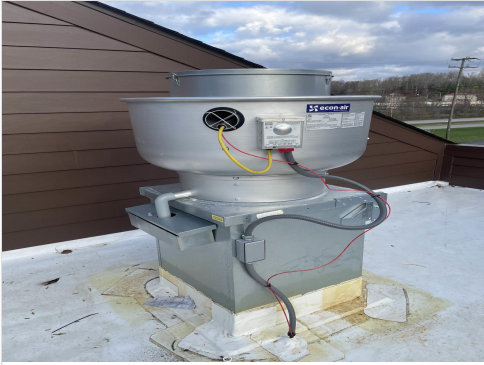
Asset: EF3

Test Data		
	Design	Actual
CFM	850	884
Fan RPM	1144	882
Fan Rotation	-	CCW
Motor RPM	-	882
System SetPt	-	49%
RL Voltage	-	124.9
RL Amperage	-	2.46
Total ESP	1.150"	0.46"
Fan Inlet SP	-	-0.46"
Fan Discharge SP	-	ATM

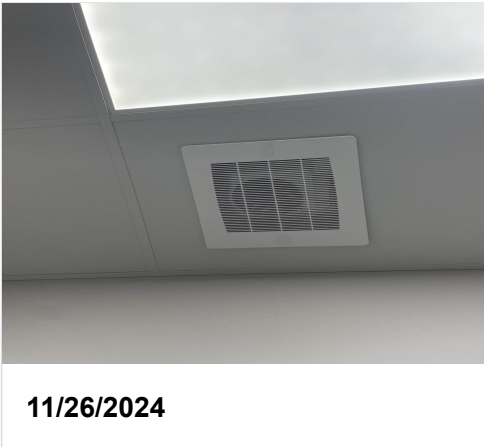
Asset: EF4

Test Data		
	Design	Actual
CFM	75	73
Fan Rotation	-	CCW
System SetPt	-	FIXED SPEED
RL Amperage	-	0.39
Fan Discharge SP	-	ATM

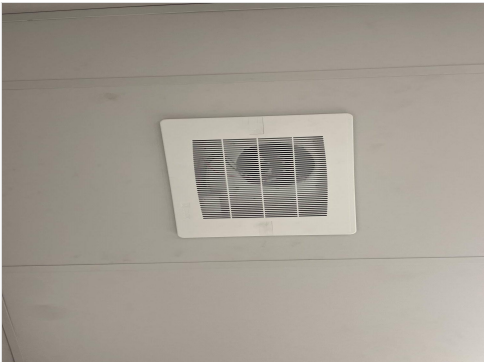
Asset: EF5

Test Data		
	Design	Actual
CFM	75	86
Fan Rotation	-	CCW
System SetPt	-	FIXED SPEED
RL Amperage	-	0.38
Fan Discharge SP	-	ATM

Notes:  
 . Unit slightly above design. Unit not equipped with speed controller, unable to reduce flow.

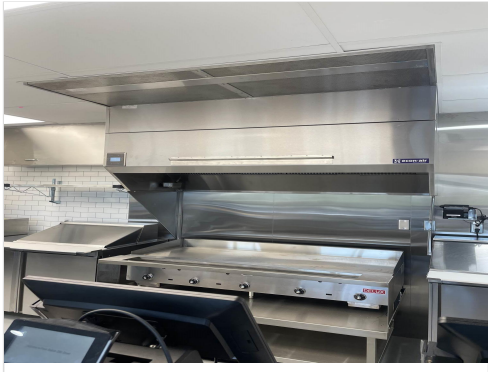
Asset: HD1

Test Data Supply		
	Design	Actual
Total AK Area	7	7
Kv factor (Vel)	0.89	0.89
Num of Readings	-	6
Reading1 FPM	-	154
Reading2 FPM	-	147
Reading3 FPM	-	164
Reading4 FPM	-	176
Reading5 FPM	-	160
Reading6 FPM	-	174
Ave FPM(corr)	-	162
CFM	1000	1009

Test Data Exhaust		
	Design	Actual
Filter Type	CAPTRATE SOLO	CAPTRATE SOLO
Filter Size 1	16X16	16X16
Filter Qty 1	4	4
Filter AK factor size 1	1.62	1.62
Filter Total AK Area	6.48	6.48
Filter1 FPM	-	176
Filter2 FPM	-	173
Filter3 FPM	-	176
Filter4 FPM	-	174
Filter Ave FPM(corr)	-	174
CFM	1120	1127

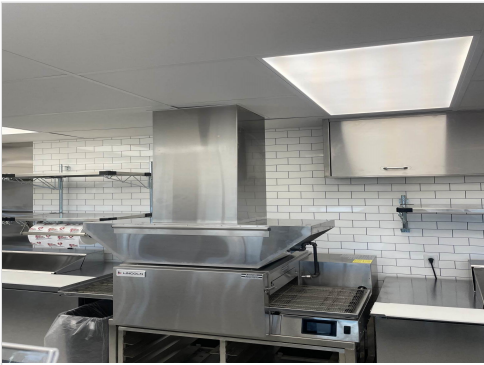
Asset: HD2

Test Data Exhaust		
	Design	Actual
Filter Type	SS BAFFLE	SS BAFFLE
Filter Size 1	20X10	20X10
Filter Qty 1	2	2
Filter AK factor size 1	-	1.27
Filter Total AK Area	-	2.54
Filter1 FPM	-	227
Filter2 FPM	-	228
Filter Ave FPM(corr)	-	227
CFM	600	579

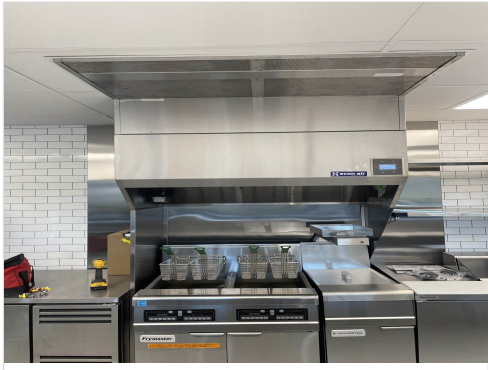
Asset: HD3

Test Data Supply		
	Design	Actual
Total AK Area	4.86	4.86
Kv factor (Vel)	0.89	0.89
Num of Readings	-	4
Reading1 FPM	-	129
Reading2 FPM	-	146
Reading3 FPM	-	128
Reading4 FPM	-	112
Ave FPM(corr)	-	128
CFM	630	553

Test Data Exhaust		
	Design	Actual
Filter Type	CAPTRATE SOLO	CAPTRATE SOLO
Filter Size 1	16X16	16X16
Filter Qty 1	3	3
Filter AK factor size 1	1.62	1.62
Filter Total AK Area	4.86	4.86
Filter1 FPM	-	177
Filter2 FPM	-	183
Filter3 FPM	-	186
Filter Ave FPM(corr)	-	182
CFM	850	884
