Report: TAB Punch-List
Function: Test, Adjust, & Balance
Date: 07/10/2025
Completed By: National TAB

Conner HS Fieldhouse (Hebron, KY)

Project: Conner HS Fieldhouse (Hebron, KY)

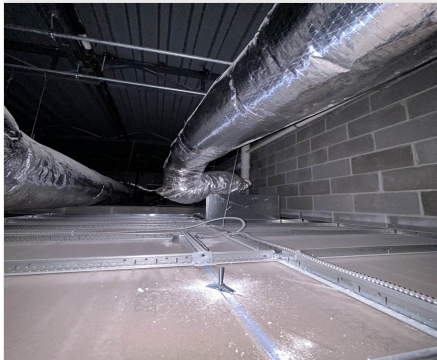
Issue Name : ERV 1 Exhaust
Description : Restrictive ductwork on the exhaust duct for restroom C7 preventing exhaust flow.
Created By : National TAB **Assigned To :** National TAB - Nick Payne
Status : Open
Priority : Medium **Asset Tag :**
Originated Date : 07/10/2025 - Gabe Merk - National TAB

- **07/11/2025 National TAB - Gabe Merk**
 - Issue has been resolved. Reread/balance flow on next trip.

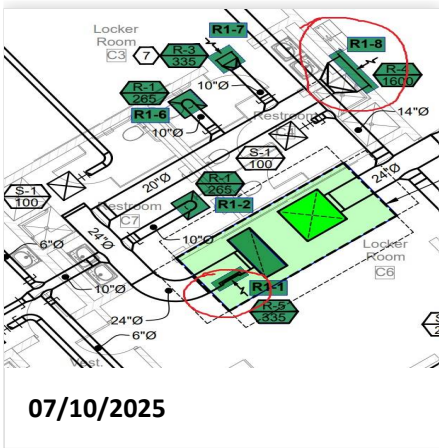
Issue Name : ERV 1 Exhaust Dampers
Description : Two exhaust grilles on ERV 1 are missing dampers. Unable to distribute flow to other individual grilles.
Created By : National TAB **Assigned To :** National TAB - Nick Payne
Status : Open
Priority : Medium **Asset Tag :**
Originated Date : 07/10/2025 - Gabe Merk - National TAB

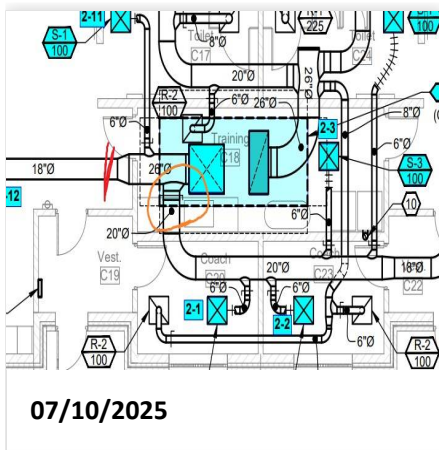
Issue Name : ERV 2 BALANCE DAMPERS
Description : ERV 2 Balance damper jammed. See attached photo highlighted in orange. Additional balance damper install likely needed in location highlighted in red.
Created By : National TAB **Assigned To :** National TAB - Nick Payne
Status : Open
Priority : Medium **Asset Tag :**
Originated Date : 07/10/2025 - Gabe Merk - National TAB

- **07/11/2025 National TAB - Gabe Merk**
 - Balance damper opened. Additional Balance damper needed to reduce flow to C13.

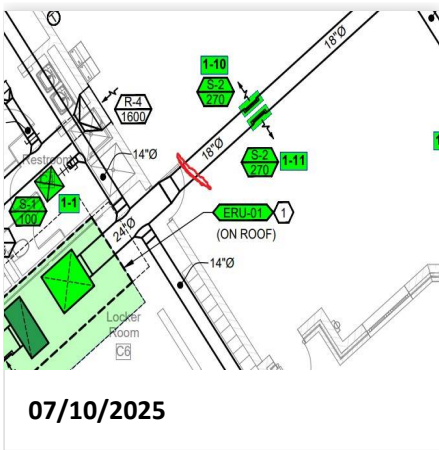
Issue Name : Weight room Damper
Description : A damper will be needed in the weight room in order to distribute flow to the remaining duct branches.
Created By : National TAB **Assigned To :** National TAB - Nick Payne
Status : Open
Priority : Medium **Asset Tag :**
Originated Date : 07/10/2025 - Gabe Merk - National TAB
