**Report: TAB Report**  
**Function: Test, Adjust, & Balance**  
**Date: 01/07/2026**  
**Completed By: National TAB**

**PROJECT**  
**02-02-26 QT #1031 HARRISBURG, NC**

# National TAB

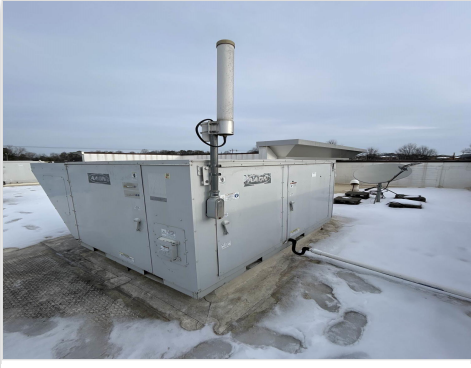
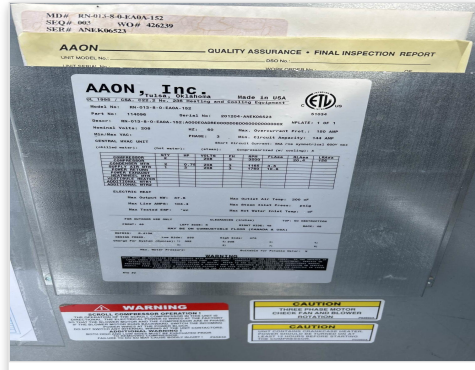
# Unit Data - PHOTO LOG

Asset: RT-1

AREA:SALES FLOOR

Unit Data	
	Actual
MFG	AAON
Serial Num	201204-ANEK06523
Model Num	RN-O13-8-0-EA0A-152
Num OA Filters 1	1
OA Filter Size 1	45X22

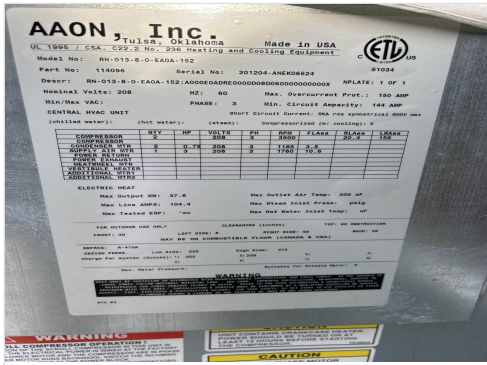
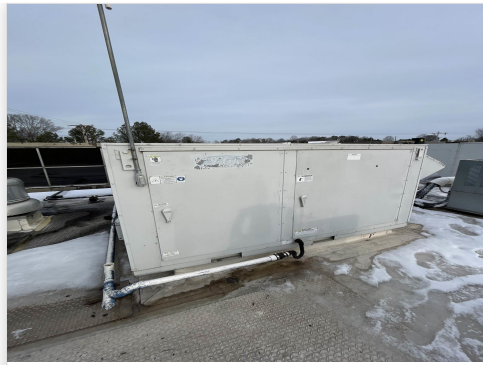
# Unit Data - PHOTO LOG

Asset: RT-3

AREA:BOH/KITCHEN

Unit Data	
	Actual
MFG	AAON
Serial Num	201204-ANEK06524
Model Num	RN-013-8-0EA0A-152
Num OA Filters 1	1
OA Filter Size 1	45X22

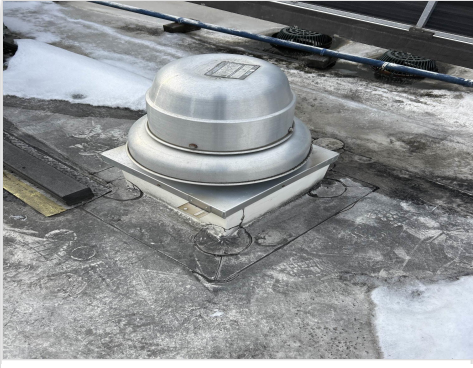
**Unit Data - PHOTO LOG**

Asset: EF1

AREA:WOMEN'S RR

Unit Data		
	Design	Actual
MFG	NA	NA
Model Num	NA	NA
Serial Num	-	4100SE15342
Type	-	UPBLAST
Configuration	-	VERTICAL

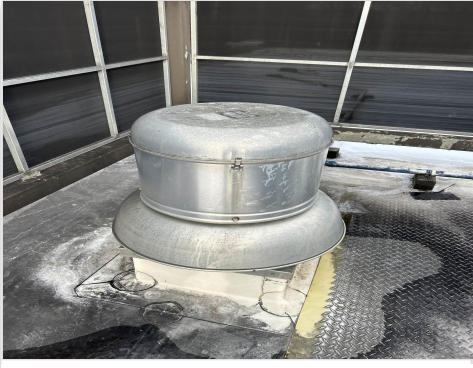
**Unit Data - PHOTO LOG**

Asset: EF2

AREA: MEN'S RR/COMBI

Unit Data		
	Design	Actual
MFG	NA	NA
Model Num	NA	NA
Serial Num	-	410SE15342
Type	-	UPBLAST
Configuration	-	VERTICAL

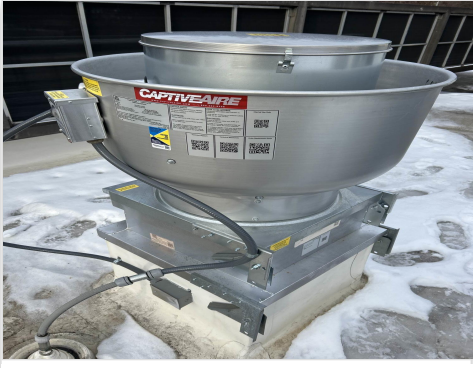
## Unit Data - PHOTO LOG

Asset: EF3

AREA: KITCHEN HD

Unit Data		
	Design	Actual
MFG	NA	CAPTIVEAIRE
Model Num	NA	DU50HFA
Serial Num	-	8262100
Type	UPBLAST	UPBLAST
Configuration	VERTICAL	VERTICAL

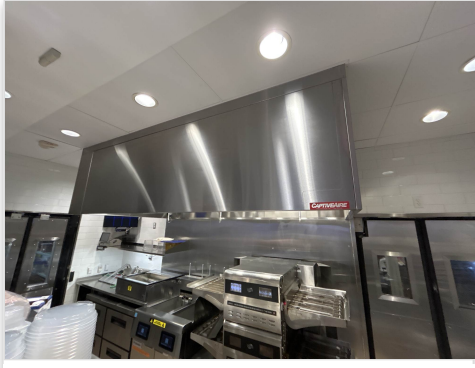
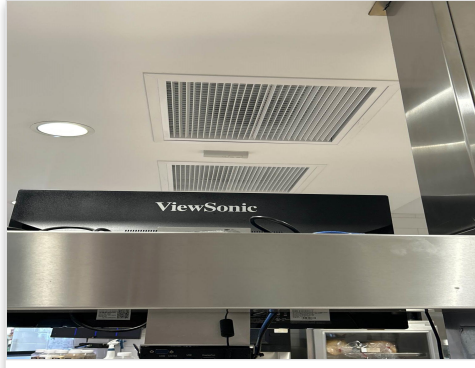
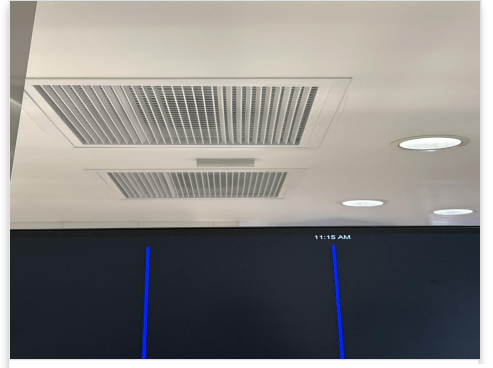
**Unit Data - PHOTO LOG**

Asset: HD1

AREA:GRIDDLE

Unit Data		
	Design	Actual
MFG	CAPTIVEAIRE	CAPTIVEAIRE
Model Num	6030ND-2-F	6030ND-2-F
Job / Serial Num	-	8262100
Type	TYPE I CANOPY	TYPE I CANOPY
Hood length	108"	108"
Hood Width	60"	60"
