Report: TAB Report
Function: Test, Adjust, & Balance
Date: 10/10/2024
Completed By: National TAB

PROJECT
10-07-24 WAWA #8179 ROBESONIA, PA

Project: 10-07-24 WAWA #8179 ROBESONIA, PA

Project Summary

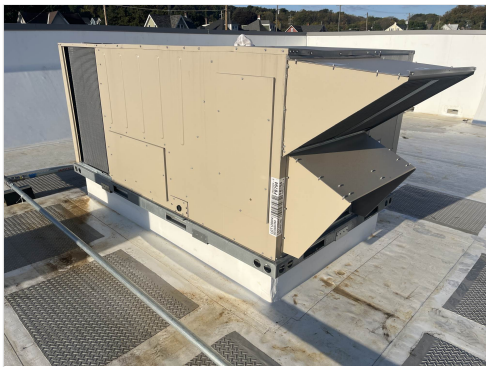
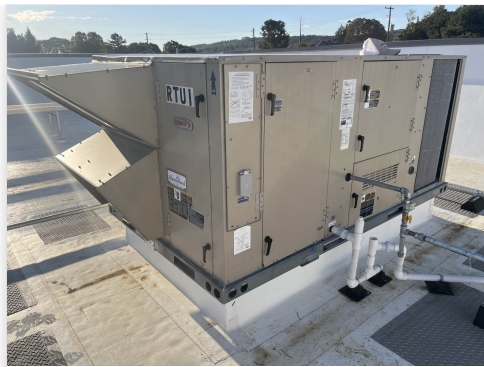
Unit Data - PHOTO LOG

Asset: RTU1

Unit Data		
	Design	Actual
MFG	LENNOX ENLIGHT	LENNOX ENLIGHT
Serial Num	-	5614A03764
Model Num	LGT120H4E	LGT120H4ES1Y
Type	RTU	RTU
Configuration	VERTICAL	VERTICAL
Num OA Filters 1	-	2
OA Filter Size 1	-	25X16
Num Final Filter 1	-	4
Final Filter Size 1	-	20X25X2

Test Data		
	Design	Actual
SF CFM	4000	4041
SF RPM	-	1760
MOTOR RPM	-	1760
RA CFM	3500	3536
OA CFM	500	505
RL Voltage	-	212.3/211.7/210.9
RL Amperage	-	5.21/5.12/5.25
SF System SetPt	-	80%
RA Damper Position	-	MECHANICAL LINKAGE
OA Damper Position	-	25%
OA Damper Type	-	ECONOMIZER

Motor Data		
	Design	Actual
Motor MFG	-	EBMPABST
Frame	-	NL
Horsepower	3.75	3300W
Motor Rpm	-	2200
Phase	3	3
Rated Voltage	208	200
Rated Amperage	-	8.7
Service Factor	-	1

Performance Data		
	Design	Actual
MA Plenum SP	-	-0.45"
Fan Suction SP	-	-0.97"
Fan Discharge SP	-	0.64"
Total ESP	0.5"	1.09"
Fan Total SP	-	1.61"

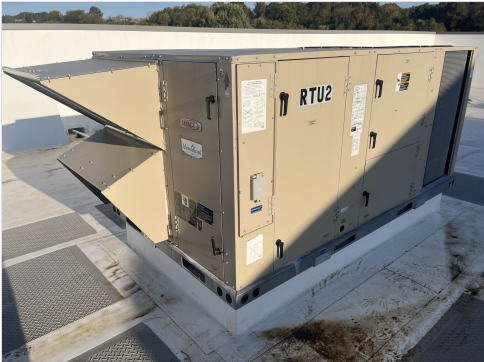
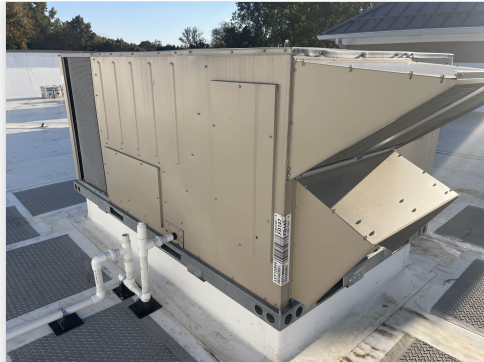
Test Data - PHOTO LOG

Asset: RTU2

Unit Data		
	Design	Actual
MFG	LENNOX ENLIGHT	LENNOX ENLIGHT
Serial Num	-	5624A03661
Model Num	LGT120H4E	LCT120H4EN1Y
Type	RTU	RTU
Configuration	VERTICAL	VERTICAL
Num OA Filters 1	-	2
OA Filter Size 1	-	25X16
Num Final Filter 1	-	4
Final Filter Size 1	-	20X25X2

Motor Data		
	Design	Actual
Motor MFG	-	EBMPABST
Frame	-	NL
Horsepower	3.75	3300W
Motor Rpm	-	2200
Phase	3	3
Rated Voltage	208	200
Rated Amperage	-	8.7
Service Factor	-	1

Test Data		
	Design	Actual
SF CFM	4000	3985
SF RPM	-	1606
MOTOR RPM	-	1606
RA CFM	3500	3466
OA CFM	500	519
RL Voltage	-	212.2/211.9/212.4
RL Amperage	-	3.97/4.07/4.04
SF System SetPt	-	73%
RA Damper Position	-	MECHANICAL LINKAGE
OA Damper Position	-	28%
OA Damper Type	-	ECONOMIZER

Performance Data		
	Design	Actual
MA Plenum SP	-	-0.26"
Fan Suction SP	-	-0.75"
Fan Discharge SP	-	0.49"
Total ESP	0.5"	0.75"
Fan Total SP	-	1.24"

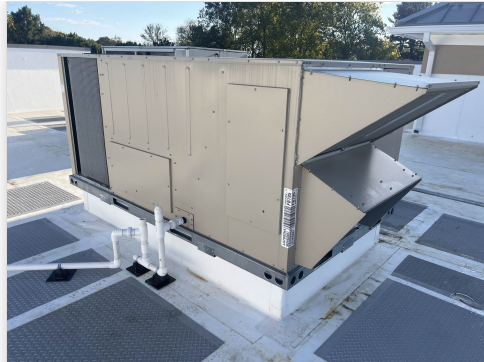
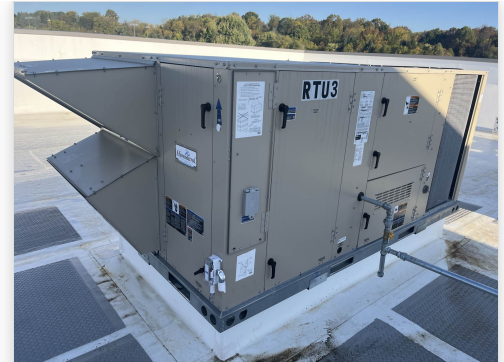
Unit Data - PHOTO LOG

Asset: RTU3

Unit Data		
	Design	Actual
MFG	LENNOX ENLIGHT	LENNOX ENLIGHT
Serial Num	-	5624A03687
Model Num	LGT092H4E	LGT092H4ES1Y
Type	RTU	RTU
Configuration	VERTICAL	VERTICAL
Num OA Filters 1	-	2
OA Filter Size 1	-	25X16
Num Final Filter 1	-	4
Final Filter Size 1	-	20X25X2

Motor Data		
	Design	Actual
Motor MFG	-	EBMPABST
Frame	-	NL
Horsepower	3.75	3300W
Motor Rpm	-	2200
Phase	3	3
Rated Voltage	208	200
Rated Amperage	-	8.7
Service Factor	-	1

Test Data		
	Design	Actual
SF CFM	3000	3028
SF RPM	-	1320
MOTOR RPM	-	1320
RA CFM	2500	2516
OA CFM	500	512
RL Voltage	-	212.8/212.3/211.7
RL Amperage	-	2.55/2.58/2.58
SF System SetPt	-	60%
RA Damper Position	-	MECHANICAL LINKAGE
OA Damper Position	-	27%
OA Damper Type	-	ECONOMIZER

Performance Data		
	Design	Actual
MA Plenum SP	-	-0.33"
Fan Suction SP	-	-0.63"
Fan Discharge SP	-	0.43"
Total ESP	0.5"	0.76"
Fan Total SP	-	1.09"

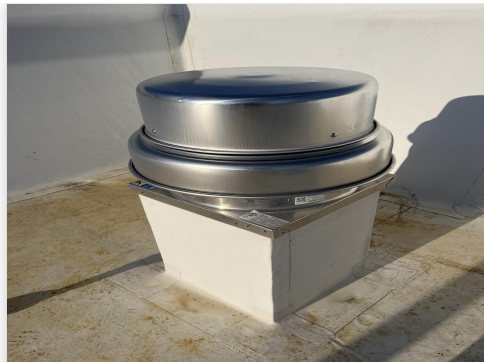
Unit Data - PHOTO LOG

Asset: EF1

Unit Data		
	Design	Actual
MFG	PENNBARRY	GREENHECK
Model Num	DX16S	G-100-A-3-1-19-X
Serial Num	-	24652015
Type	DOWNBLAST	DOWNBLAST
Configuration	VERTICAL	VERTICAL

Test Data		
	Design	Actual
CFM	1000	1036
Fan RPM	1300	NA
Fan Rotation	-	CW
Motor RPM	-	NA
System SetPt	-	MARKED ON DIAL
RL Voltage	-	67.7
RL Amperage	-	5.4
Total ESP	0.25"	0.44"
Fan Inlet SP	-	-0.44"
Fan Discharge SP	-	ATM

Motor Data		
	Design	Actual
Motor MFG	-	MARATHON
Frame	-	56
Horsepower	1/3	0.33
Motor Rpm	-	1725
Phase	1	1
Voltage (rated)	120	115
Amperage (rated)	-	3.5
Service Factor	-	1

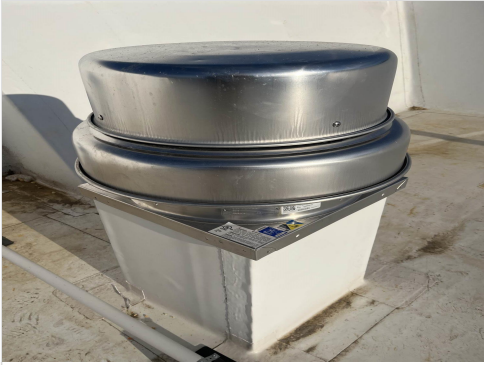
Unit Data - PHOTO LOG

Asset: EF2

Unit Data		
	Design	Actual
MFG	PENNBARRY	GREENHECK
Model Num	DX08Q	G-097-B-6-1-19-X
Serial Num	-	24652016
Type	DOWNBLAST	DOWNBLAST
Configuration	VERTICAL	VERTICAL

Motor Data		
	Design	Actual
Motor MFG	-	NL
Frame	-	48Y
Horsepower	1/6	1/6
Motor Rpm	-	1140
Phase	1	1
Voltage (rated)	120	115
Amperage (rated)	-	2.2
Service Factor	-	1

Test Data		
	Design	Actual
CFM	200	207
Fan RPM	1725	1140
Fan Rotation	-	CW
Motor RPM	-	1140
System SetPt	-	MARKED ON DIAL/FULL
RL Voltage	-	108.7
RL Amperage	-	1.38
Total ESP	0.13"	0.45"
Fan Inlet SP	-	-0.45"
Fan Discharge SP	-	ATM
