Report: TAB Report
Function: Test, Adjust, & Balance
Date: 01/15/2026
Completed By: National TAB

**07-21-25 WHATABURGER #1609 EASTLAND,
TX**

1401 MAIN ST

EASTLAND, TX

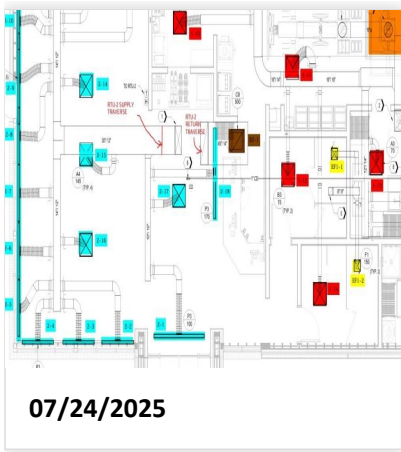
Screenshot of the GRD marked up with supply and return traverse locations for RTU-2 (Add picture here)

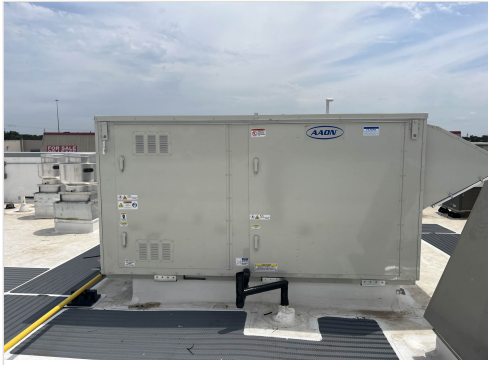
Unit Data - PHOTO LOG

Asset: RTU1

Test Data		
	Design	Actual
SF CFM (Traverse)	-	3973
SF CFM	3850	3802
SF RPM	-	940
MOTOR RPM	-	940
RA CFM (Traverse)	-	1288
RA CFM	1390	1399
OA CFM	2460	2529
RL Voltage	-	294 VFD
RL Amperage	-	6.1 VFD
SF System SetPt	-	48 HZ
RA Damper Position	-	35%
Min OA Damper Position	-	65%
Min OA Damper Type	-	ECONOMIZER

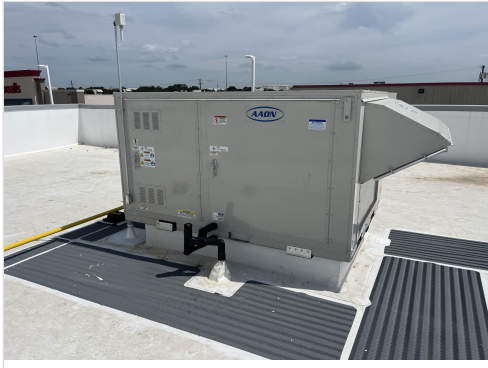
Unit Data - PHOTO LOG

Asset: RTU2

Test Data		
	Design	Actual
SF CFM (Traverse)	-	2070
SF CFM	2050	2030
SF RPM	-	955
MOTOR RPM	-	955
RA CFM (Traverse)	-	479
RA CFM	500	528
OA CFM	1550	1502
RL Voltage	-	296 VFD
RL Amperage	-	2.88 VFD
SF System SetPt	-	49 HZ
RA Damper Position	-	30%
Min OA Damper Position	-	70%
Min OA Damper Type	-	ECONOMIZER

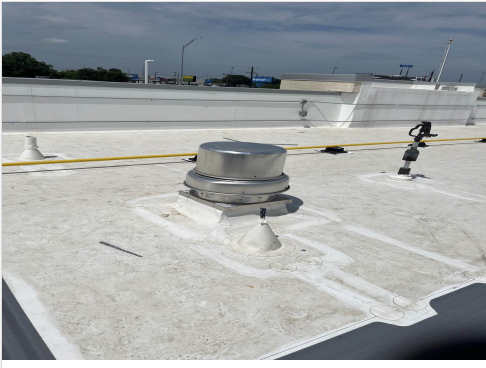
Unit Data - PHOTO LOG

Asset: EF1

Test Data		
	Design	Actual
CFM	300	318
Fan RPM	1680	1613
Fan Rotation	-	CW
Motor RPM	-	1715
System SetPt	-	3 TURNS OUT
RL Voltage	-	120
RL Amperage	-	3.3
Total ESP	.50"	0.26"
Fan Inlet SP	-	-0.26"
Fan Discharge SP	-	ATM

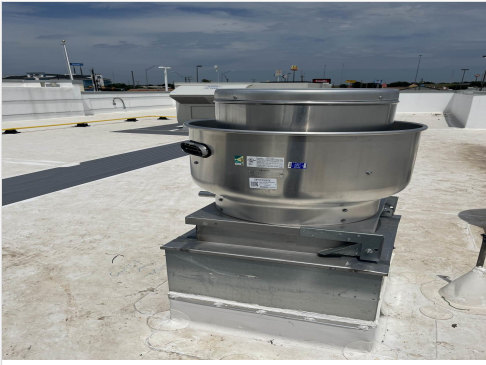
Unit Data - PHOTO LOG

Asset: KEF1

Test Data		
	Design	Actual
CFM	1995	1944
Fan RPM	1517	1137
Fan Rotation	-	CW
Motor RPM	-	1137
System SetPt	-	6.5 (SPEED DIAL)
RL Voltage	-	120
RL Amperage	-	2.8
Total ESP	1.00"	0.42"
Fan Inlet SP	-	-0.42"
Fan Discharge SP	-	ATM

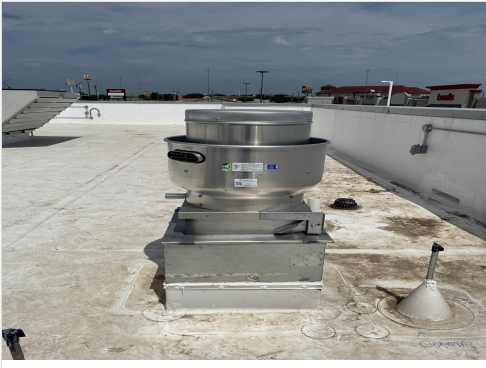
Unit Data - PHOTO LOG

Asset: KEF2

Test Data		
	Design	Actual
CFM	1216	1225
Fan RPM	1415	1312
Fan Rotation	-	CW
Motor RPM	-	1312
System SetPt	-	7.5 (SPEED DIAL)
RL Voltage	-	120
RL Amperage	-	3.1
Total ESP	.75"	0.35"
Fan Inlet SP	-	-0.35"
Fan Discharge SP	-	ATM

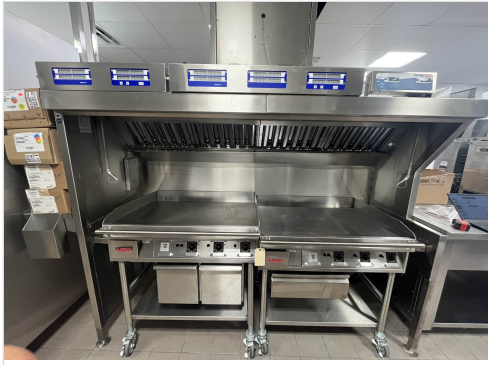
Unit Data - PHOTO LOG

Asset: HD1

Test Data Exhaust		
	Design	Actual
Filter Type	KASON TRAPPER SS FILTER	FLAME GUARD TYPE VI
Filter Size 1	-	12X20
Filter Qty 1	-	8
Filter AK factor size 1	-	1.5
Filter Total AK Area	-	12
Filter1 FPM	-	156
Filter2 FPM	-	162
Filter3 FPM	-	179
Filter4 FPM	-	162
Filter5 FPM	-	164
Filter6 FPM	-	177
Filter7 FPM	-	163
Filter8 FPM	-	134
Filter Ave FPM(corr)	-	162
CFM	1995	1944

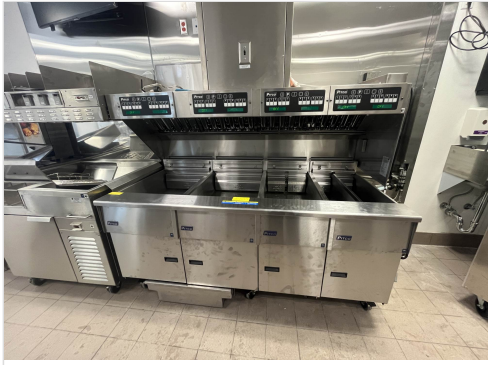
Unit Data - PHOTO LOG

Asset: HD2

Test Data Exhaust		
	Design	Actual
Filter Type	KASON TRAPPER SS	FLAME GUARD TYPE VI
Filter Size 1	-	12X16
Filter Qty 1	-	4
Filter AK factor size 1	-	1.16
Filter Total AK Area	-	4.64
Filter1 FPM	-	250
Filter2 FPM	-	276
Filter3 FPM	-	277
Filter4 FPM	-	256
Filter Ave FPM(corr)	-	264
CFM	1216	1225
