Report: TAB Report
Function: Test, Adjust, & Balance
Date: 02/17/2026
Completed By: National TAB

PROJECT
02-23-26 QT #1043 GASTONIA, GA

Project: 02-23-26 QT #1043 GASTONIA, GA

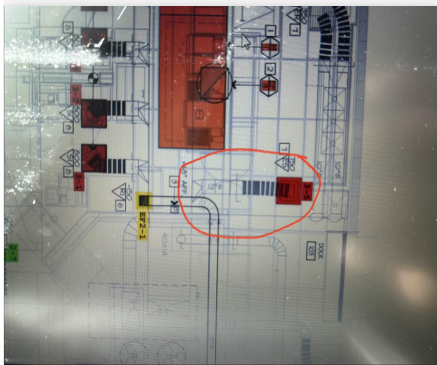
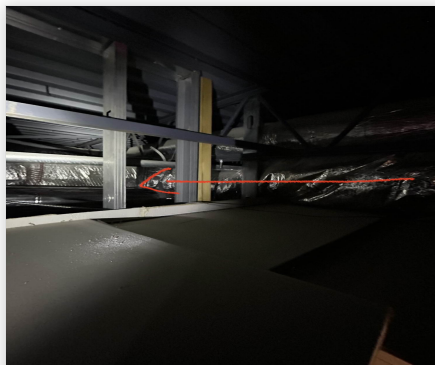
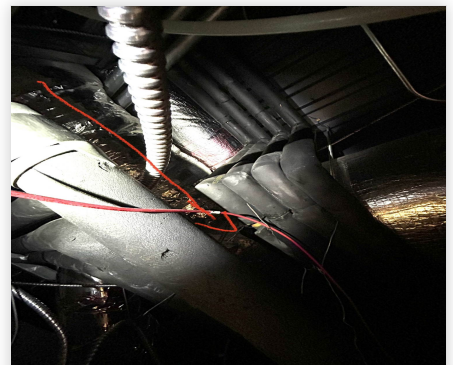
Issue Name : SGRD 3-5 damper inaccessible
Description : SGRD 3-5 damper out of reach, plumbing pipes restrict accessibility.
Created By : National TAB **Assigned To :** National TAB - Dan Hertenstein
Status : Open
Priority : Medium **Asset Tag :** SGRD5
Originated Date : 02/24/2026 - Jearod Ferrette - National TAB

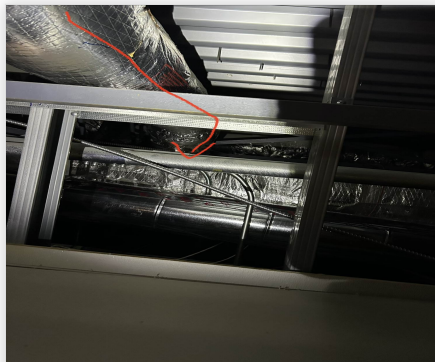
Issue Name : SGRD 3-6 damper inaccessible
Description : SGRD 3-6 damper out reach unable access.
Created By : National TAB **Assigned To :** National TAB - Dan Hertenstein
Status : Open
Priority : Medium **Asset Tag :** SGRD6
Originated Date : 02/24/2026 - Jearod Ferrette - National TAB

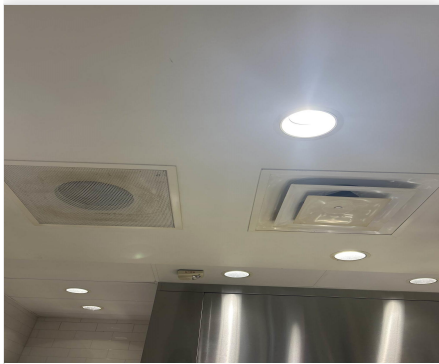
Issue Name : Specified diffusers not installed
Description : SGRD 3-1 to 3-4 diffusers are not per design.
Created By : National TAB **Assigned To :** National TAB - Dan Hertenstein
Status : Open
Priority : Low **Asset Tag :** RT-3
Originated Date : 02/24/2026 - Jearod Ferrette - National TAB

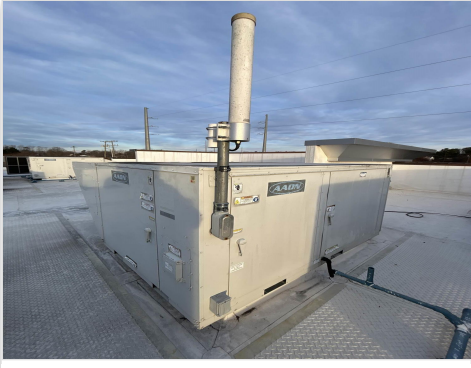
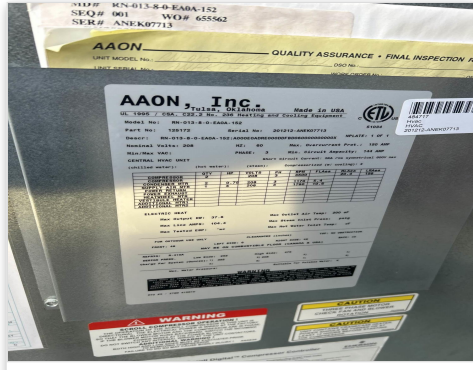
Unit Data - PHOTO LOG

Unit Data	
	Actual
MFG	AAON
Serial Num	201212-ANEK07713
Model Num	RN-013-8-0-EA0A-152
Num OA Filters 1	1
OA Filter Size 1	22.5X44.5
Num Final Filter 1	2
Final Filter Size 1	56X45

Test Data		
	Design	Actual
SF CFM	4200	4155
SF RPM	-	DD/ 41 HZ
OA CFM (Hoods On)	800	820
OA CFM (Hoods Off)	350	347
RL Voltage	-	130 VFD
RL Amperage	-	8.8 VFD
VFD Max SetPt	-	41 HZ
OA Damper Position (Hoods On)	-	46%
OA Damper Position (Hoods Off)	-	26%

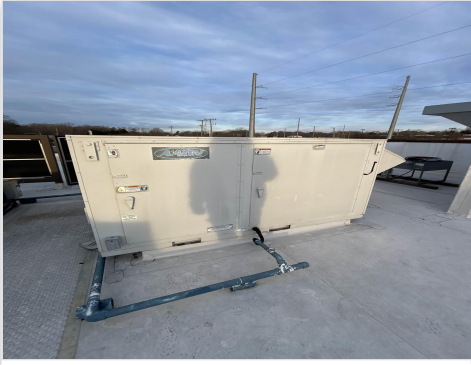
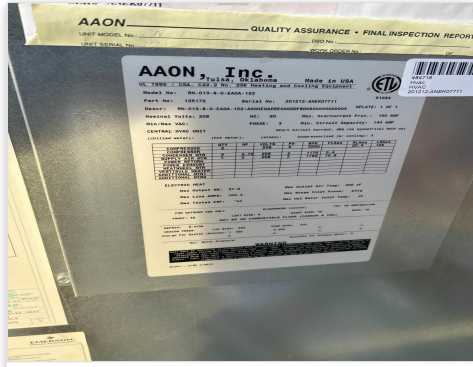
Unit Data - PHOTO LOG

Unit Data	
	Actual
MFG	AAON
Serial Num	201212-ANEK07711
Model Num	RN-013-8-0-EA0A-152
Num OA Filters 1	1
OA Filter Size 1	22.5X44.5
Num Final Filter 1	2
Final Filter Size 1	56X45

Test Data		
	Design	Actual
SF CFM	4200	4310
SF RPM	-	DD/ 43HZ
OA CFM (Hoods On)	800	813
OA CFM (Hoods Off)	350	368
RL Voltage	-	130 VFD
RL Amperage	-	9.9 VFD
VFD Max SetPt	-	43 HZ
OA Damper Position (Hoods On)	-	46%
OA Damper Position (Hoods Off)	-	26%

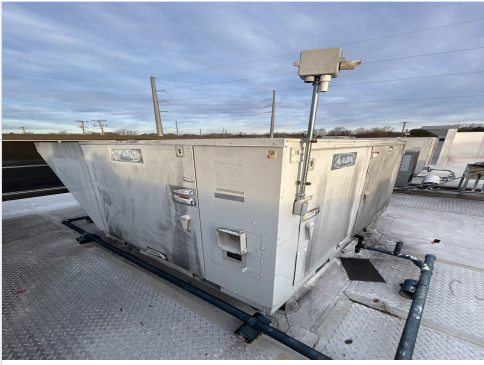
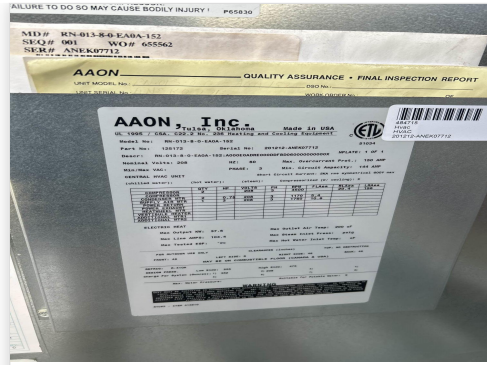
Unit Data - PHOTO LOG

Unit Data	
	Actual
MFG	AAON
Serial Num	201212-ANEK07711
Model Num	RN-013-8-0-EA0A-152
Num OA Filters 1	1
OA Filter Size 1	22.5X44.5
Num Final Filter 1	2
Final Filter Size 1	56X45

Test Data		
	Design	Actual
SF CFM	4200	4333
SF RPM	-	DD/ 41 HZ
OA CFM (Hoods On)	800	799
OA CFM (Hoods Off)	350	354
RL Voltage	-	130 VFD
RL Amperage	-	8.9 VFD
VFD Max SetPt	-	41 HZ
OA Damper Position (Hoods On)	-	46%
OA Damper Position (Hoods Off)	-	26%

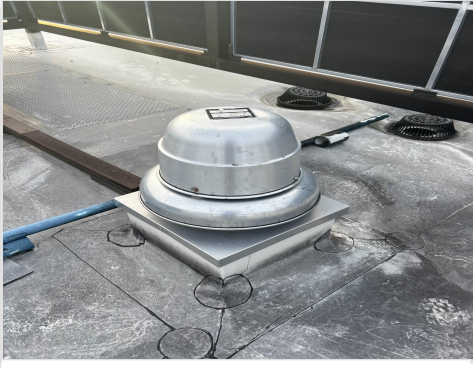
Unit Data - PHOTO LOG

Unit Data	
	Actual
MFG	COOK
Model Num	90 ACEH
Serial Num	410SE42062
Type	DOWNBLAST
Configuration	VERTICAL

Test Data		
	Design	Actual
CFM	225	226
Fan RPM	-	DD
Fan Rotation	-	CCW
Motor RPM	-	DD
System SetPt	-	50%
Total ESP	-	0.15"
Fan Inlet SP	-	-0.15"
Fan Discharge SP	-	ATMO

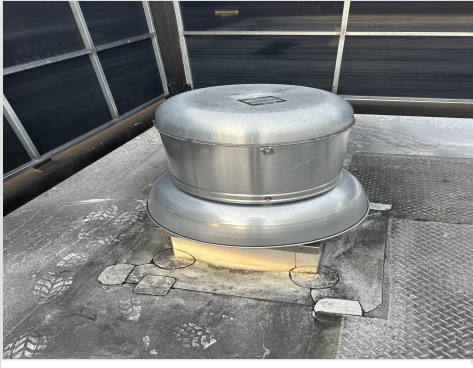
Unit Data - PHOTO LOG

Unit Data	
	Actual
MFG	COOK
Model Num	120 ACE
Serial Num	410SE42062
Type	DOWNBLAST
Configuration	VERTICAL

Test Data		
	Design	Actual
CFM	525	457
Fan RPM	-	DD
Fan Rotation	-	CCW
Motor RPM	-	DD
System SetPt	-	MAX
Total ESP	-	0.17"
Fan Inlet SP	-	-0.17"
Fan Discharge SP	-	ATMO

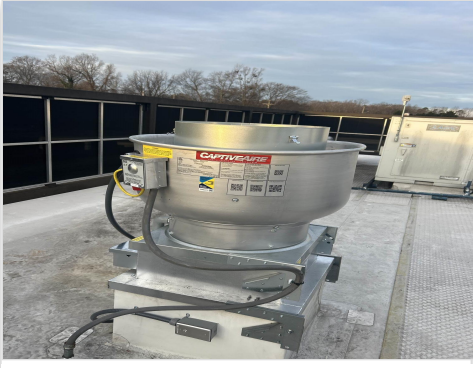
Unit Data - PHOTO LOG

Unit Data	
	Actual
MFG	CAPTIVEAIRE
Model Num	DU50HFA
Serial Num	8428207
Type	UPBLAST
Configuration	VERTICAL

Test Data		
	Design	Actual
CFM	1350	1385
Fan RPM	-	1195
Fan Rotation	-	CCW
Motor RPM	-	1195
System SetPt	-	52.8 HZ
Total ESP	-	0.24"
Fan Inlet SP	-	-0.24"
Fan Discharge SP	-	ATMO

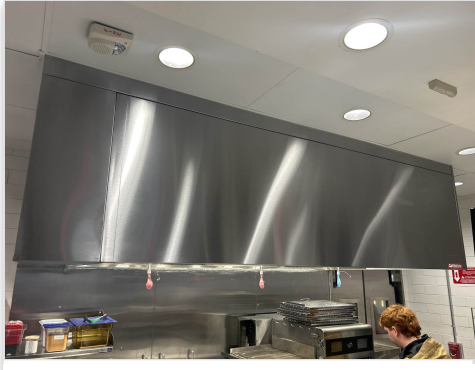
Unit Data - PHOTO LOG

Unit Data		
	Design	Actual
MFG	CAPTIVEAIRE	CAPTIVEAIRE
Model Num	6030ND-2-F	6030ND-2-F
Job / Serial Num	-	8428207
Type	TYPE I CANOPY	TYPE I CANOPY
Hood length	108"	108"
Hood Width	60"	60"

Test Data Exhaust		
	Design	Actual
Filter Type	CAPTRATE SOLO FILTER	CAPTRATE SOLO FILTER
Filter Size 1	20X16	20X16
Filter Qty 1	6	6
Filter AK factor size 1	2.08	2.08
Filter Total AK Area	12.48	12.48
Filter1 FPM	-	119
Filter2 FPM	-	118
Filter3 FPM	-	116
Filter4 FPM	-	105
Filter5 FPM	-	105
Filter6 FPM	-	103
Filter Ave FPM(corr)	-	111
CFM	1350
