Report: TAB Report
Function: Test, Adjust, & Balance
Date: 10/06/2025
Completed By: National TAB

11-03-25 WAWA #7210 EASTGATE, OH

Project: 11-03-25 WAWA #7210 EASTGATE, OH

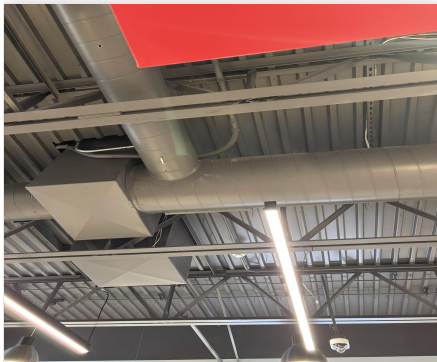
Issue Name : Ductwork not far enough away from drop
Description : The branch containing diffusers 6,7, & 8 on RTU-2 is too close to the drop and even with the damper wide open we are unable to get full flow to these diffusers. Since it serves the open space of the sales floor, this can be compensated for by the other diffusers without causing a problem.
Created By : National TAB **Assigned To :** National TAB - Will Turnbough
Status : Open
Priority : Low **Asset Tag :**
Originated Date : 11/12/2025 - Corey Dick - National TAB

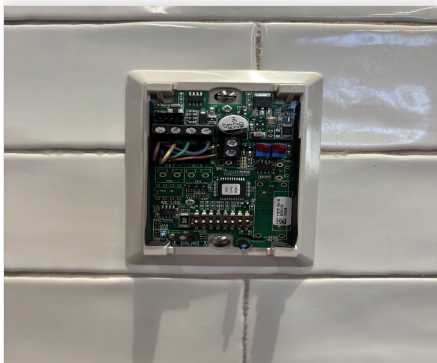
Issue Name : Sensor wiring not correct
Description : The sensor wiring is not correct and is preventing the unit from getting proper info regarding space temp and relative humidity. This is also causing the units to display a low-level alarm about the sensor.
Created By : National TAB **Assigned To :** National TAB - Will Turnbough
Status : Open
Priority : Medium **Asset Tag :**
Originated Date : 11/12/2025 - Corey Dick - National TAB

2 conductor shielded cable has one wire landed to Vin, one to GND, and the shield wire is not connected. Fail

For second shielded cable, one wire is landed to Vout and the shield wire is not connected. Fail

Verify that the CORE or Prodigy controller is sensing a relative humidity (record the reading) Fail

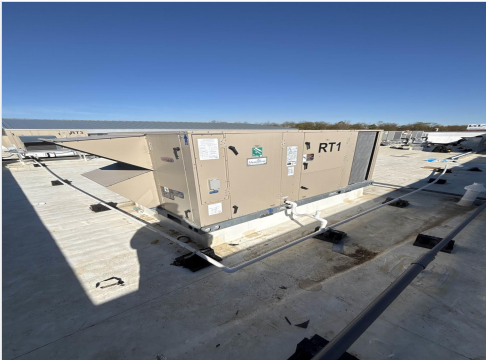
Unit Data - PHOTO LOG

Asset: RTU1

Unit Data		
	Design	Actual
MFG	LENNOX	LENNOX
Model Num	LCT150H4E	LCT150H4E
Type	RTU	RTU
Configuration	VERTICAL	VERTICAL
Num OA Filters 1	-	2
OA Filter Size 1	-	14.25"x23"
Num Final Filter 1	-	4
Final Filter Size 1	-	20"x25"x2"

Test Data		
	Design	Actual
SF CFM	4500	4610
RA CFM	3800	3842
OA CFM	700	760
RL Voltage	-	213/212/213
RL Amperage	-	4.1/4.2/4.1
SF System SetPt	-	79%
RA Damper Position	-	81%
RA Damper Type	-	MECHANICALLY LINKED
OA Damper Position	-	19%
OA Damper Type	-	PARALLEL BLADE

Performance Data		
	Design	Actual
MA Plenum SP	-	-0.53"
Fan Suction SP	-	-0.86"
Fan Discharge SP	-	0.55"
Total ESP	0.70"	1.08"
Fan Total SP	-	1.41"

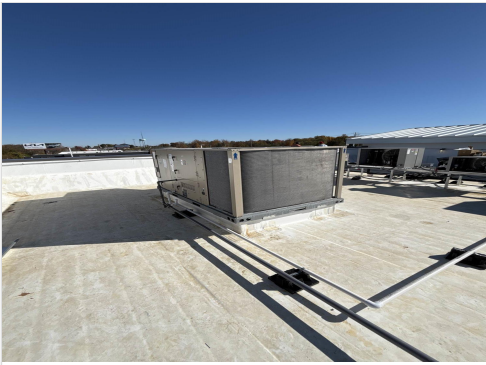
Unit Data - PHOTO LOG

Asset: RTU2

Unit Data		
	Design	Actual
MFG	LENNOX	LENNOX
Serial Num	-	5624L02340
Model Num	LGT102H4E	LGT102H4E
Type	RTU	RTU
Configuration	VERTICAL	VERTICAL
Num OA Filters 1	-	2
OA Filter Size 1	-	14.25"x23"
Num Final Filter 1	-	4
Final Filter Size 1	-	20"x20"x2"

Test Data		
	Design	Actual
SF CFM	3400	3336
RA CFM	3020	2921
OA CFM	380	415
RL Voltage	-	214/212/213
RL Amperage	-	3.2/3.1/3.2
SF System SetPt	-	70%
RA Damper Position	-	71%
RA Damper Type	-	MECHANICALLY LINKED
OA Damper Position	-	29%
OA Damper Type	-	ECONOMIZER

Performance Data		
	Design	Actual
MA Plenum SP	-	-0.34"
Fan Suction SP	-	-0.59"
Fan Discharge SP	-	0.67"
Total ESP	1.00"	1.01"
Fan Total SP	-	1.26"

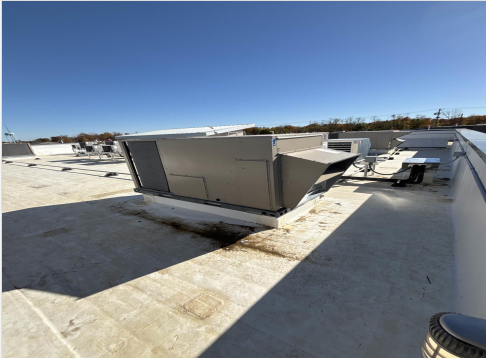
Unit Data - PHOTO LOG

Asset: RTU3

Unit Data		
	Design	Actual
MFG	LENNOX	LENNOX
Serial Num	-	5624M01118
Model Num	LGT072H4E	LGT072H4E
Type	RTU	RTU
Configuration	VERTICAL	VERTICAL
Num OA Filters 1	-	2
OA Filter Size 1	-	14"x14"
Num Final Filter 1	-	4
Final Filter Size 1	-	20"x20"x2"

Test Data		
	Design	Actual
SF CFM	2400	2348
RA CFM	2200	2128
OA CFM	200	220
RL Voltage	-	212/212/213
RL Amperage	-	4.12/4.01/4.15
SF System SetPt	-	96%
RA Damper Position	-	79%
RA Damper Type	-	MECHANICALLY LINKED
OA Damper Position	-	21%
OA Damper Type	-	OPPOSABLE BLADE

Performance Data		
	Design	Actual
MA Plenum SP	-	-0.59"
Fan Suction SP	-	-0.81"
Fan Discharge SP	-	0.80"
Total ESP	0.50"	1.39"
Fan Total SP	-	1.61"

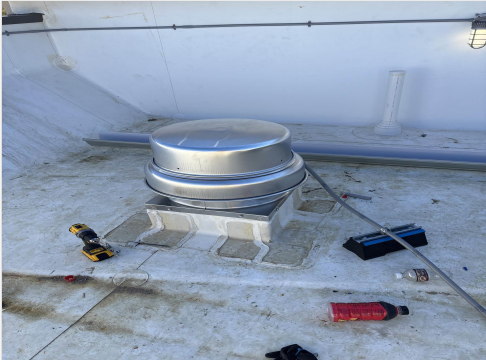
Unit Data - PHOTO LOG

Asset: EF2

Unit Data		
	Design	Actual
MFG	GREENHECK	GREENHECK
Model Num	GB-098-6	GB-098-6
Serial Num	-	27949443
Type	DOWNBLAST	DOWN BLAST
Configuration	VERTICAL	VERTICAL

Test Data		
	Design	Actual
CFM	400	387
Fan Rotation	-	CORRECT
System SetPt	-	LOW (DIAL MARKED)
Total ESP	0.38"	0.34"
Fan Inlet SP	-	-0.34"
Fan Discharge SP	-	ATM
