**Report: TAB REPORT**  
**Function: Test, Adjust, & Balance**  
**Date: 09/18/2025**  
**Completed By: National TAB**

**09-15-25 WAWA #6306 LEESBURG, GA**

1384 US HWY 82

ALBANY, GA 31763

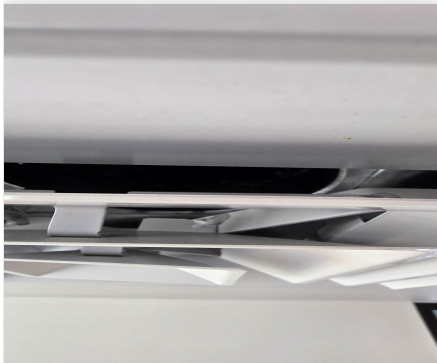
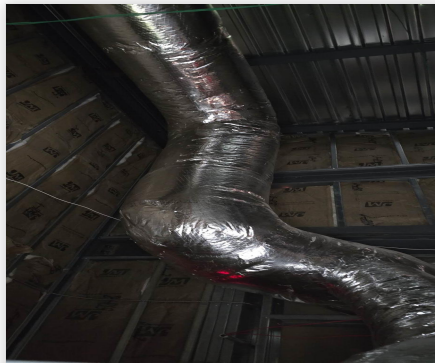
**Issue Name :** DIFFUSER 3-1 MISSING OBD  
**Description :** Diffuser 3-1 is missing an OBD for balancing. The branch damper is too high in the ceiling to reach. Airflow is 362 CFM out of design of 250 CFM.  
**Created By :** National TAB                      **Assigned To :** National TAB - Will Turnbough  
**Status :** Open  
**Priority :** Medium                                      **Asset Tag :** SGRD1  
**Originated Date :** 09/17/2025 - Sagar Patel - National TAB

[1] DIFFUSER 1 DOES NOT HAVE OBD INSTALLED, BRANCH DAMPER IS 20 FT HIGH MAKING IT UNACCESSIBLE.

Asset	Notes	Date	Written By
SGRD1	[1] NO ACCESSIBLE DAMPER	10/07/2025	Tyler Youells

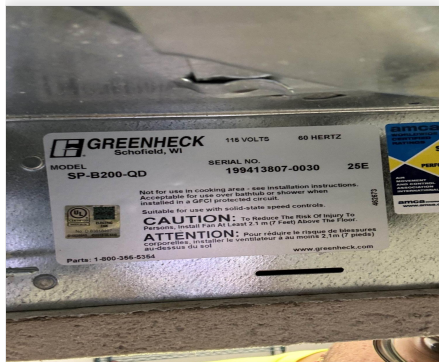
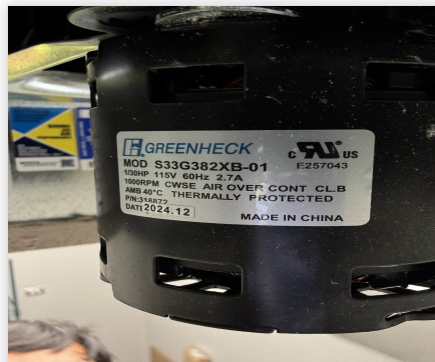
**Issue Name :** EF-3 AIRFLOW LOW  
**Description :** EF3 serving trash room is low on flow. Airflow is 80 CFM out of design of 200 CFM. It needs to be verified that the internal backdraft damper can fully open. It should also be noted that the HP does not match design. Design horsepower is  $1/6 = 0.167$ . The current motor installed has a horsepower of  $1/30 = 0.033$ .  
**Created By :** National TAB      **Assigned To :** National TAB - Will Turnbough  
**Status :** Open  
**Priority :** Medium      **Asset Tag :** EF3  
**Originated Date :** 09/17/2025 - Sagar Patel - National TAB

Notes:  
FLOW IS LOW DUE TO INCORRECT MOTOR SIZE

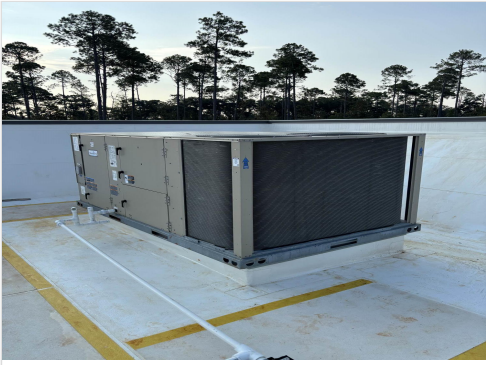
## Unit Data - PHOTO LOG

Asset: RTU1

Unit Data		
	Design	Actual
MFG	LENNOX	LENNOX
Serial Num	-	5626D02336
Model Num	LCT150H5E	LCT150H5E
Type	RTU	RTU
Configuration	VERTICAL	VERTICAL
Num OA Filters 1	-	2
OA Filter Size 1	-	14X23"
Num Final Filter 1	-	4
Final Filter Size 1	-	20X25X2"

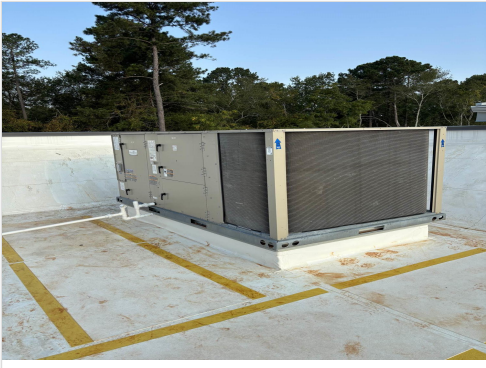
## Unit Data - PHOTO LOG

Asset: RTU2

Unit Data		
	Design	Actual
MFG	LENNOX	LENNOX
Serial Num	-	5626D02336
Model Num	LGT102H5E	LGT102H5E
Type	RTU	RTU
Configuration	VERTICAL	VERTICAL
Num OA Filters 1	-	2
OA Filter Size 1	-	14X23"
Num Final Filter 1	-	4
Final Filter Size 1	-	20X25X2"

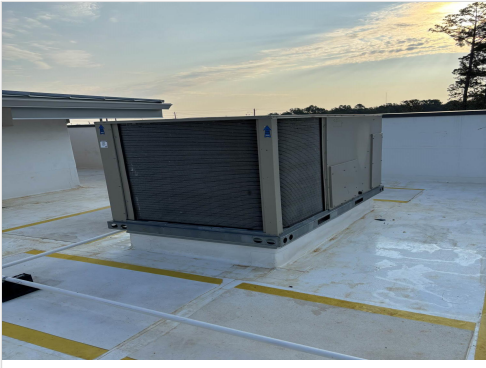
## Unit Data - PHOTO LOG

Asset: RTU3

Unit Data		
	Design	Actual
MFG	LENNOX	LENNOX
Serial Num	-	5625E00868
Model Num	LGT072H5E	LGT072H5E
Type	RTU	RTU
Configuration	VERTICAL	VERTICAL
Num OA Filters 1	-	1
OA Filter Size 1	-	28.75X14"
Num Final Filter 1	-	4
Final Filter Size 1	-	20X20X2

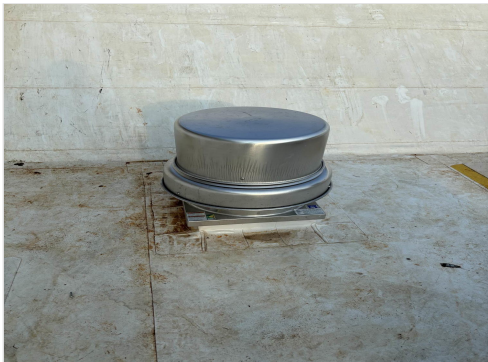
## Unit Data - PHOTO LOG

Asset: EF1

Unit Data		
	Design	Actual
MFG	GREENHECK	GREENHECK
Model Num	GB-098-6	GB-098-6
Serial Num	-	27212659
Type	DOWNBLAST	DOWNBLAST
Configuration	VERTICAL	VERTICAL

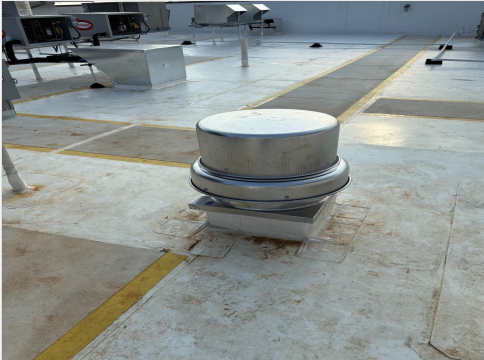
## Unit Data - PHOTO LOG

Asset: EF2

Unit Data		
	Design	Actual
MFG	GREENHECK	GREENHECK
Model Num	GB-098-6	GB-098-6
Serial Num	-	27212661
Type	DOWNBLAST	DOWNBLAST
Configuration	VERTICAL	VERTICAL
