Report: TAB REPORT
Function: Test, Adjust, & Balance
Date: 09/18/2025
Completed By: National TAB

09-15-25 WAWA #6306 LEESBURG, GA

Project: 09-15-25 WAWA #6306 LEESBURG, GA

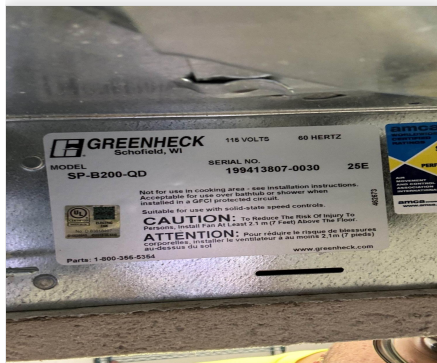
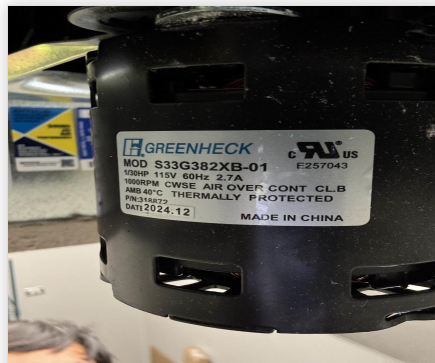
Issue Name : EF-3 MOTOR HAS INCORRECT HORSEPOWER
Description : Exhaust Fan 3 is the incorrect motor. Design horsepower is $1/6 = 0.167$. The current motor installed has a horsepower of $1/30 = 0.033$.
Created By : National TAB **Assigned To :** National TAB - Will Turnbough
Status : Open
Priority : Urgent **Asset Tag :**
Originated Date : 09/17/2025 - Sagar Patel - National TAB

Notes:
MOTOR IS NOT CORRECT

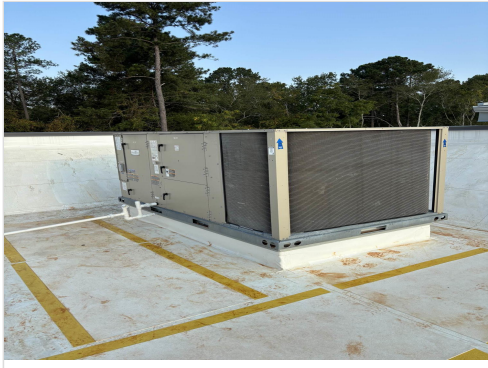
Unit Data - PHOTO LOG

Unit Data		
	Design	Actual
MFG	LENNOX	LENNOX
Serial Num	-	5626D02336
Model Num	LGT102H5E	LGT102H5E
Type	RTU	RTU
Configuration	VERTICAL	VERTICAL
Num OA Filters 1	-	2
OA Filter Size 1	-	14X23"
Num Final Filter 1	-	4
Final Filter Size 1	-	20X25X2"

Test Data		
	Design	Actual
SF CFM	3400	3428
RA CFM	3020	3044
OA CFM	380	384
RL Voltage	-	210 / 210 / 211
RL Amperage	-	7.2 / 7.3 / 7.6
SF System SetPt	-	53%
RA Damper Position	-	73%
RA Damper Type	-	ECONOMIZER
OA Damper Position	-	27%
OA Damper Type	-	ECONOMIZER

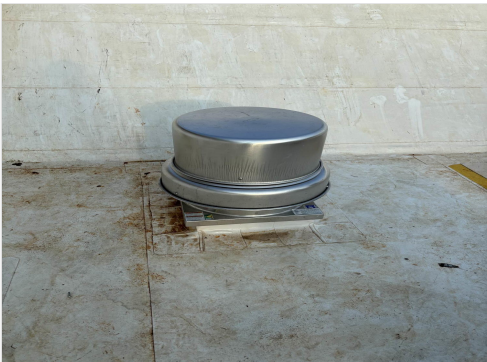
Unit Data - PHOTO LOG

Unit Data		
	Design	Actual
MFG	GREENHECK	GREENHECK
Model Num	GB-098-6	GB-098-6
Serial Num	-	27212659
Type	DOWNBLAST	DOWNBLAST
Configuration	VERTICAL	VERTICAL

[1] UNABLE TO SAFELY READ VOLTS AND AMPS

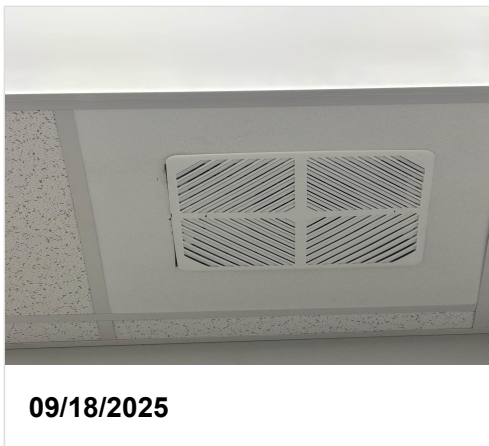
Unit Data - PHOTO LOG

Motor Data		
	Design	Actual
Motor MFG	-	GREENHECK
Frame	-	N/L
Horsepower	0.167	0.033
Motor Rpm	-	1000
Phase	1	1
Voltage (rated)	120	115
Amperage (rated)	-	2.7
Service Factor	-	N/L
