Report: TAB Report
Function: Test, Adjust, & Balance
Date: 02/19/2026
Completed By: National TAB

PROJECT
01-05-26 QT #1726 ATHENS, GA

Project: 01-05-26 QT #1726 ATHENS, GA

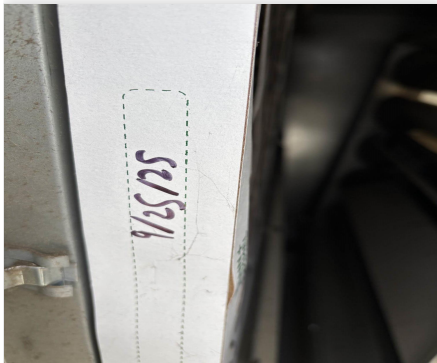
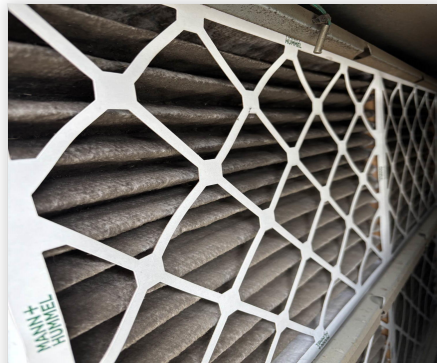
Project Issue File Details

Issue Name : All RTUs: Dirty Filters
Description : All RTUs have dirty filters. The date when all filters were last replaced was on 9/25/25. It is recommended they get replaced.
Created By : National TAB **Assigned To :** National TAB - Dan Hertenstein
Status : Open
Priority : Medium **Asset Tag :**
Originated Date : 02/19/2026 - Sagar Patel - National TAB

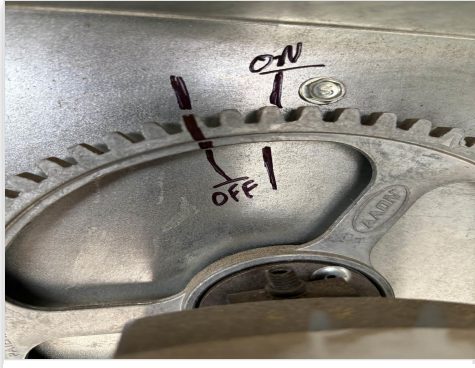
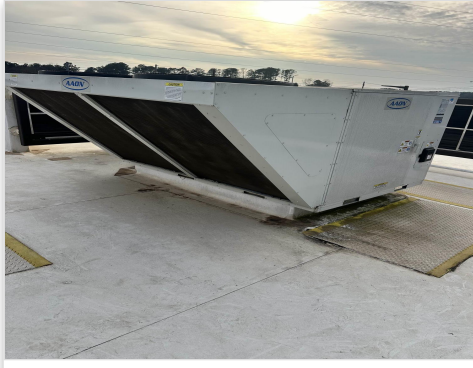
Unit Data - PHOTO LOG

Asset: RT-1

General	
	Actual
Fan Rotation Correct	YES
Unit Filters Clean	NO
Condensate Drain Installed	YES

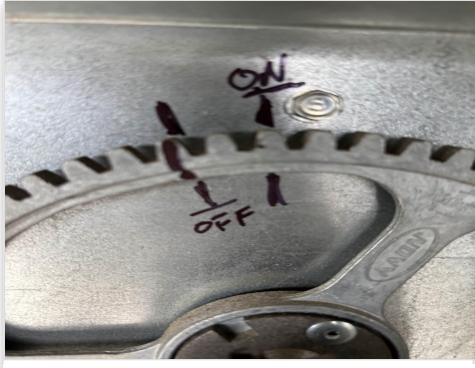
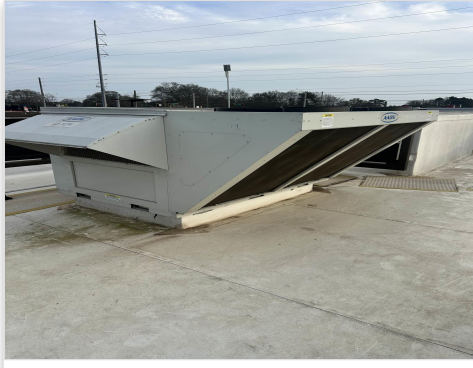
Unit Data - PHOTO LOG

Asset: RT-2

General	
	Actual
Fan Rotation Correct	YES
Unit Filters Clean	NO
Condensate Drain Installed	YES

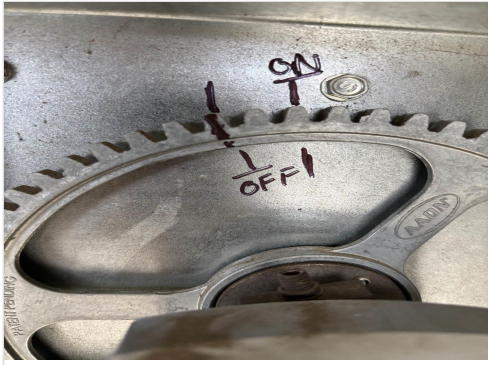
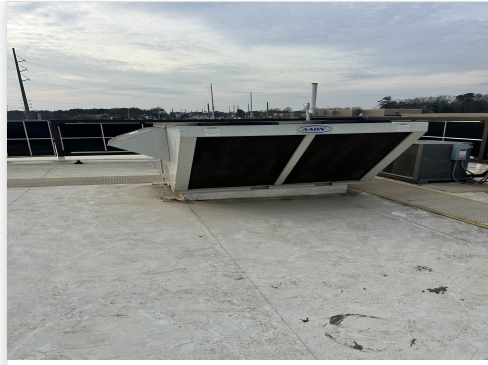
Unit Data - PHOTO LOG

Asset: RT-3

General	
	Actual
Fan Rotation Correct	YES
Unit Filters Clean	NO
Condensate Drain Installed	YES

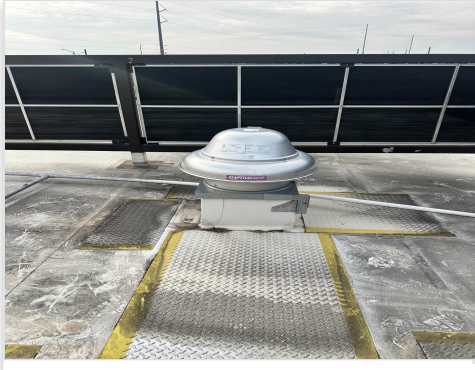
Unit Data - PHOTO LOG

Asset: EF1

Test Data		
	Design	Actual
CFM	750	720
Fan RPM	-	DIAL
Fan Rotation	-	CCW
Motor RPM	-	DIAL
System SetPt	-	DIAL
Total ESP	-	0.38"
Fan Inlet SP	-	-0.38"
Fan Discharge SP	-	ATM

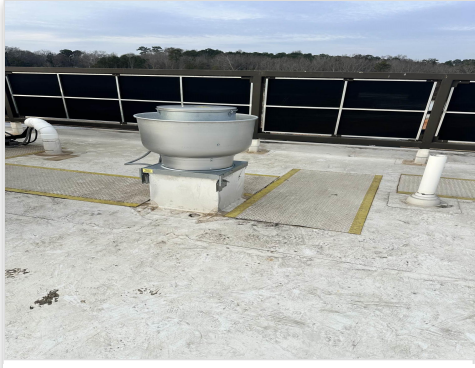
Unit Data - PHOTO LOG

Asset: EF3

Test Data		
	Design	Actual
CFM	1350	1297
Fan RPM	-	1154
Fan Rotation	-	CCW
Motor RPM	-	1154
System SetPt	-	51.8 hz /63% SPEED - VFD
RL Voltage	-	210
RL Amperage	-	1.8
Total ESP	-	0.19"
Fan Inlet SP	-	-0.19"
Fan Discharge SP	-	ATM

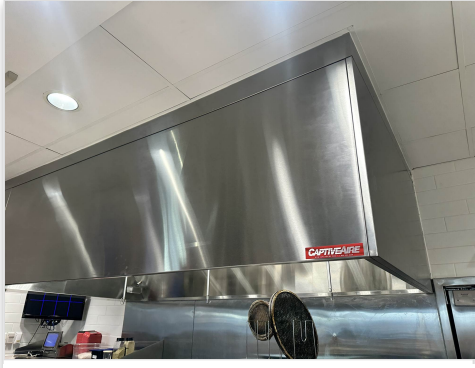
Unit Data - PHOTO LOG

Asset: HD1

Design	Actual
Filter Type	-	CAPTIVEAIRE
Filter Size 1	-	16X20
Filter Qty 1	-	6
Filter AK factor size 1	-	2.08
Filter Total AK Area	-	12.48
Filter1 FPM	-	110
Filter2 FPM	-	104
Filter3 FPM	-	100
Filter4 FPM	-	107
Filter5 FPM	-	105
Filter6 FPM	-	110
Filter Ave FPM(corr)	-	104
CFM	1350	1297
