Report: TAB Report
Function: Test, Adjust, & Balance
Date: 02/25/2026
Completed By: National TAB

PROJECT
02-16-26 CHOPT COLUMBIA, SC

Project: 02-16-26 CHOPT COLUMBIA, SC

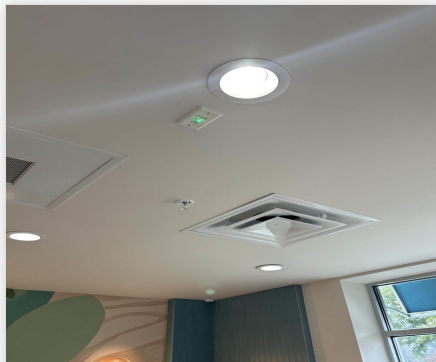
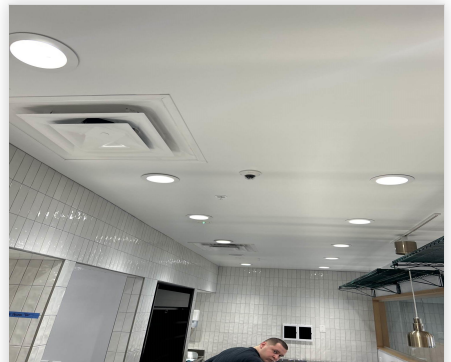
Issue Name : Missing dampers on RTU 2
Description : Missing face dampers. Unable to proportionally balance.
Created By : National TAB **Assigned To :** National TAB - Dan Hertenstein
Status : Open
Priority : Medium **Asset Tag :** RTU2
Originated Date : 02/19/2026 - Jearod Ferrette - National TAB
