Report: TAB Report
Function: Test, Adjust, & Balance
Date: 02/25/2026
Completed By: National TAB

PROJECT
02-16-26 CHOPT COLUMBIA, SC

Project: 02-16-26 CHOPT COLUMBIA, SC

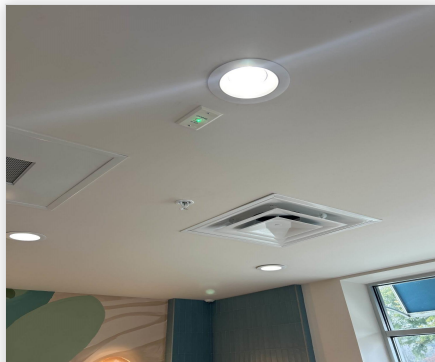
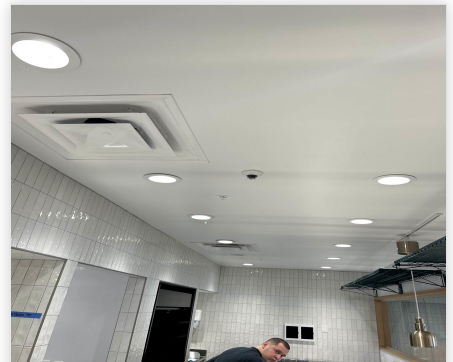
Issue Name : Missing dampers on RTU 2
Description : Missing face dampers. Unable to proportionally balance.
Created By : National TAB **Assigned To :** National TAB - Dan Hertenstein
Status : Open
Priority : Medium **Asset Tag :** RTU2
Originated Date : 02/19/2026 - Jearod Ferrette - National TAB

Asset	Notes	Date	Written By
SGRD1	NO FACE DAMPER	02/19/2026	Jearod Ferrette
SGRD2	NO FACE DAMPER	02/19/2026	Jearod Ferrette
SGRD6	NO FACE DAMPER	02/19/2026	Jearod Ferrette

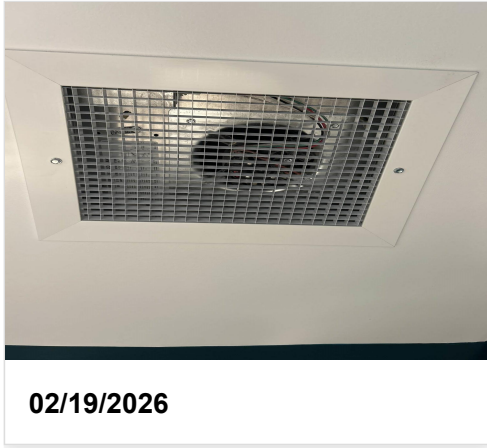
Unit Data - PHOTO LOG

Unit Data		
	Design	Actual
MFG	COOK	COOK
Model Num	GC-146	GC-146
Type	CEILING	CEILING
Configuration	VERTICAL	VERTICAL

Test Data		
	Design	Actual
CFM	75	69
Fan RPM	-	DD
Fan Rotation	-	CCW
Motor RPM	-	DD
System SetPt	-	MAX
RL Voltage	-	NA
RL Amperage	-	0.34
Fan Discharge SP	-	ATMO
