Pre-Evaluation Report Prior to ReDesign Phase

DILLONS 615-074

This test completed on 12/6/2016
This report completed on 1/6/2017

Defining Overall Scope/ Issues

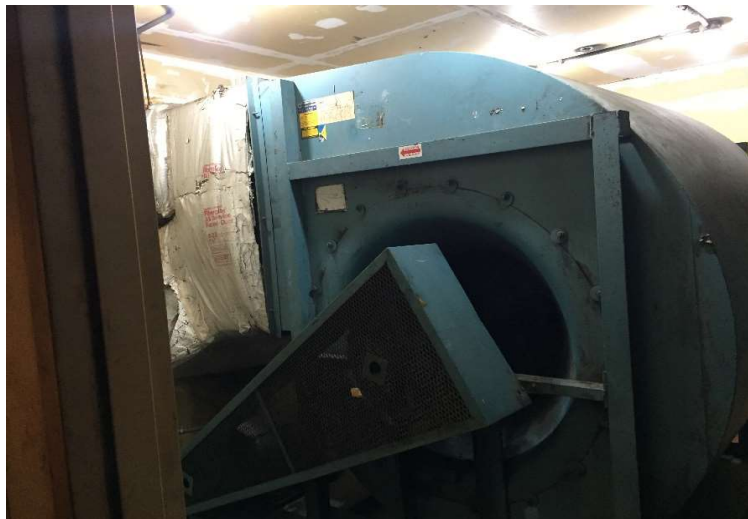
2) Draw an elevation diagram of unit arrangement below showing main system components on diagram, main duct size coming off unit, where outside air is supplied and size.

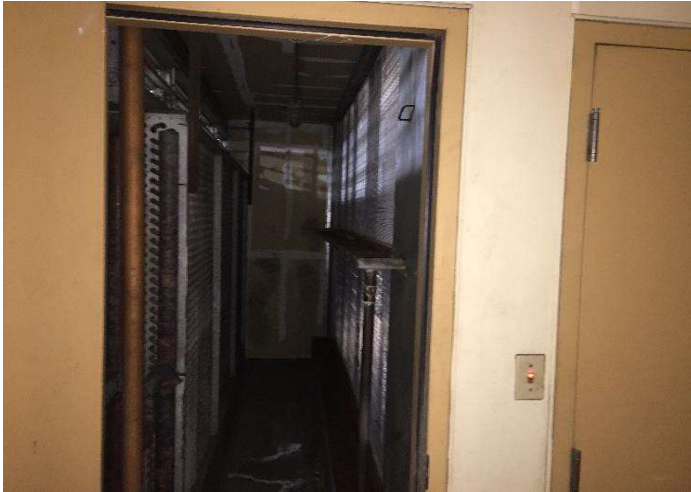
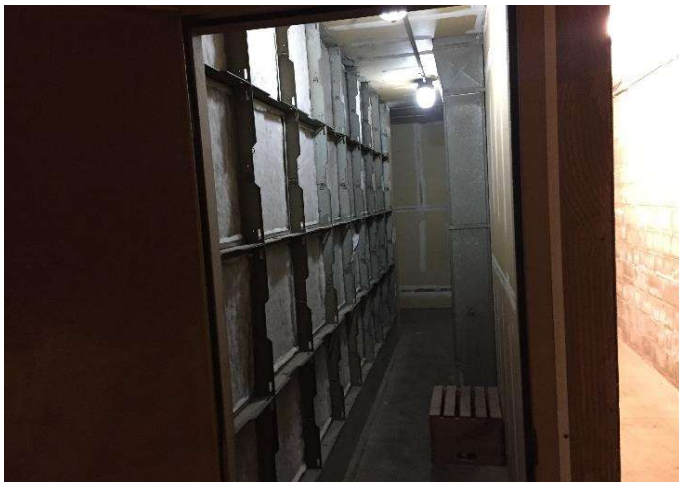
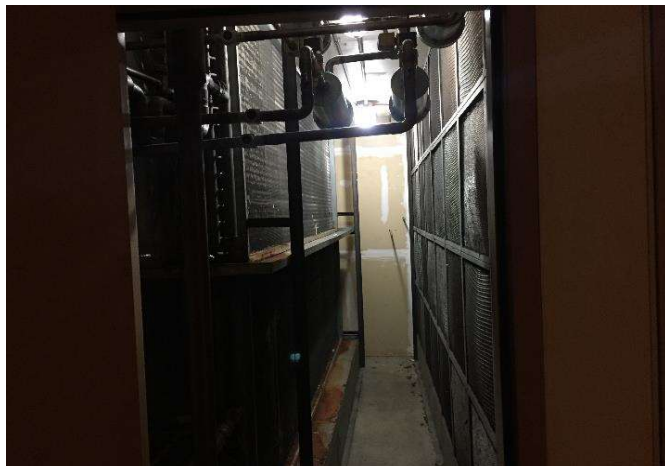
SYSTEM: MAIN SALES FLOOR RTU PICTURES

REMARKS:
 DESIGN AIRFLOW IS 40,000 CFM
 OA DAMPER WAS FOUND CLOSED. TEMPORARILY OPENED TO TEST OA.

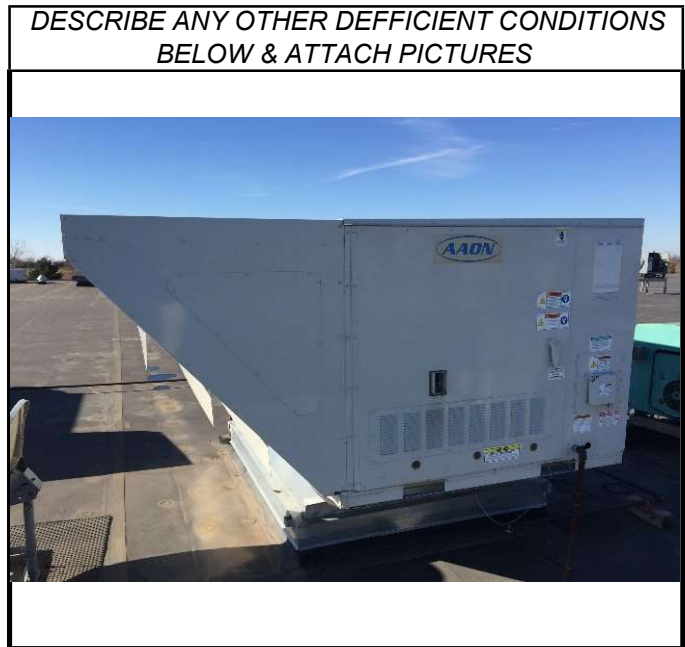
PROJECT: DILLONS 074
SYSTEM/UNIT: RTU- 3 **AREA SERVED:** OFFICES / MEZZ

UNIT CONDITION:	
PHYSICAL DAMAGE	NONE
PULLEY/BELT WEAR	DIRECT DRIVE
WIRING	GOOD
FILTERS	2-14 1/2 X 49 X 2
OUTSIDE AIR DAMPER TYPE	MANUAL BLADE
SIZE OF OUTSIDE AIR DAMPER	25 X 15
DX FILTER CONDITION	CLEAN

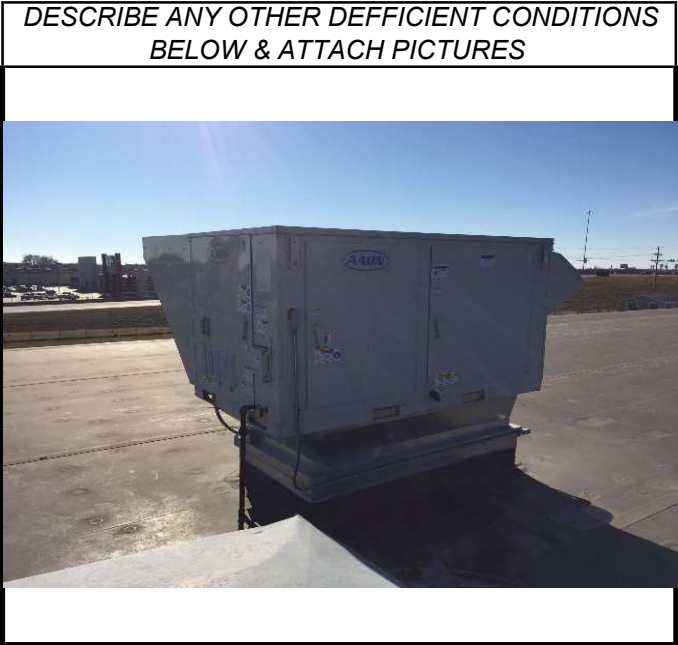
PROJECT: DILLONS 074
SYSTEM/UNIT: RTU- 2 **AREA SERVED:** PHARMACY

UNIT CONDITION:	
PHYSICAL DAMAGE	NONE
PULLEY/BELT WEAR	DIRECT DRIVE
WIRING	GOOD
FILTERS	2-15 1/2 X 39 X 2
OUTSIDE AIR DAMPER TYPE	MANUAL BLADE
SIZE OF OUTSIDE AIR DAMPER	33 X 17
DX FILTER CONDITION	CLEAN

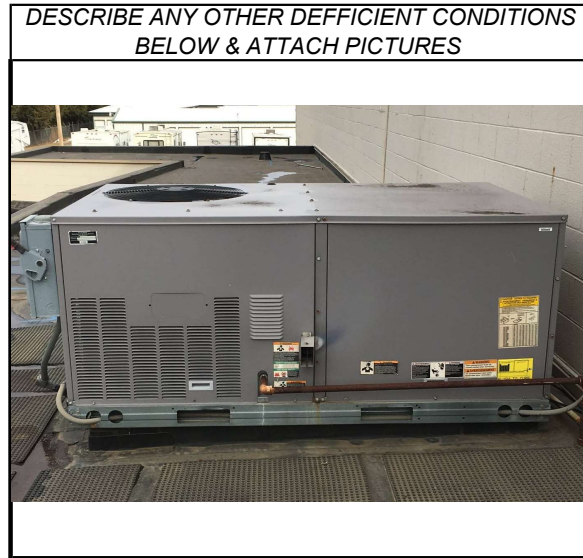
PROJECT: DILLONS 074
SYSTEM/UNIT: RTU- 6 AREA SERVED: RECEIVING

UNIT CONDITION:	
PHYSICAL DAMAGE	RAKING NOISE WHEN RUN
PULLEY/BELT WEAR	PULLEY WORN, BELT WO
WIRING	OLD BUT APPEARS FINE
FILTERS	2 - 24.75"X 15.5"
OUTSIDE AIR DAMPER TYPE	NONE
SIZE OF OUTSIDE AIR DAMPER	NONE
DX FILTER CONDITION	BENT, DIRTY

REMARKS:
 FILTERS ARE DIRTY AND COIL IS DIRTY AND BENT UP AS WELL. NO REAL STRUCTRURE DAMAGE ON RTU BUT MAKES A RATTILING/SQUEAKING NOISE DURING OPERATION. NO OUTSIDE AIR DAMPER. BELT WAS LOOSE AND MOTOR IS MOVING DURING OPERATION AS WELL. TIGHTEND BOTH DOWN. STILL RATTLES AND SQUEAKS.

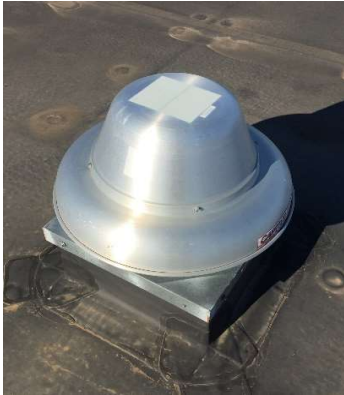
FAN SERVES:	PUBLIC RESTROOMS
FAN TAG:	EF-10
MFG	CAPTIVE AIRE
MODEL	DR30HFA
HP	0.25
NAMEPLATE VOLT	115
NAMEPLATE AMP	4
BELT SIZE & CONDITION	DIRECT DRIVE
EXHAUST (ACTUAL AIRFLOW MEASURED)	316
ADDITIONAL NOTES (OVERALL DEFFICIENCY OR CONDITION OF FAN-DESCRIBE & INDICATE HOW YOU MEASURED AIRFLOW:MEASURED WITH FLOW HOOD

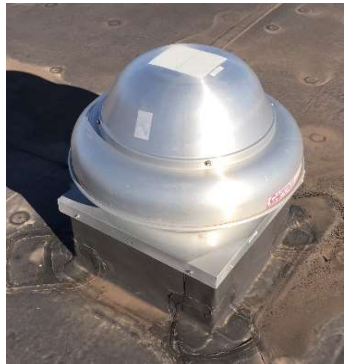
FAN SERVES:	MEZZ / OFFICE RESTROOMS
FAN TAG:	EF-17
MFG	CAPTIVE AIRE
MODEL	DR12HFA
HP	0.18
NAMEPLATE VOLT	115
NAMEPLATE AMP	2
BELT SIZE & CONDITION	DIRECT DRIVE
EXHAUST (ACTUAL AIRFLOW MEASURED)	244
ADDITIONAL NOTES (OVERALL DEFFICIENCY OR CONDITION OF FAN-DESCRIBE & INDICATE HOW YOU MEASURED AIRFLOW:MEASURED WITH FLOW HOOD

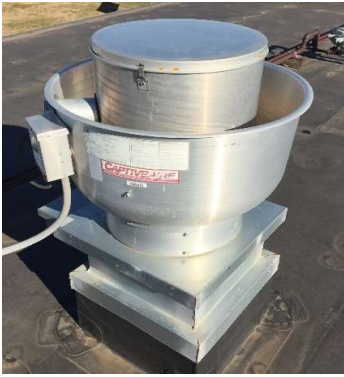
FAN SERVES:	DOUGHNUT HOOD
FAN TAG:	EF-14
MFG	CAPTIVE AIRE
MODEL	NCA10FA
HP	0.5
NAMEPLATE VOLT	208
NAMEPLATE AMP	1.8
BELT SIZE & CONDITION	AX23 GOOD
EXHAUST (ACTUAL AIRFLOW MEASURED)	NR NO POWER NOT IN USE
ADDITIONAL NOTES (OVERALL DEFFICIENCY OR CONDITION OF FAN-DESCRIBE & INDICATE HOW YOU MEASURED AIRFLOW:

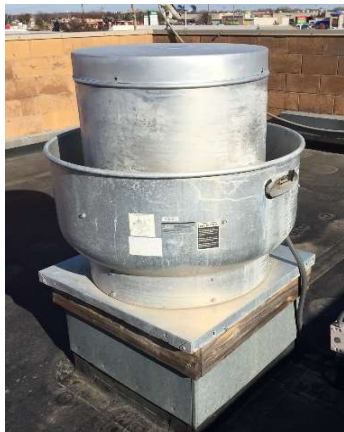
FAN SERVES:	DELI FRYER HOOD BACK
FAN TAG:	EF-15
MFG	DAYTON
MODEL	4YY18
HP	NO LABEL
NAMEPLATE VOLT	NO LABEL
NAMEPLATE AMP	NO LABEL
BELT SIZE & CONDITION	3L190
EXHAUST (ACTUAL AIRFLOW MEASURED)	1822
ADDITIONAL NOTES (OVERALL DEFFICIENCY OR CONDITION OF FAN-DESCRIBE & INDICATE HOW YOU MEASURED AIRFLOW:MEASURED WITH VELGRID

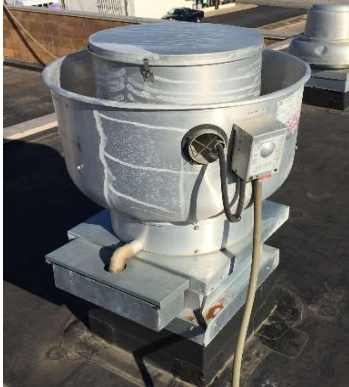
FAN SERVES:	DELI OVEN HOOD
FAN TAG:	EF-13
MFG	CAPTIVE AIRE
MODEL	NCA14HPFA
HP	0.33
NAMEPLATE VOLT	115
NAMEPLATE AMP	7
BELT SIZE & CONDITION	AX20 / GOOD
EXHAUST (ACTUAL AIRFLOW MEASURED)	1514
ADDITIONAL NOTES (OVERALL DEFFICIENCY OR CONDITION OF FAN-DESCRIBE & INDICATE HOW YOU MEASURED AIRFLOW:MEASURED WITH VELGRID

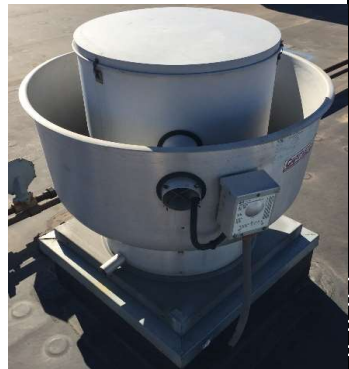
FAN SERVES:	BAKERY OVEN
FAN TAG:	EF-7
MFG	CAPTIVE AIRE
MODEL	DU33HFA
HP	0.33
NAMEPLATE VOLT	115
NAMEPLATE AMP	4.1
BELT SIZE & CONDITION	DIRECT DRIVE
EXHAUST (ACTUAL AIRFLOW MEASURED)	657
ADDITIONAL NOTES (OVERALL DEFFICIENCY OR CONDITION OF FAN-DESCRIBE & INDICATE HOW YOU MEASURED AIRFLOW:MEASURED WITH

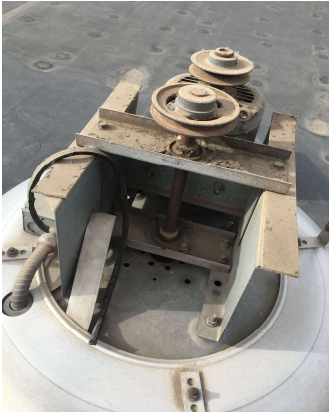
FAN SERVES:	NORTH BACK ROOM
FAN TAG:	EF-2
MFG	LOREN COOK COMPANY
MODEL	150C2B
HP	0.5
NAMEPLATE VOLT	208
NAMEPLATE AMP	NOT LISTED / WORN
BELT SIZE & CONDITION	291ET - BROKEN
EXHAUST (ACTUAL AIRFLOW MEASURED)	NOT RUNNING
ADDITIONAL NOTES (OVERALL DEFFICIENCY OR CONDITION OF FAN-DESCRIBE & INDICATE HOW YOU MEASURED) FAN BELT IS BROKEN. NO VOLTAGE WAS RECORDED TO THE MOTOR. UNIT IS IN POOR CONDITION.

NO BELT IS BROKEN

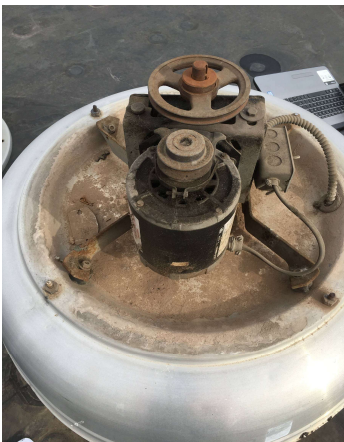
FAN SERVES:	REAR MEZZANINE / ELECTRICAL ROOM
FAN TAG:	EF-3
MFG	UTO - NO TAG OR LABEL
MODEL	UTO - NO TAG OR LABEL
HP	0.33
NAMEPLATE VOLT	UTO - NO TAG OR LABEL
NAMEPLATE AMP	UTO - NO TAG OR LABEL
BELT SIZE & CONDITION	NO BELT IS INSTALLED
EXHAUST (ACTUAL AIRFLOW MEASURED)	UNIT NOT RUNNING
ADDITIONAL NOTES (OVERALL DEFFICIENCY OR CONDITION OF FAN-DESCRIBE & INDICATE HOW YOU MEASURED AIRFLOW: THERE IS NO BELT INSTALLED. THERE IS NO VOLTAGE RECORDED TO THE MOTOR.

NO NO BELT IS INSTALLED

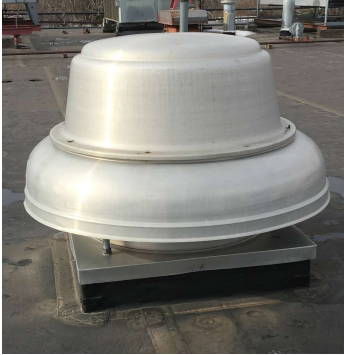
FAN SERVES:	ABOVE SALES FLOOR CEILING - WEST
FAN TAG:	EF 4
MFG	UTO - NO TAG OR LABEL
MODEL	UTO - NO TAG OR LABEL
HP	0.75 (MOTOR STICKER)
NAMEPLATE VOLT	208-230/460 (MOTOR STICKER)
NAMEPLATE AMP	2.6/1.3 (MOTOR STICKER)
BELT SIZE & CONDITION	BELT SIZE IS WORN OFF OF BELT
EXHAUST (ACTUAL AIRFLOW MEASURED)	UNIT NOT RUNNING
ADDITIONAL NOTES (OVERALL DEFFICIENCY OR CONDITION OF FAN-DESCRIBE & INDICATE HOW YOU MEASURED) THERE WAS NO VOLTAGE RECORDED AT THE MOTOR.

NO BELT IS WORN

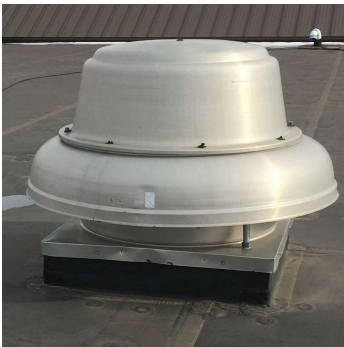
FAN SERVES:	ABOVE SALES FLOOR CEILING - EAST
FAN TAG:	EF 5
MFG	UTO - NO TAG OR LABEL
MODEL	UTO - NO TAG OR LABEL
HP	0.75
NAMEPLATE VOLT	208-230/460
NAMEPLATE AMP	2.6/1.3
BELT SIZE & CONDITION	B2T
EXHAUST (ACTUAL AIRFLOW MEASURED)	UNIT NOT RUNNING
ADDITIONAL NOTES (OVERALL DEFFICIENCY OR CONDITION OF FAN-DESCRIBE & INDICATE HOW YOU MEASURED AIRFLOW: THERE WAS NO VOLTAGE RECORDED AT THE MOTOR.

NO BELT IS WORN

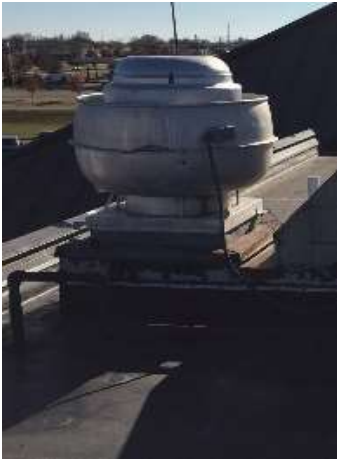
FAN SERVES:	CHINESE LEFT AND RIGHT
FAN TAG:	EF-12
MFG	DUO AIRE
MODEL	NOT LISTED
HP	2
NAMEPLATE VOLT	208
NAMEPLATE AMP	NOT LISTED
BELT SIZE & CONDITION	AX25 GOOD
EXHAUST (ACTUAL AIRFLOW MEASURED)	4767
ADDITIONAL NOTES (OVERALL DEFFICIENCY OR CONDITION OF FAN-DESCRIBE & INDICATE HOW YOU MEASURED AIRFLOW:MEASURED WITH VELGRID

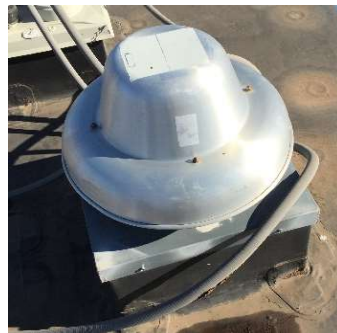
FAN SERVES:	SEAFOOD
FAN TAG:	EF11
MFG	CAPTIVE AIRE
MODEL	DR12HFA
HP	0.18
NAMEPLATE VOLT	115
NAMEPLATE AMP	2
BELT SIZE & CONDITION	DD
EXHAUST (ACTUAL AIRFLOW MEASURED)	466
ADDITIONAL NOTES (OVERALL DEFFICIENCY OR CONDITION OF FAN-DESCRIBE & INDICATE HOW YOU MEASURED AIRFLOW:MEASURED WITH FLOWHOOD

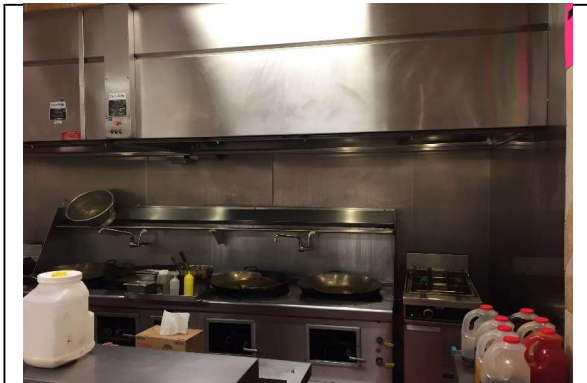
KH #1 RIGHT	FIELD NOTES
SIZE OF HOOD (L x W)	96 X 50
LOCATION OF HOOD (IE- FRONT CHARBROILER DISPLAY HD)	DELI FRYERS RIGHT
IS HOOD EXHAUST ONLY OR EXHAUST WITH MU-AIR?	MUA
IF HOOD HAS MUA AIR - IS AIR COMING OUT OF PLENUM OR IS IT CLOGGED WITH DIRT?	NOT USED
ANY MISSING FILTERS (QTY/SIZE):	NO
ANY EVIDENCE OF GREASE ACCUMILATION IN OR AROUND HOOD?	NO

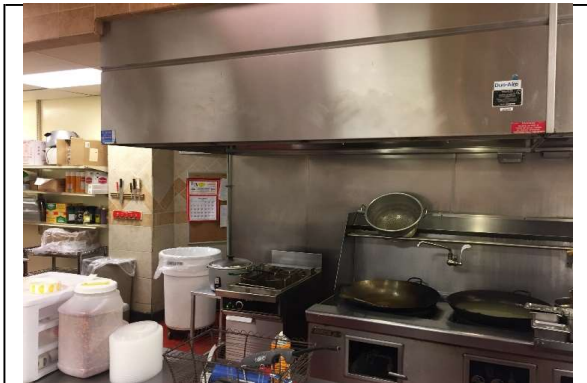
KH#2 LEFT	FIELD NOTES
SIZE OF HOOD (L x W)	96 X 50
LOCATION OF HOOD (IE- FRONT CHARBROILER DISPLAY HD)	DELI FRYERS RIGHT
IS HOOD EXHAUST ONLY OR EXHAUST WITH MU-AIR?	MUA
IF HOOD HAS MUA AIR - IS AIR COMING OUT OF PLENUM OR IS IT CLOGGED WITH DIRT?	NOT USED
ANY MISSING FILTERS (QTY/SIZE):	NO
ANY EVIDENCE OF GREASE ACCUMILATION IN OR AROUND HOOD?	NO

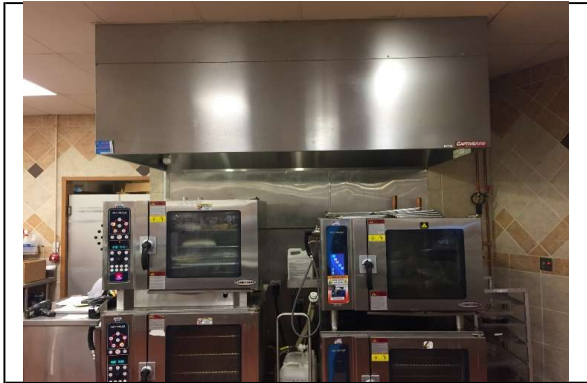
KH #2	FIELD NOTES
SIZE OF HOOD (L x W)	96 X 60
LOCATION OF HOOD (IE- FRONT CHARBROILER DISPLAY HD)	DELI OVENS
IS HOOD EXHAUST ONLY OR EXHAUST WITH MU-AIR?	EXHAUST ONLY
IF HOOD HAS MUA AIR - IS AIR COMING OUT OF PLENUM OR IS IT CLOGGED WITH DIRT?	NA
ANY MISSING FILTERS (QTY/SIZE):	NO
ANY EVIDENCE OF GREASE ACCUMILATION IN OR AROUND HOOD?	NO

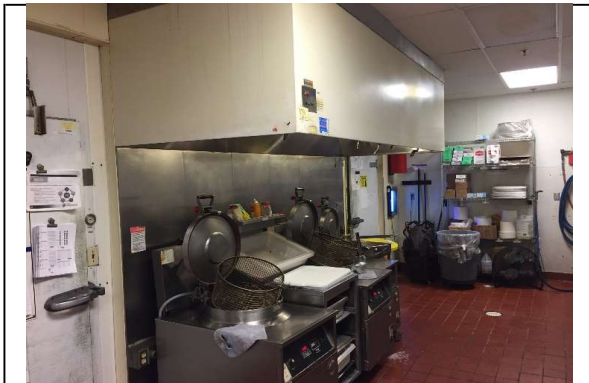
KH #4	FIELD NOTES
SIZE OF HOOD (L x W)	132 X 48
LOCATION OF HOOD (IE- FRONT CHARBROILER DISPLAY HD)	DELI FRYERS BACK
IS HOOD EXHAUST ONLY OR EXHAUST WITH MU-AIR?	MUA
IF HOOD HAS MUA AIR - IS AIR COMING OUT OF PLENUM OR IS IT CLOGGED WITH DIRT?	NOT USED
ANY MISSING FILTERS (QTY/SIZE):	NO
ANY EVIDENCE OF GREASE ACCUMILATION IN OR AROUND HOOD?	NO

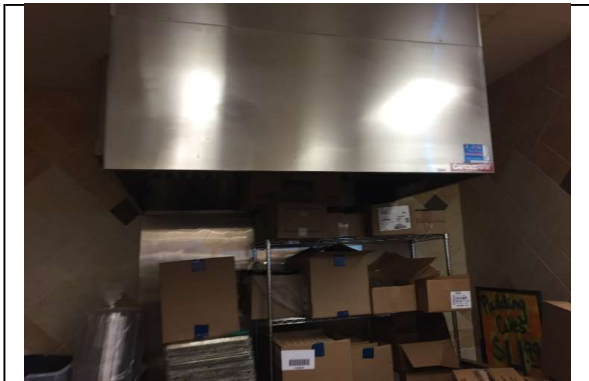
KH #3	FIELD NOTES
SIZE OF HOOD (L x W)	59 X 60
LOCATION OF HOOD (IE- FRONT CHARBROILER DISPLAY HD)	BAKERY DOUGHNUT
IS HOOD EXHAUST ONLY OR EXHAUST WITH MU-AIR?	EXHAUST ONLY
IF HOOD HAS MUA AIR - IS AIR COMING OUT OF PLENUM OR IS IT CLOGGED WITH DIRT?	NA
ANY MISSING FILTERS (QTY/SIZE):	NO
ANY EVIDENCE OF GREASE ACCUMILATION IN OR AROUND HOOD?	NO
