**Report: TAB REPORT**  
**Function: Test, Adjust, & Balance**  
**Date: 09/19/2024**

**09-16-24 DOLLAR TREE- SPRINGFIELD, IL**

1713 W JEFFERSON ST

SPRINGFIELD, IL 62702

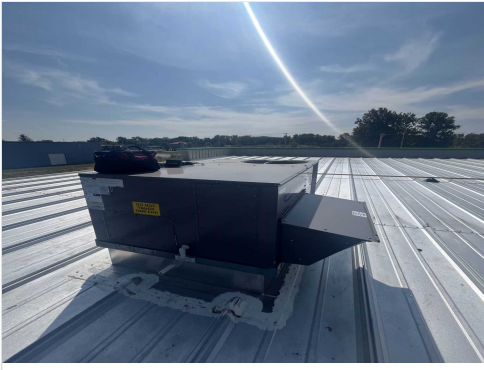
IMG\_5540\_1467347826.j..

Unit Data		
	Design	Actual
MFG	CARRIER	CARRIER
Serial Num	-	3823C10455
Model Num	48GCE	48GCEM05A2M5A6W1F0
Type	RTU	RTU
Configuration	VERTICAL	VERTICAL
Num OA Filters 1	-	1
OA Filter Size 1	-	28X14
Num Final Filter 1	-	2
Final Filter Size 1	-	16X25X2

Test Data		
	Design	Actual
SF CFM	1750	1796
SF RPM	-	1581
RA CFM	1600	1649
OA CFM	150	147
RL Voltage	-	211.5/211.3/211.5
RL Amperage	-	3.0/3.1/3.0
SF Rotation	-	CW
SF System SetPt	-	7.6VDC
RA Damper Position	-	7.40V
Min OA Damper Position	-	2.60V
Min OA Damper Type	-	ECONOMIZER
OA Enthalpy Setpt	-	ES5

Performance Data		
	Design	Actual
MA Plenum SP	-	-0.51"
Fan Suction SP	-	-0.71"
Fan Discharge SP	-	0.11"
Total ESP	1.0	0.62"
Fan Total SP	-	0.82"

General	
	Actual
Fan Rotation Correct	YES
Unit Filters Clean	YES
Condensate Drain Installed	YES

[1] Diffuser 1-8 high on flow, face damper is fully closed, branch damper is broken loose and free spinning. unable to decrease flow.

**Issue Name :** All RTU final filters  
**Description :** All RTUs final filters are construction filters. Recommend replacing with correct size merv 8 rated Pleated filters.  
**Created By :** National TAB                      **Assigned To :** National TAB - Dylan Crisman  
**Status :** Open  
**Priority :** InfoOnly                                      **Asset Tag :**  
**Originated Date :** 09/17/2024 - Dylan Crisman - National TAB

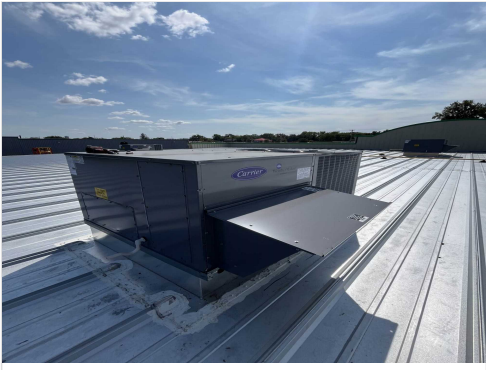
IMG\_5542\_2102762514.j..

Unit Data		
	Design	Actual
MFG	CARRIER	CARRIER
Serial Num	-	3323P67904
Model Num	48FCE	48FCEM08A2M5A6W1F0
Type	RTU	RTU
Configuration	VERTICAL	VERTICAL
Num OA Filters 1	-	1
OA Filter Size 1	-	35X19.5
Num Final Filter 1	-	4
Final Filter Size 1	-	16X20X2

Test Data		
	Design	Actual
SF CFM	2800	2931
SF RPM	-	1426
RA CFM	2450	2561
OA CFM	350	370
RL Voltage	-	210.9/211.9/211.3
RL Amperage	-	2.2/3.1/2.6
SF Rotation	-	CW
SF System SetPt	-	6.4VDC
RA Damper Position	-	7.10V
Min OA Damper Position	-	2.90V
Min OA Damper Type	-	ECONOMIZER
OA Enthalpy Setpt	-	ES5

Performance Data		
	Design	Actual
MA Plenum SP	-	-0.43"
Fan Suction SP	-	-0.64"
Fan Discharge SP	-	0.26"
Total ESP	1.0	0.69"
Fan Total SP	-	0.9"

General	
	Actual
Fan Rotation Correct	YES
Unit Filters Clean	YES
Condensate Drain Installed	YES

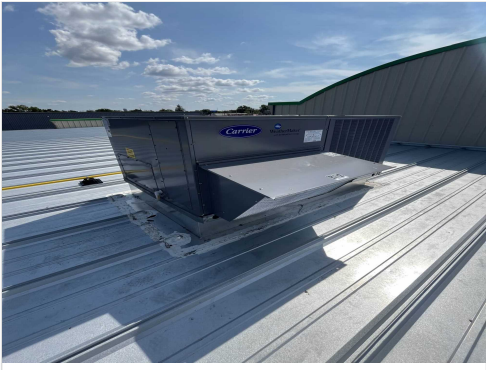
IMG\_5546\_988885526.jp..

Unit Data		
	Design	Actual
MFG	CARRIER	CARRIER
Serial Num	-	3223P67835
Model Num	48FCE	48FCEM08A2M5AYW1F0
Type	RTU	RTU
Configuration	VERTICAL	VERTICAL
Num OA Filters 1	-	1
OA Filter Size 1	-	35X19.5
Num Final Filter 1	-	4
Final Filter Size 1	-	16X20X2

Test Data		
	Design	Actual
SF CFM	2800	2777
SF RPM	-	1325
RA CFM	2450	2417
OA CFM	350	360
RL Voltage	-	210.6/210.6/210.8
RL Amperage	-	2.6/2.7/2.3
SF Rotation	-	CW
SF System SetPt	-	6.7VDC
RA Damper Position	-	7.10V
Min OA Damper Position	-	2.90V
Min OA Damper Type	-	ECONOMIZER
OA Enthalpy Setpt	-	ES5

Performance Data		
	Design	Actual
MA Plenum SP	-	-0.47"
Fan Suction SP	-	-0.74"
Fan Discharge SP	-	0.30"
Total ESP	-	0.77"
Fan Total SP	-	1.04"

General	
	Actual
Fan Rotation Correct	YES
Unit Filters Clean	YES
Condensate Drain Installed	YES

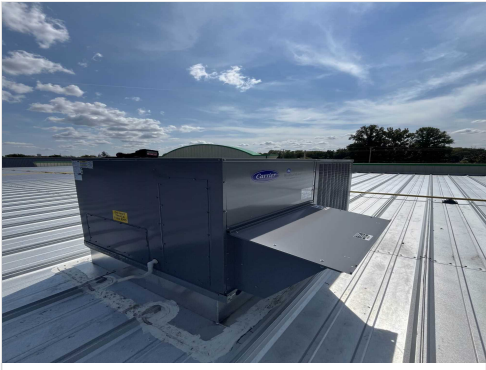
IMG\_5548\_638524269.jp..

**Issue Name :** RTU-4 economizer not functional  
**Description :** RTU-4 economizer was not functional via controller setpoints. Manually set OA damper to 1/2" open to achieve design airflow. Recommend mechanical service economizer.  
**Created By :** National TAB                      **Assigned To :** National TAB - Dylan Crisman  
**Status :** Open  
**Priority :** High                                      **Asset Tag :**  
**Originated Date :** 09/18/2024 - Dylan Crisman - National TAB

Unit Data		
	Design	Actual
MFG	CARRIER	CARRIER
Serial Num	-	3523P69287
Model Num	48FCE	48FCEM12A2M5A6W1F0
Type	RTU	RTU
Configuration	VERTICAL	VERTICAL
Num OA Filters 1	-	1
OA Filter Size 1	-	35X19.5
Num Final Filter 1	-	4
Final Filter Size 1	-	20X20X2

Test Data		
	Design	Actual
SF CFM	3500	3624
SF RPM	-	1669
RA CFM	3100	3207
OA CFM	400	417
RL Voltage	-	207.9/207.8/208.2
RL Amperage	-	4.3/4.4/4.1
SF Rotation	-	CW
SF System SetPt	-	7.9VDC
RA Damper Position	-	NA
Min OA Damper Position	-	MANUALLY SET 1/2" OPEN
Min OA Damper Type	-	ECONOMIZER
OA Enthalpy Setpt	-	ES5

Performance Data		
	Design	Actual
MA Plenum SP	-	-0.59"
Fan Suction SP	-	-0.90"
Fan Discharge SP	-	0.47"
Total ESP	1.0	1.06"
Fan Total SP	-	1.37"

General	
	Actual
Fan Rotation Correct	YES
Unit Filters Clean	YES
Condensate Drain Installed	YES

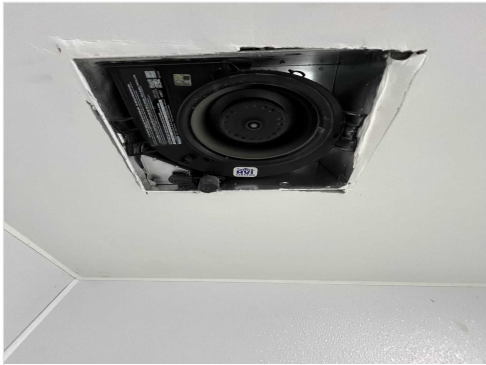
IMG\_5550\_53801962.jpe..

**Issue Name :** EF-1 low on flow  
**Description :** EF-1 is low on flow at 40/75 CFM. Unit is single speed wired for 80CFM. Unable to increase airflow. Recommend mechanical inspect unit.  
**Created By :** National TAB                      **Assigned To :** National TAB - Dylan Crisman  
**Status :** Open  
**Priority :** High                                      **Asset Tag :**  
**Originated Date :** 09/17/2024 - Dylan Crisman - National TAB

Unit Data		
	Design	Actual
MFG	GREENHECK	BROAN
Model Num	SP-B110	AE80B-B
Serial Num	-	42D03T
Type	CEILING	CEILING
Configuration	VERTICAL	VERTICAL

Test Data		
	Design	Actual
CFM	75	40
Fan RPM	-	900
Fan Rotation	-	CCW
Motor RPM	-	
System SetPt	-	HIGH SPEED
RL Voltage	-	NA
RL Amperage	-	NA
Total ESP	0.25	NA
Fan Inlet SP	-	NA
Fan Discharge SP	-	ATM

Motor Data		
	Design	Actual
Motor MFG	-	OCEAN MOTOR
Frame	-	NL
Horsepower	80	NL
Motor Rpm	-	900
Phase	1	1
Voltage (rated)	120	120
Amperage (rated)	-	0.3
Service Factor	-	NL

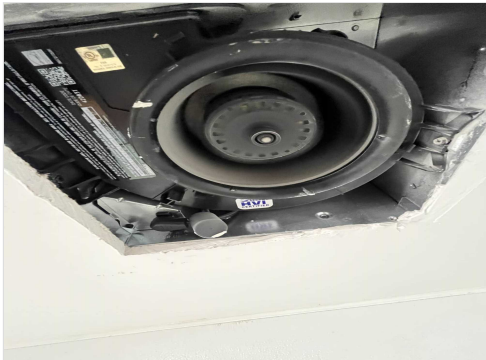
IMG\_5554\_1428039598.j..

**Issue Name :** EF-2 low on flow  
**Description :** EF-2 is low on flow at 39/75 CFM. Unit is single speed wired for 80CFM. Unable to increase airflow. Recommend mechanical inspect unit.  
**Created By :** National TAB                      **Assigned To :** National TAB - Dylan Crisman  
**Status :** Open  
**Priority :** High                                      **Asset Tag :**  
**Originated Date :** 09/17/2024 - Dylan Crisman - National TAB

Unit Data		
	Design	Actual
MFG	GREENHECK	BROAN
Model Num	SP-B110	AE80B-B
Serial Num	-	42D03T
Type	CEILING	CEILING
Configuration	VERTICAL	VERTICAL

Motor Data		
	Design	Actual
Motor MFG	-	OCEAN MOTOR
Frame	-	NL
Horsepower	80	NL
Motor Rpm	-	900
Phase	1	1
Voltage (rated)	120	120
Amperage (rated)	-	0.3
Service Factor	-	NL

Test Data		
	Design	Actual
CFM	75	39
Fan RPM	-	900
Fan Rotation	-	CCW
Motor RPM	-	900
System SetPt	-	HIGH SPEED
RL Voltage	-	NA
RL Amperage	-	NA
Total ESP	0.25	NA
Fan Inlet SP	-	NA
Fan Discharge SP	-	ATM
