Exhaust Only hoods  
(1) 141" L Charbroiler Hd  
(1) 144" L Fryer Hd  
Fire Cabinet on right end with a MELINK Energy Management System. Original MELINK system had temp sensors, optic Eyes on hoods, VFD's, Controller & low voltage wiring throughout. System has been bypassed.

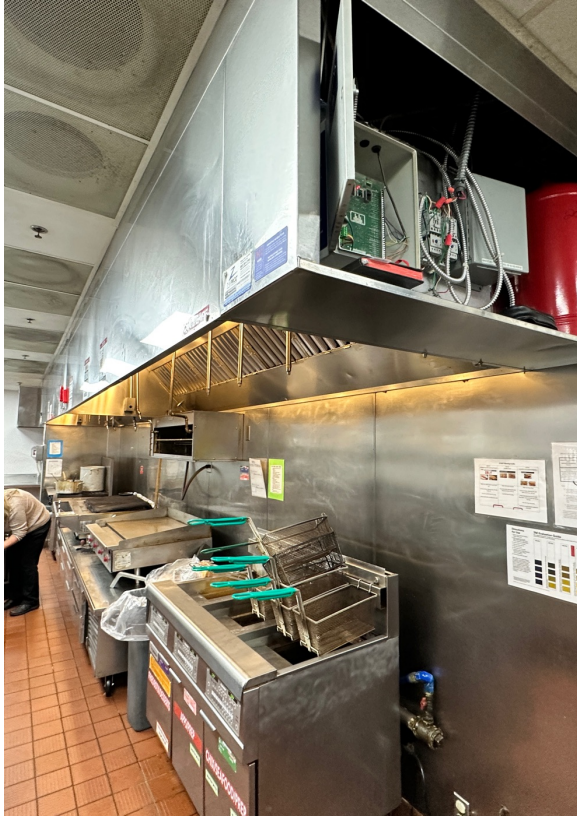
All outside air is designed to be brought in via air devices (Return + Outside Air = Supply Air)

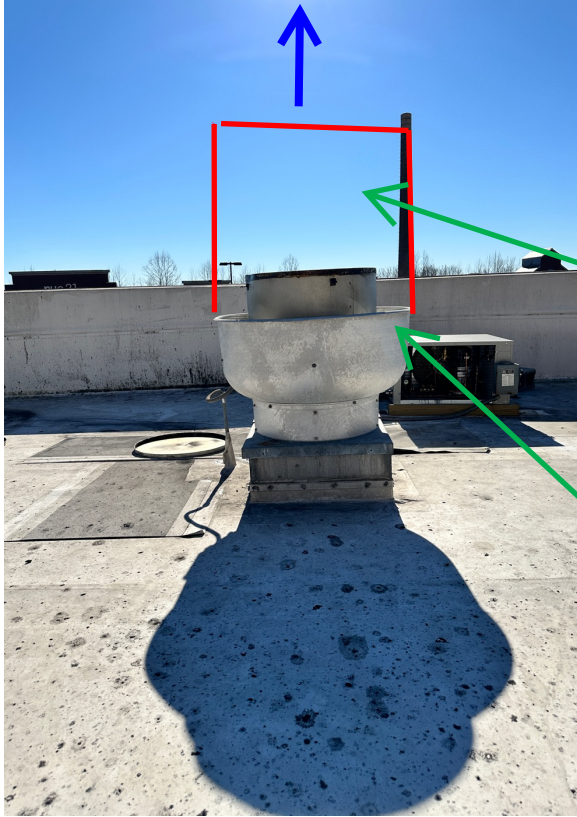
**NO UNIT TAG LEGIBLE. FAN DIAMETER IS ABOUT 38.5" OD. BELIEVE IT IS AN OLD PENN-CAS NCA18 FAN. WILL VERIFY WITH SPEC RESEARCH.**

**RECOMMEND INSTALLING CAPTIVE AIRE 36" WINDBAND EXTENSIONS ON BOTH EXHAUST FANS TO KEEP FROM SMOKE FROM GETTING SUCKED IN FROM RTU UNITS DUE TO HIGHER PARAPET & HIGH HILLS ON FRONT SIDE OF BUILDING. THIS WILL ALLOW FOR OUTSIDE AIR ON RTU UNIT FOR KITCHEN TO BE OPENED.**

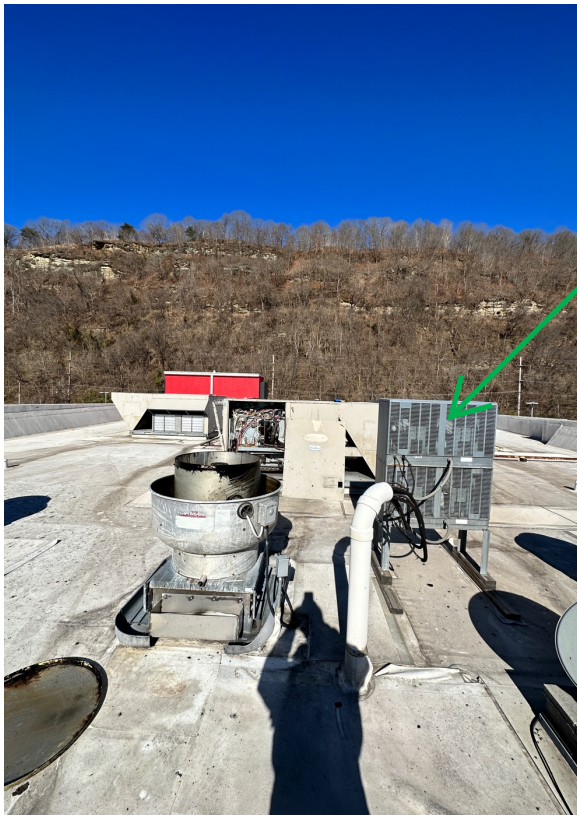
**KITCHEN RTU, THAT HAS OUTSIDE AIR DAMPER CLOSED & GETS COVERED WITH SMOKE AT TIMES DURING COOKING.**

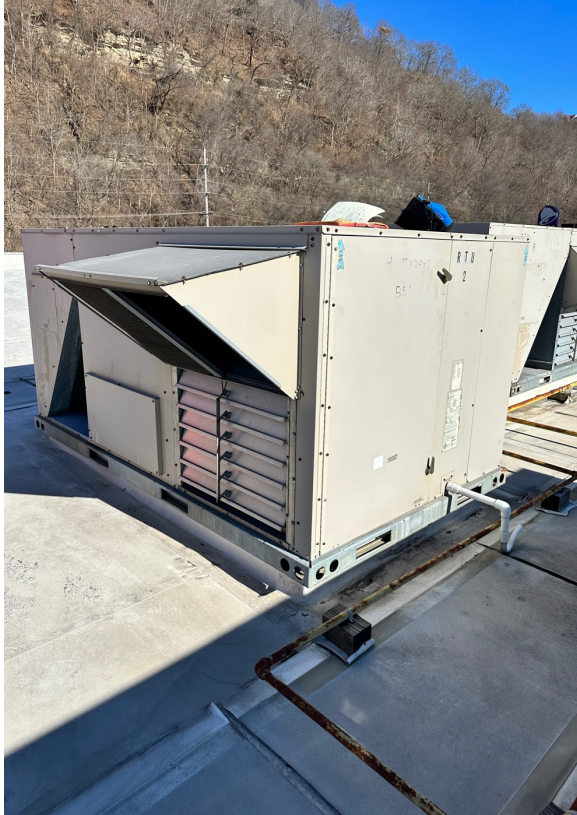
THERE ARE 3 DINING RTU UNITS. TWO LARGE UNITS & ONE SMALLER UNIT (SHOWN). ONE UNIT OA DAMPER FUNCTIONS. HOWEVER THE OTHER TWO UNITS THEY DO NOT & HAVE BEEN UNPLUGGED BY OTHERS & THEN THEY USED BREAD TIES TO OPEN RELIEF DAMPERS SOME TO BRING IN SOME OUTSIDE AIR. RECOMMEND AT MIN TO MAKE OA DAMPERS MANUAL FIX DAMPERS & SET THEM PROPERLY FOR THE RIGHT AMOUNT OF OUTSIDE AIR.

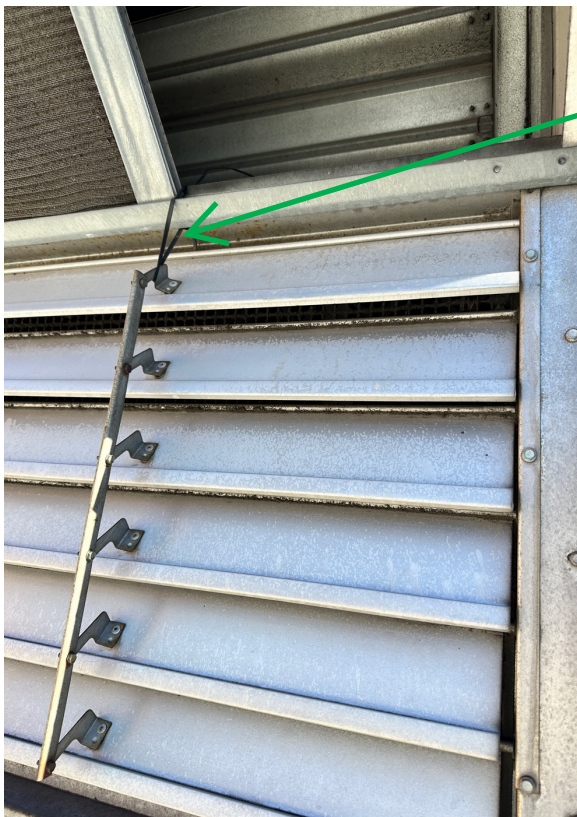
BUILDING PRESSURE WAS FAIRLY NEGATIVE WHEN ARRIVED. SET OUTSIDE AIR ON ONE OF THE LARGE RTU DINING UNITS & SLOWED DISH HOOD DOWN TO GET BUILDING PRESSURE DECENT. REALLY NEEDS TO BE BALANCED PROPERLY ONCE MECHANICAL FIXES ARE PERFORMED.

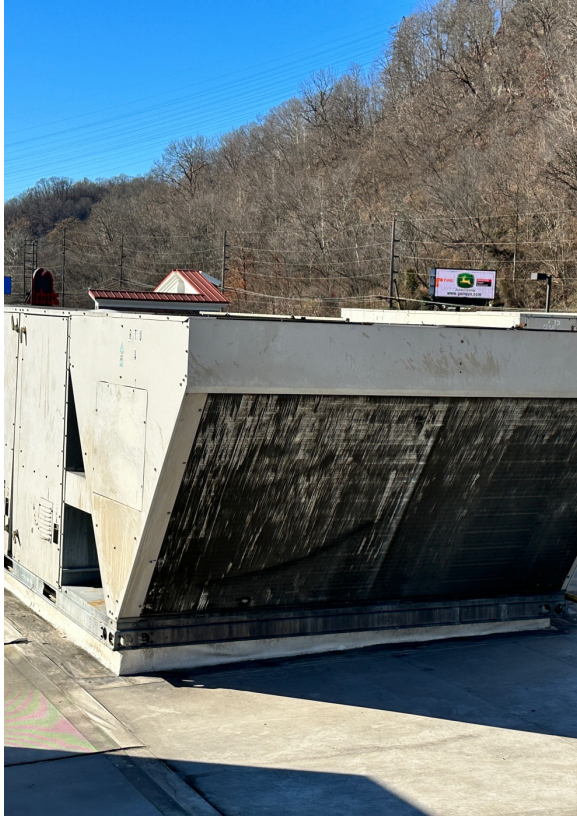
**LARGE 25 TON KITCHEN RTU. NOT IN BEST SHAPE. COOLING NEEDS TO BE LOOKED AT. DON'T BELIEVE THE COOLING CYCLE WORKS. NEED TO WORK WITH MAINTENANCE TEAM. SOME CONTROL WIRING WAS DISCONNECTED.**

**107.5" x 87" x 9" curb**

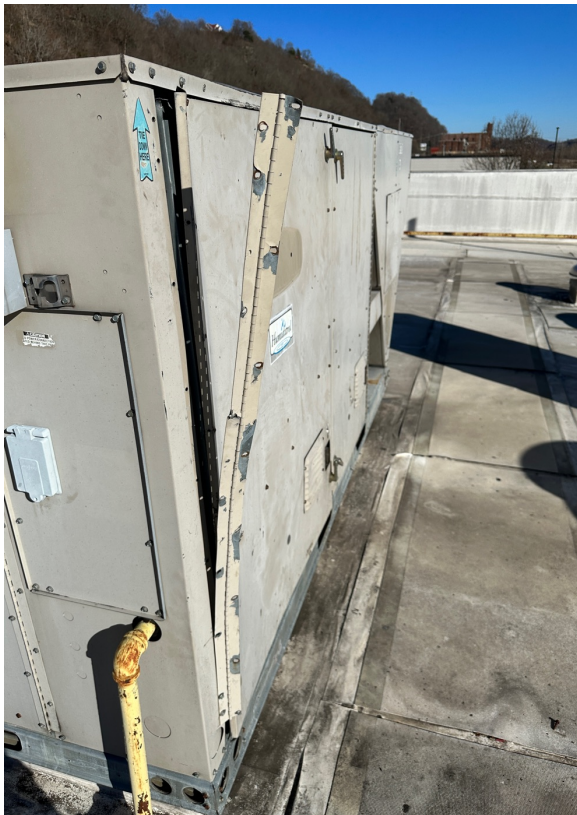
**THE ELECTRICAL DOOR IS FAIRLY DAMAGED & THE HINGE FOR DOOR IS DAMAGED. RECOMMEND TO REPLACE DOOR OR FIX WITH OTHER HINGE SYSTEM IF UNIT IS TO BE MAINTAINED IF THE COOLING IS FUNCTIONAL. IT BELIEVE COOLING HAS NOT WORKED FOR SEVERAL MONTHS. EXTREMELY HOT IN SUMMER TIME IN KITCHEN (85 TO 90 DEGREES IN KITCHEN IN SUMMER. COULD NOT GET THE COOLING TO KICK ON WHILE ON SITE.**

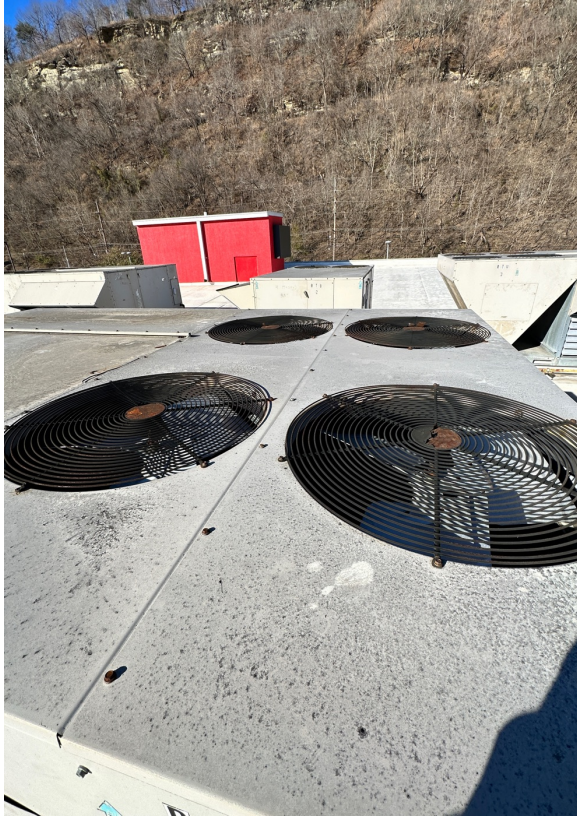
**CONDENSER FANS ON  
KITCHEN RTU UNIT.**

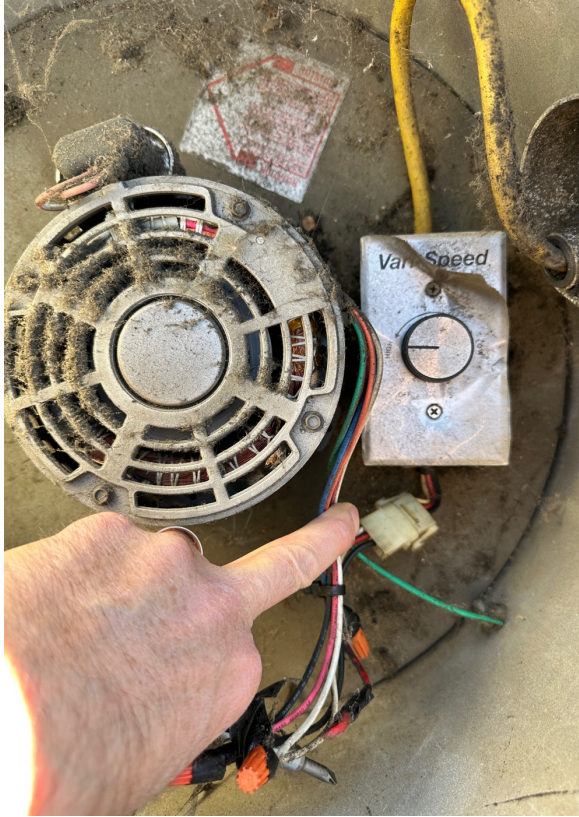
**DISH FAN WAS ORIGINALLY SET ON HIGH SPEED. SLOWED DOWN TO LOW TO HELP WITH BUILDING PRESSURE.**
