**Report: TAB Report**  
**Function: Test, Adjust, & Balance**  
**Date: 05/29/2025**  
**Completed By: National TAB**

**PROJECT**  
**05-26-25 CAVA WARWICK, RI**

Project: 05-26-25 CAVA WARWICK, RI

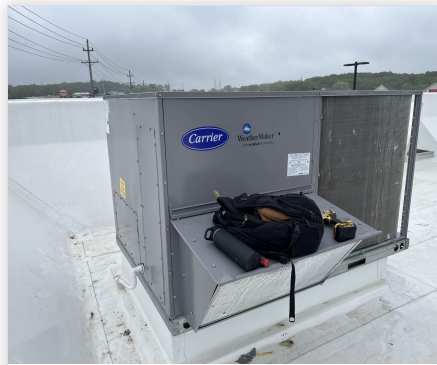
**Issue Name :** Condensate Drains  
**Description :** All condensate drains on the rooftop terminate immediately after the P-Traps. The RTU P-Traps do not match the drawing on M401.  
**Created By :** National TAB      **Assigned To :** National TAB - Will Turnbough  
**Status :** Open  
**Priority :** Low      **Asset Tag :**  
**Originated Date :** 05/29/2025 - Stephen Tassinaro - National TAB

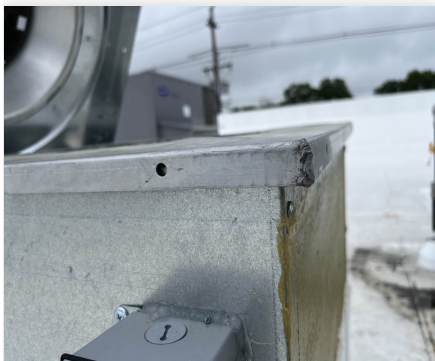
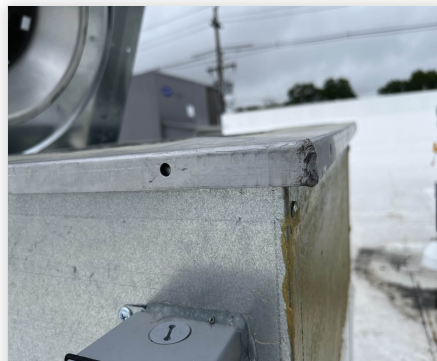
**Issue Name :** Grease Duct Not Secured to Curb  
**Description :** Duct top plate flanges to the edges of the curb, but it is not secured. This allows for movement of the grease duct and grease will accumulate.  
**Created By :** National TAB      **Assigned To :** National TAB - Will Turnbough  
**Status :** Open  
**Priority :** Medium      **Asset Tag :**  
**Originated Date :** 05/29/2025 - Stephen Tassinaro - National TAB

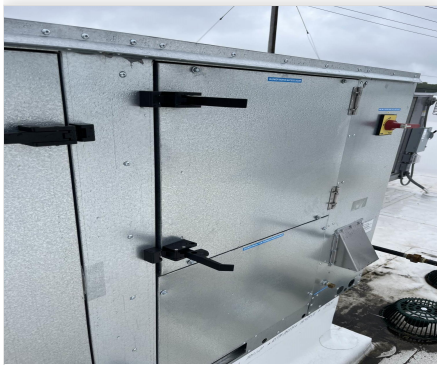
**Issue Name :** MAU Blower Access Door  
**Description :** The MAU blower access door is stuck shut and not able to be opened without prying.  
**Created By :** National TAB      **Assigned To :** National TAB - Will Turnbough  
**Status :** Open  
**Priority :** Low      **Asset Tag :**  
**Originated Date :** 05/29/2025 - Stephen Tassinaro - National TAB
