**Report: TAB Report**  
**Function: Test, Adjust, & Balance**  
**Date: 05/29/2025**  
**Completed By: National TAB**

**PROJECT**  
**05-26-25 CAVA WARWICK, RI**

Project: 05-26-25 CAVA WARWICK, RI

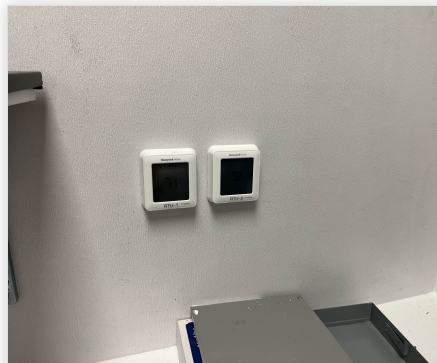
**Issue Name :** Incorrect Thermostats  
**Description :** The currently installed thermostats are not the correct model and do not have all the desired functions (occupancy, humidity, remote sensors, exc). The current thermostats are can schedule just temperature setpoints.  
**Created By :** National TAB                      **Assigned To :** National TAB - Will Turnbough  
**Status :** Open  
**Priority :** High                                      **Asset Tag :**  
**Originated Date :** 05/28/2025 - Stephen Tassinaro - National TAB

- **05/29/2025 National TAB - Stephen Tassinaro**
  - Both new and original thermostats do not have an OCC terminal. Default Carrier RTU setup puts unit into occupied mode whenever the blower is running.

- **05/29/2025 National TAB - Stephen Tassinaro**
  - One thermostat has been changed as of 5/29. MC to replace second thermostat 5/30.

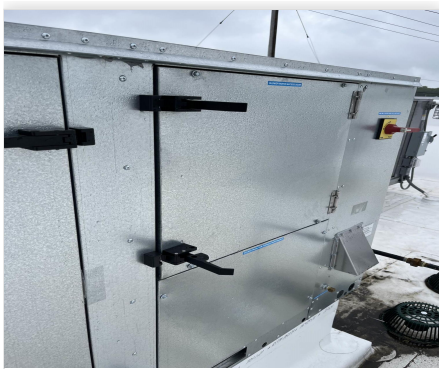
**Issue Name :** MAU Blower Access Door  
**Description :** The MAU blower access door is stuck shut and not able to be opened without prying.  
**Created By :** National TAB                      **Assigned To :** National TAB - Will Turnbough  
**Status :** Open  
**Priority :** Low                                      **Asset Tag :**  
**Originated Date :** 05/29/2025 - Stephen Tassinaro - National TAB
