Report: TAB Report
Function: Test, Adjust, & Balance
Date: 05/29/2025
Completed By: National TAB

PROJECT
05-26-25 CAVA WARWICK, RI

Project: 05-26-25 CAVA WARWICK, RI

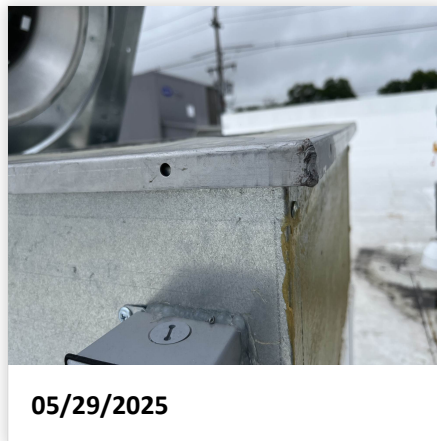
Issue Name : Grease Duct Not Secured to Curb
Description : Duct top plate flanges to the edges of the curb, but it is not secured. This allows for movement of the grease duct and grease will accumulate.
Created By : National TAB **Assigned To :** National TAB - Will Turnbough
Status : Open
Priority : Medium **Asset Tag :**
Originated Date : 05/29/2025 - Stephen Tassinaro - National TAB

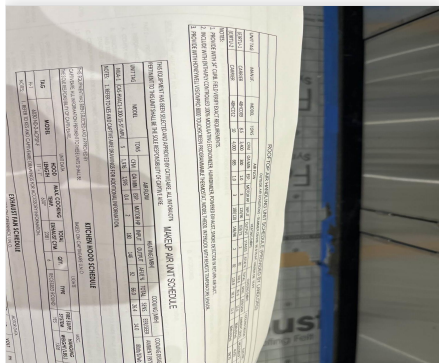
Issue Name : Incorrect Thermostats
Description : The currently installed thermostats are not the correct model and do not have all the desired functions (occupancy, humidity, remote sensors, exc). The current thermostats are can schedule just temperature setpoints.
Created By : National TAB **Assigned To :** National TAB - Will Turnbough
Status : Open
Priority : High **Asset Tag :**
Originated Date : 05/28/2025 - Stephen Tassinaro - National TAB

- **05/29/2025 National TAB - Stephen Tassinaro**
 - Both new and original thermostats do not have an OCC terminal. Default Carrier RTU setup puts unit into occupied mode whenever the blower is running.

- **05/29/2025 National TAB - Stephen Tassinaro**
 - One thermostat has been changed as of 5/29. MC to replace second thermostat 5/30.
