Report: TAB Report
Function: Test, Adjust, & Balance
Date: 05/29/2025
Completed By: National TAB

PROJECT
05-26-25 FREDDYS ELKHART, IN

Project: 05-26-25 FREDDYS ELKHART, IN

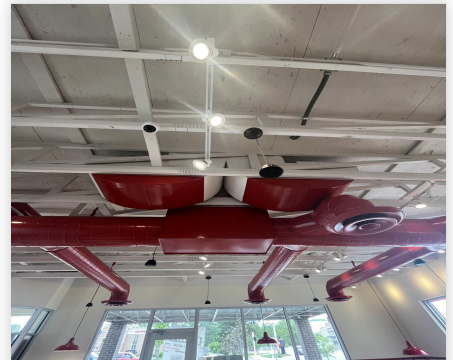
Issue Name : RTU-1 low on flow
Description : RTU-1 is low on flow. Static pressures are high showing restriction in ductwork. Return drop ducts are looped back up towards the ceiling shortly after entry to the dining room pointed up at the ceiling with only 11 inches of clearance. This could be causing the restriction in ductwork. Unit is at 4296/5000CFM. Balanced proportionally low.

[1] Unit low on flow at FLA. Balanced proportionally low.

[2] Unit is above FLA (13.5) but under service factor (14.65) at 14.2 amps.

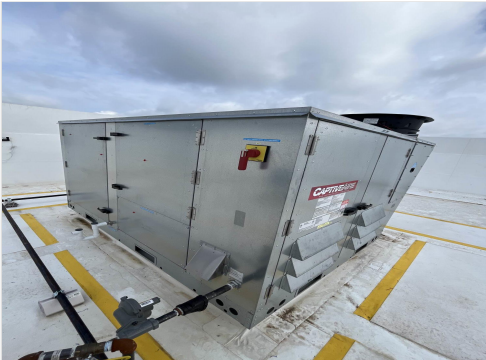
Unit Data - PHOTO LOG

Unit Data		
	Design	Actual
MFG	CAPTIVEAIRE	CAPTIVEAIRE
Serial Num	-	6917261
Model Num	CASRTU3-1.300.15-20T-DOAS	CAS-HVAC3-1.300-15-15T
Type	DOAS	DOAS
Configuration	VERTICAL	VERTICAL
Num OA Filters 1	-	4
OA Filter Size 1	-	16X25X2
Num Final Filter 1	-	8
Final Filter Size 1	-	20X25X2

Test Data		
	Design	Actual
SF CFM	2300	2313
SF RPM	-	1751
RA CFM	0	0
OA CFM	2300	2313
RL Voltage	-	207
RL Amperage	-	5.1
SF Rotation	-	CW
SF System SetPt	-	60.4
RA Damper Position	-	MECHANICAL LINKAGE
Min OA Damper Position	-	100%
Min OA Damper Type	-	ECONOMIZER

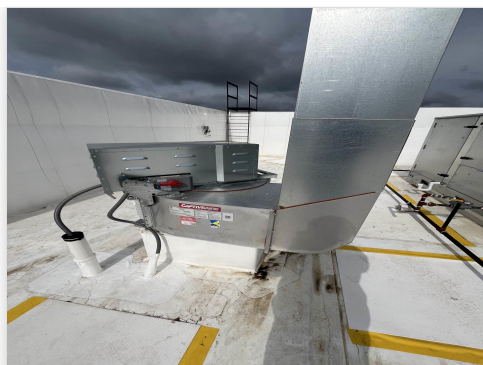
Unit Data - PHOTO LOG

Unit Data		
	Design	Actual
MFG	CAPTIVEAIRE	CAPTIVEAIRE
Model Num	CASRE18DD	CASRE18DD
Serial Num	-	6917261
Type	UTILITY	UTILITY
Configuration	VERTICAL	VERTICAL

Test Data		
	Design	Actual
CFM	1600	1604
Fan RPM	-	1125
Fan Rotation	-	CCW
Motor RPM	-	1125
RL Voltage	-	163@VFD
RL Amperage	-	3.1@VFD
Suction ESP	-	-0.67"
Discharge ESP	-	ATM
Total ESP	1.500"	-0.67"

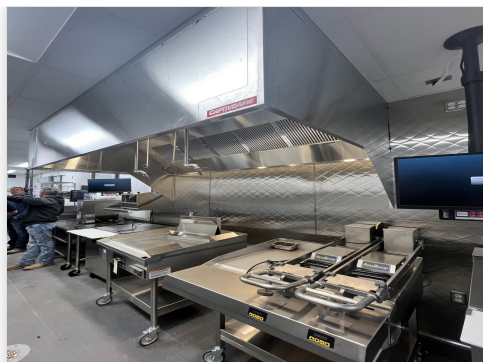
Unit Data - PHOTO LOG

Unit Data		
	Design	Actual
MFG	CAPTIVEAIRE	CAPTIVEAIRE
Model Num	5424-ND-2	5424-ND-2
Job / Serial Num	-	6917261
Type	TYPE I - CANOPY	TYPE I CANOPY
Hood length	96"	96"
Hood Width	54"	54"

Test Data Exhaust		
	Design	Actual
Filter Type	CAPTRATE SOLO FILTER	CAPTRATE SOLO
Filter Size 1	16X16	16X16
Filter Qty 1	5	5
Filter AK factor size 1	1.62	1.62
Filter Total AK Area	8.1	8.1
Filter1 FPM	-	189
Filter2 FPM	-	207
Filter3 FPM	-	193
Filter4 FPM	-	206
Filter5 FPM	-	198
Filter Ave FPM(corr)	-	198
CFM	1600	1604

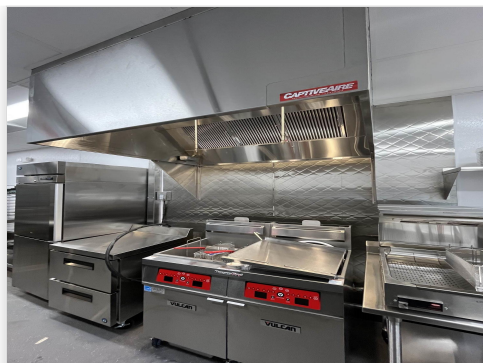
Unit Data - PHOTO LOG

Unit Data		
	Design	Actual
MFG	CAPTIVEAIRE	CAPTIVEAIRE
Model Num	54024-ND-2	54024-ND-2
Job / Serial Num	-	6917261
Type	TYPE I - CANOPY	TYPE I CANOPY
Hood length	60"	60"
Hood Width	54"	54"

Test Data Exhaust		
	Design	Actual
Filter Type	CAPTRATE SOLO FILTER	CAPTRATE SOLO
Filter Size 1	16X16	16X16
Filter Qty 1	3	3
Filter AK factor size 1	1.62	1.62
Filter Total AK Area	4.86	4.86
Filter1 FPM	-	154
Filter2 FPM	-	165
Filter3 FPM	-	159
Filter Ave FPM(corr)	-	159
CFM	775	773
