**Report: TAB Report**  
**Function: Test, Adjust, & Balance**  
**Date: 05/29/2025**  
**Completed By: National TAB**

**PROJECT**  
**05-26-25 FREDDYS ELKHART, IN**

2701 Cassopolis Street

Elkhart, IN 46514

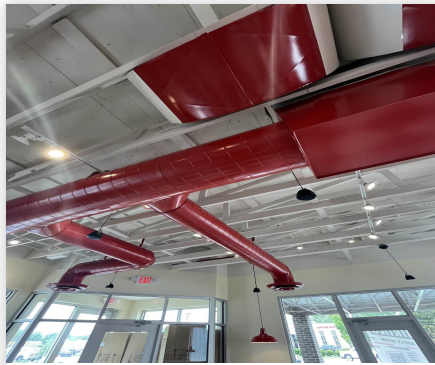
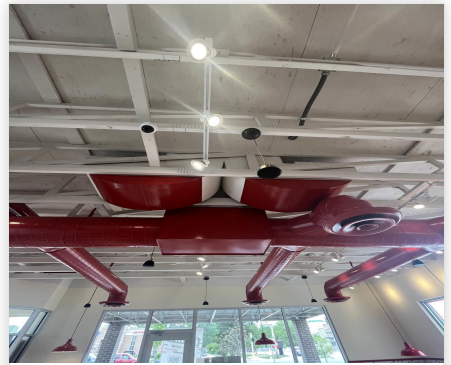
**Issue Name :** Diffuser 1-6 low on flow  
**Description :** RTU-1 diffuser 1-6 is low on flow, this could be to it being the first duct run closest to the supply drop causing airflow to shoot passed it, Recommend installing a scoop inside the ductwork to help direct airflow to this diffuser.

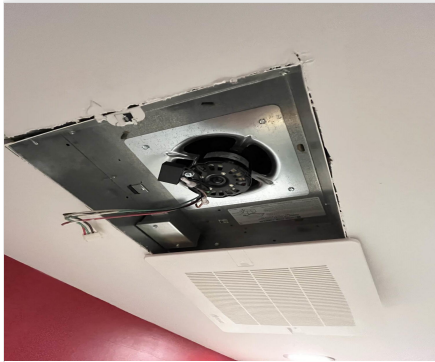
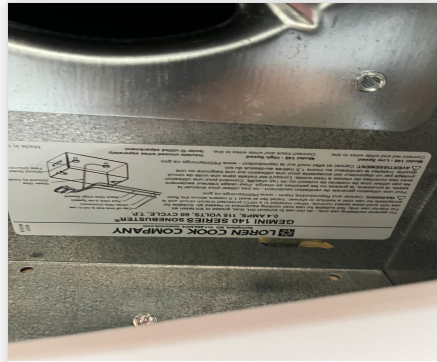
**Issue Name :** EF-1/EF-2 high on flow  
**Description :** EF-1/EF-2 are high on flow at 99/75CFM and 94/75CFM. Units have been rewired for low speed and cannot be reduced further.  
**Created By :** National TAB      **Assigned To :** National TAB - Dylan Crisman  
**Status :** Open  
**Priority :** High      **Asset Tag :**  
**Originated Date :** 05/29/2025 - Dylan Crisman - National TAB

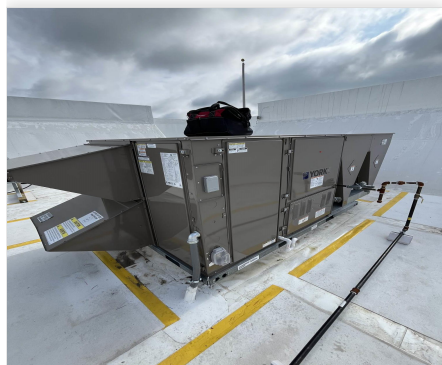
**Issue Name :** RTU-1 ALARM  
**Description :** RTU-1 alarm reads “using return air instead of space temp” recommend mechanical check wiring on space sensor and at unit for short/loose wire to correct.  
**Created By :** National TAB  
**Assigned To :** National TAB - Dylan Crisman  
**Status :** Open  
**Priority :** High  
**Asset Tag :**  
**Originated Date :** 05/29/2025 - Dylan Crisman - National TAB

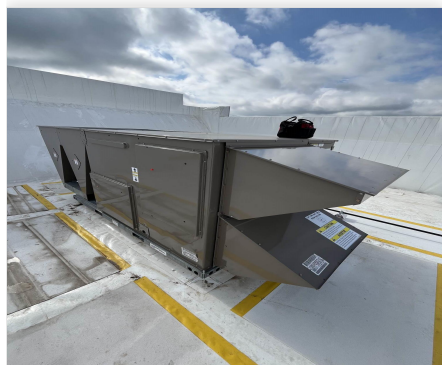
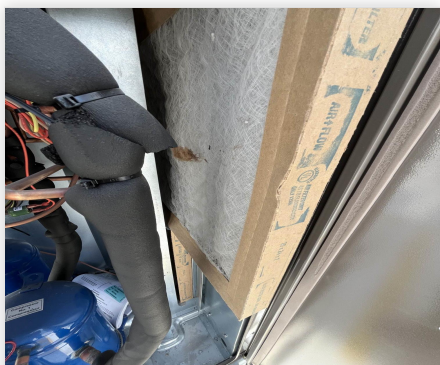
**Issue Name :** RTU-1 Final Filters  
**Description :** RTU-1 has construction filters installed. Recommend replacing with correct size (20x24x2) merv 8 rated pleated filters.  
**Created By :** National TAB  
**Assigned To :** National TAB - Dylan Crisman  
**Status :** Open  
**Priority :** Low  
**Asset Tag :**  
**Originated Date :** 05/29/2025 - Dylan Crisman - National TAB

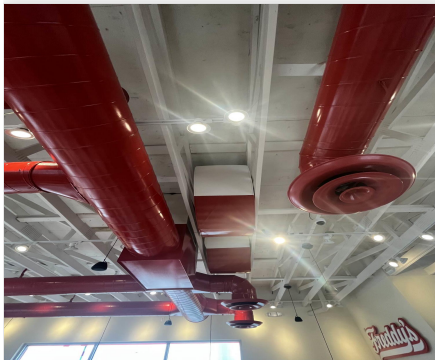
**Issue Name :** RTU-1 low on flow  
**Description :** RTU-1 is low on flow. Static pressures are high showing restriction in ductwork. Return drop ducts are looped back up towards the ceiling shortly after entry to the dining room pointed up at the ceiling with only 11 inches of clearance. This could be causing the restriction in ductwork. Unit is at 4296/5000CFM. Balanced proportionally low.

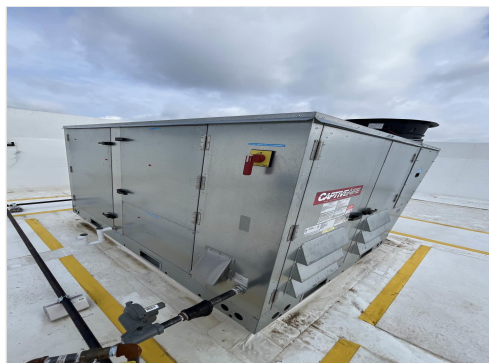
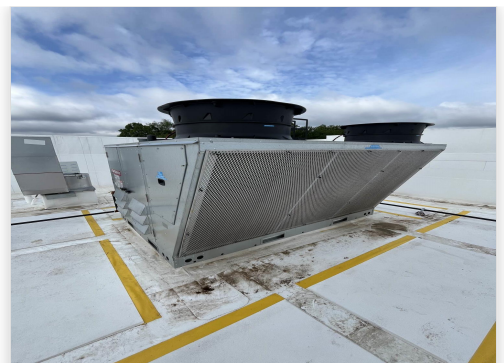
## Unit Data - PHOTO LOG

Notes:  
Unit in unoccupied/recirculation 2140CFM

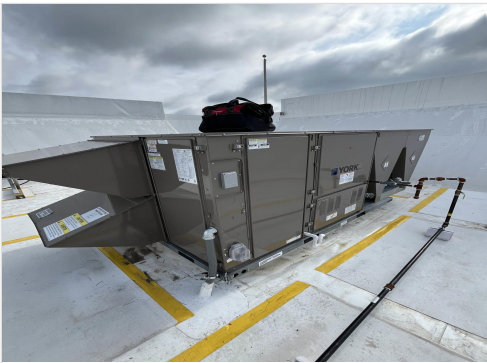
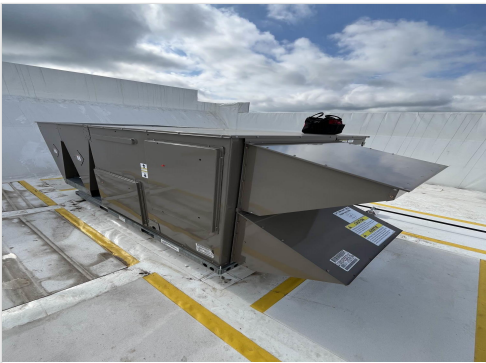
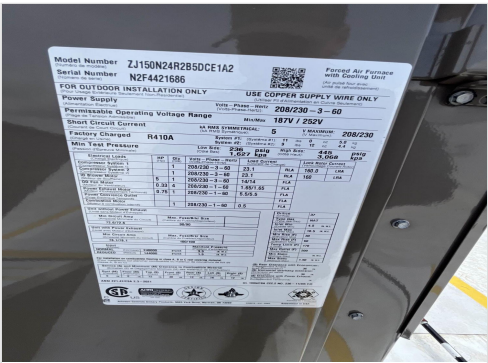
Unit Data - PHOTO LOG

- [1]Unit low on flow at FLA. balanced proportionally low.  
 [2] unit is above FLA (13.5) but under service factor (14.65) at (14.2)
