Report: TAB Report
Function: Test, Adjust, & Balance
Date: 05/29/2025
Completed By: National TAB

PROJECT
05-26-25 FREDDYS ELKHART, IN

Project: 05-26-25 FREDDYS ELKHART, IN

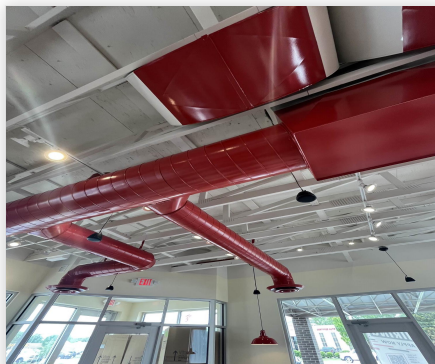
Issue Name : Diffuser 1-6 low on flow
Description : RTU-1 diffuser 1-6 is low on flow, this could be to it being the first duct run closest to the supply drop causing airflow to shoot passed it, Recommend installing a scoop inside the ductwork to help direct airflow to this diffuser.
Created By : National TAB **Assigned To :** National TAB - Dylan Crisman
Status : Open
Priority : Medium **Asset Tag :**
Originated Date : 05/29/2025 - Dylan Crisman - National TAB

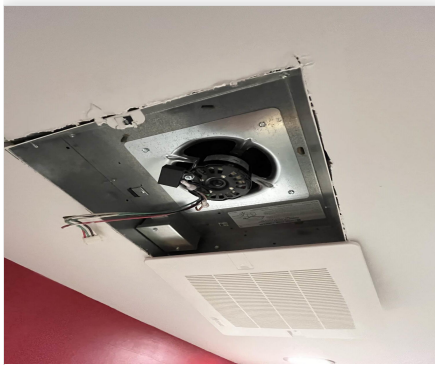
Issue Name : EF-1/EF-2 high on flow
Description : EF-1/EF-2 are high on flow at 99/75CFM and 94/75CFM. Units have been rewired for low speed and cannot be reduced further.
Created By : National TAB **Assigned To :** National TAB - Dylan Crisman
Status : Open
Priority : High **Asset Tag :**
Originated Date : 05/29/2025 - Dylan Crisman - National TAB

Notes:
EF is high on flow at 99/75CFM. Unit is wired for low speed unable to reduce speed further.

Notes:
EF is high on flow at 94/75CFM. Unit is wired for low speed unable to reduce speed further.

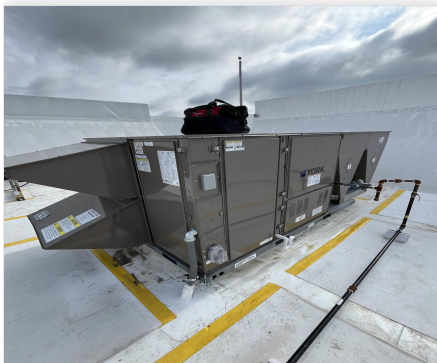
Issue Name : RTU-1 ALARM
Description : RTU-1 alarm reads “using return air instead of space temp” recommend mechanical check wiring on space sensor and at unit for short/loose wire to correct.

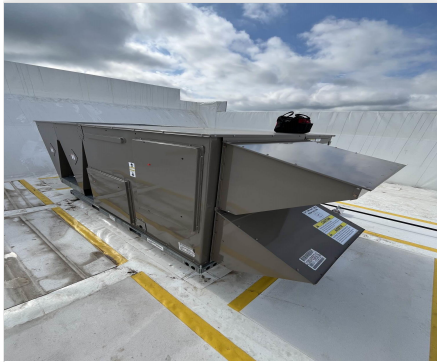
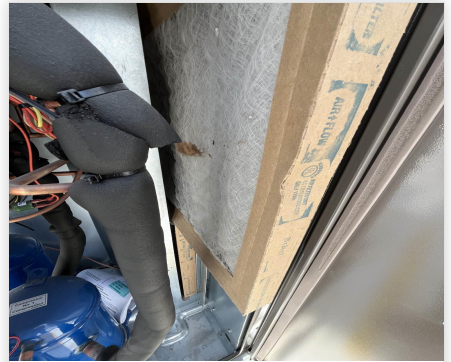
Issue Name : RTU-1 Final Filters
Description : RTU-1 has construction filters installed. Recommend replacing with correct size (20x24x2) merv 8 rated pleated filters.
Created By : National TAB **Assigned To :** National TAB - Dylan Crisman
Status : Open
Priority : Low **Asset Tag :**
Originated Date : 05/29/2025 - Dylan Crisman - National TAB

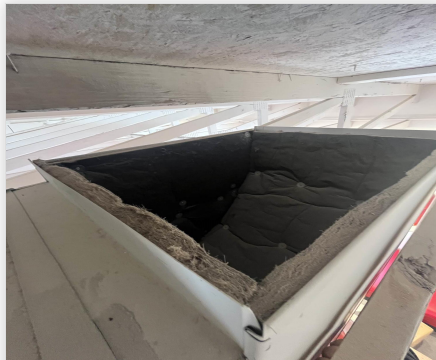
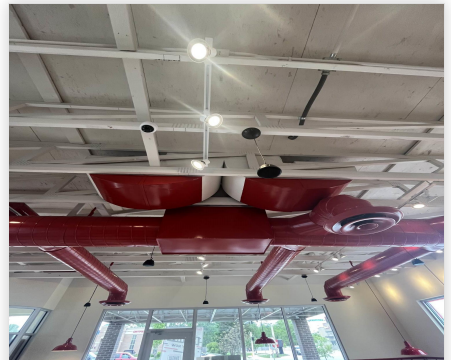
Issue Name : RTU-1 low on flow
Description : RTU-1 is low on flow. Static pressures are high showing restriction in ductwork. Return drop ducts are looped back up towards the ceiling shortly after entry to the dining room pointed up at the ceiling with only 11 inches of clearance. This could be causing the restriction in ductwork. Unit is at 4296/5000CFM. Balanced proportionally low.

- [1]Unit low on flow at FLA. balanced proportionally low.
- [2] unit is above FLA (13.5) but under service factor (14.65) at (14.2)

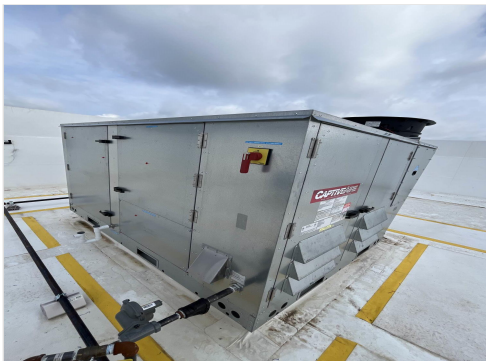
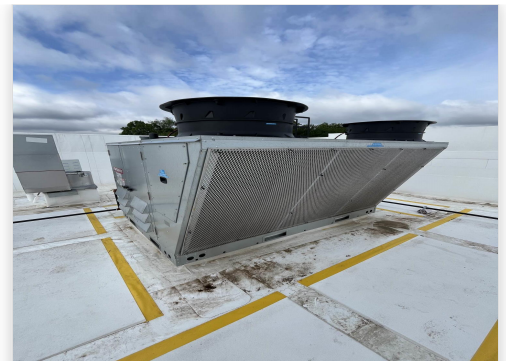
Unit Data - PHOTO LOG

Unit Data		
	Design	Actual
MFG	CAPTIVEAIRE	CAPTIVEAIRE
Serial Num	-	6917261
Model Num	CASRTU3- I.300.15-20T- DOAS	CAS-HVAC3- I.300-15-15T
Type	DOAS	DOAS
Configuration	VERTICAL	VERTICAL
Num OA Filters 1	-	4
OA Filter Size 1	-	16X25X2
Num Final Filter 1	-	8
Final Filter Size 1	-	20X25X2

Test Data		
	Design	Actual
SF CFM	2300	2313
SF RPM	-	1751
RA CFM	0	0
OA CFM	2300	2313
RL Voltage	-	207
RL Amperage	-	5.1
SF Rotation	-	CW
SF System SetPt	-	60.4
RA Damper Position	-	MECHANICAL LINKAGE
Min OA Damper Position	-	100%
Min OA Damper Type	-	ECONOMIZER

Notes:
Unit in unoccupied/recirculation 2140CFM

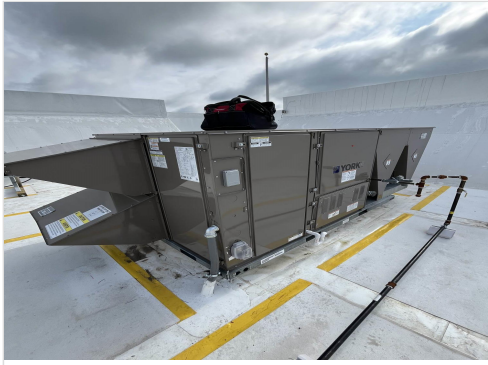
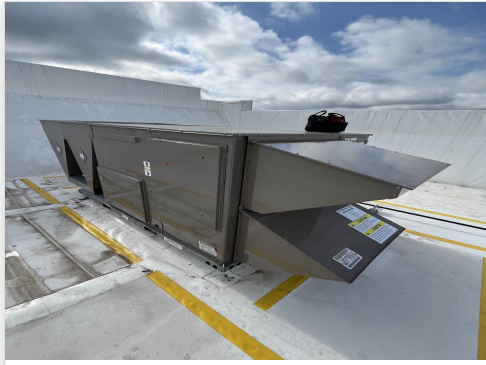
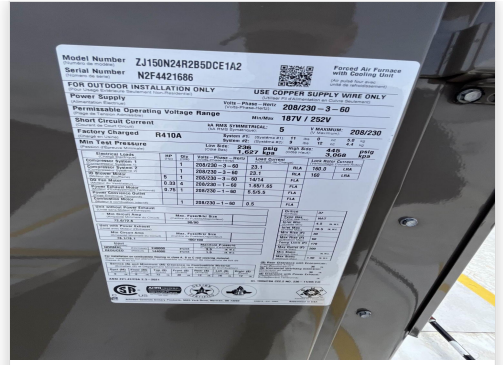
Unit Data - PHOTO LOG

Unit Data		
	Design	Actual
MFG	TRANE	YORK
Serial Num	-	N2F4421686
Model Num	YSJ-150	ZJ150N24R2B5DCE1A2
Type	RTU	RTU
Configuration	VERTICAL	VERTICAL
Num OA Filters 1	-	1
OA Filter Size 1	-	29X21
Num Final Filter 1	-	4
Final Filter Size 1	-	20X24X2

Test Data		
	Design	Actual
SF CFM	5000	4296[1]
SF RPM	-	
RA CFM	4019	3408
OA CFM	890	888
RL Voltage	-	214/212/212
RL Amperage	-	14.2[2]
SF Rotation	-	CW
SF System SetPt	-	3 TURNS OPEN
RA Damper Position	-	MECHANICAL LINKAGE
Min OA Damper Position	-	20%
Min OA Damper Type	-	ECONOMIZER
OA Enthalpy Setpt	-	27B

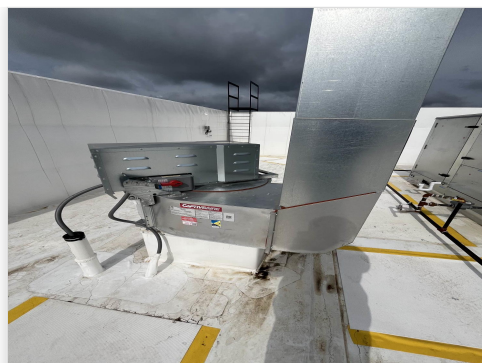
Unit Data - PHOTO LOG

Unit Data		
	Design	Actual
MFG	CAPTIVEAIRE	CAPTIVEAIRE
Model Num	CASRE18DD	CASRE18DD
Serial Num	-	6917261
Type	UTILITY	UTILITY
Configuration	VERTICAL	VERTICAL

Test Data		
	Design	Actual
CFM	1600	1604
Fan RPM	-	1125
Fan Rotation	-	CCW
Motor RPM	-	1125
RL Voltage	-	163@VFD
RL Amperage	-	3.1@VFD
Suction ESP	-	-0.67"
Discharge ESP	-	ATM
Total ESP	1.500"	-0.67"

Notes:
System setpoint 58.7Hz

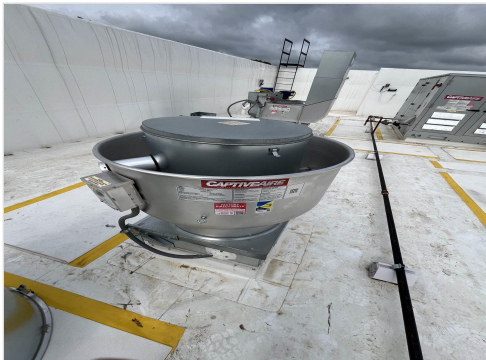
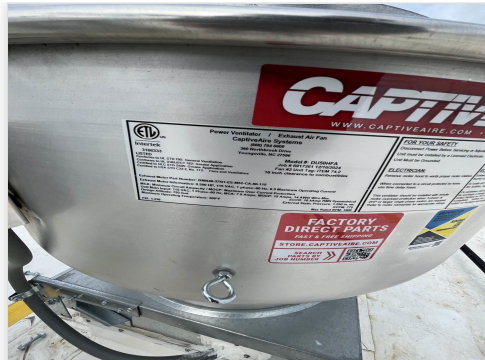
Unit Data - PHOTO LOG

Unit Data		
	Design	Actual
MFG	CAPTIVEAIRE	CAPTIVEAIRE
Model Num	DU50HFA	DU50HFA
Serial Num	-	6917261
Type	UPBLAST/CEILING	UPBLAST
Configuration	VERTICAL	VERTICAL

Test Data		
	Design	Actual
CFM	775	773
Fan RPM	-	1044
Fan Rotation	-	CCW
Motor RPM	-	1044
System SetPt	-	58%
RL Voltage	-	216/216
RL Amperage	-	1.1/1.2
Total ESP	1.200"	0.41"
Fan Inlet SP	-	-0.41"
Fan Discharge SP	-	ATM

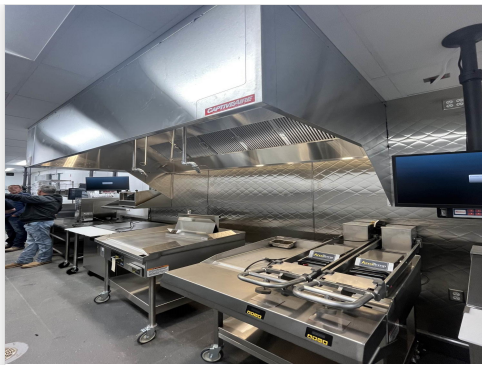
Unit Data - PHOTO LOG

Unit Data		
	Design	Actual
MFG	CAPTIVEAIRE	CAPTIVEAIRE
Model Num	5424-ND-2	5424-ND-2
Job / Serial Num	-	6917261
Type	TYPE I - CANOPY	TYPE I CANOPY
Hood length	96"	96"
Hood Width	54"	54"

Test Data Exhaust		
	Design	Actual
Filter Type	CAPTRATE SOLO FILTER	CAPTRATE SOLO
Filter Size 1	16X16	16X16
Filter Qty 1	5	5
Filter AK factor size 1	1.62	1.62
Filter Total AK Area	8.1	8.1
Filter1 FPM	-	189
Filter2 FPM	-	207
Filter3 FPM	-	193
Filter4 FPM	-	206
Filter5 FPM	-	198
Filter Ave FPM(corr)	-	198
CFM	1600	1604

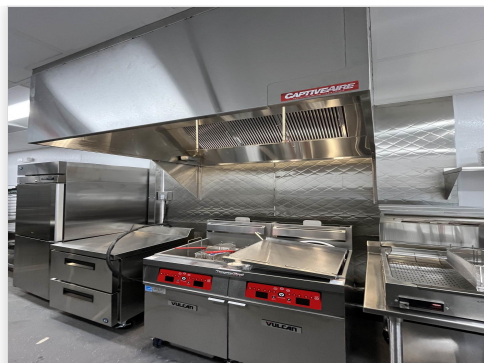
Unit Data - PHOTO LOG

Unit Data		
	Design	Actual
MFG	CAPTIVEAIRE	CAPTIVEAIRE
Model Num	54024-ND-2	54024-ND-2
Job / Serial Num	-	6917261
Type	TYPE I - CANOPY	TYPE I CANOPY
Hood length	60"	60"
Hood Width	54"	54"

Test Data Exhaust		
	Design	Actual
Filter Type	CAPTRATE SOLO FILTER	CAPTRATE SOLO
Filter Size 1	16X16	16X16
Filter Qty 1	3	3
Filter AK factor size 1	1.62	1.62
Filter Total AK Area	4.86	4.86
Filter1 FPM	-	154
Filter2 FPM	-	165
Filter3 FPM	-	159
Filter Ave FPM(corr)	-	159
CFM	775	773
