Report: TAB REPORT
Function: Test, Adjust, & Balance
Date: 12/02/2022

**01-09-23 WALGREENS #4708 - HAINES CITY,
FL**

Project: 01-09-23 WALGREENS #4708 - HAINES CITY, FL

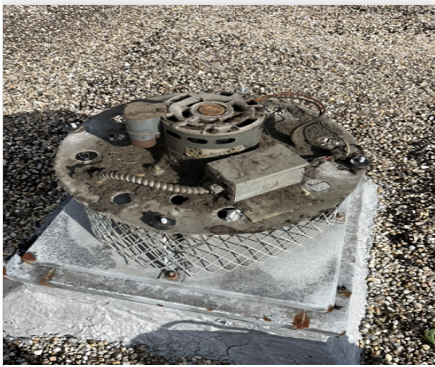
EF5.jpeg

Issue Name : EF1 (Office) and EF5 (Photo) are not functional.

Description : EF-1 is not operational and could not be balanced. EF-5 will be capped off.

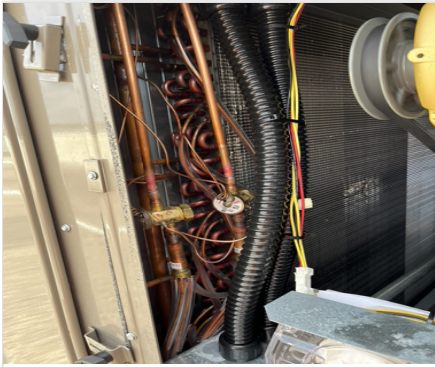
Evaporatorcoils.jpeg

Issue Name : RTU5 has alarm: "c1 locked due to coil freeze"

Description : Alarm does not allow c1 to turn on. Coils are not frozen and the compressor is lukewarm. Possible faulty sensor.

- **12/02/2022 National TAB - Will Turnbough**
 - Installing contractor inspected and said the sensor is faulty and they ordered a new one to replace it.

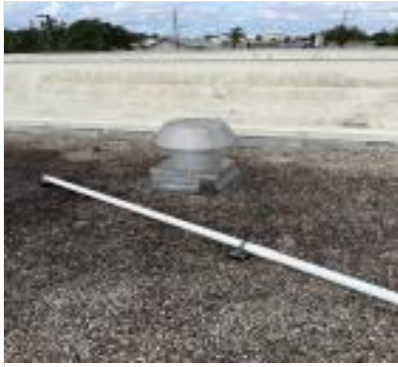
EF-1

Fan rotation is correct	Pass
Pulleys are aligned and belts are tensioned properly	NA
Speed controller installed and functional (direct drive)	YES
Fan is secured to the curb	Pass
Back draft damper is installed and functional	Pass
No exterior damage to the fan	Pass
No unusual noise or vibration	Pass
Controls are functional	Pass
Additional Comments:	EF#5 IS NOT FUNCTIONAL. (RESOLVED) EF#1 IS NOT FUNCTIONAL
