**Report: TAB REPORT**  
**Function: Test, Adjust, & Balance**  
**Date: 12/02/2022**

**01-09-23 WALGREENS #4708 - HAINES CITY,  
FL**

Project: 01-09-23 WALGREENS #4708 - HAINES CITY, FL

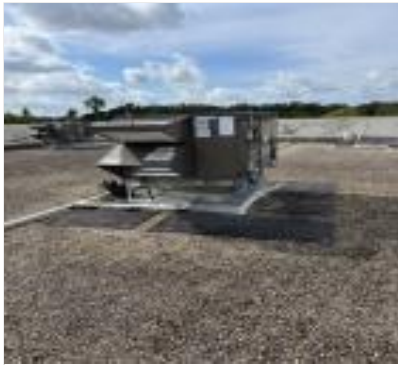
**Issue Name :** RTU-3 & RTU-4

**Description :** RTU's 3 and 4 labeled per submittal but the label does not match the locations on the drawings. Recommend verifying that they are installed properly.

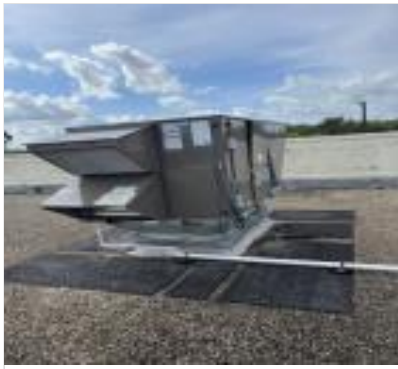
RTU-5

Verify all required equipment has been replaced per TA and BOM.	Pass
All units are installed in the proper locations	Pass
Units are labeled correctly	Pass
Asset tag installed	Pass
Roof is clear of debris.	Pass
Maintenance access for all unit access panels is acceptable and panels open freely.	Fail
Cabinet and general installation is complete.	Pass
Unit is secure to curb and level horizontally and vertically.	Pass
Access doors close tightly with no leaks	Pass
Condensate and gas piping is properly supported.	Pass
Costgaurd is installed per scope of work and piping unions are cemented.	Pass
Additional Comments	RTU#5 MOTOR ACCESS DOOR DOESN'T CLOSE EASILY.

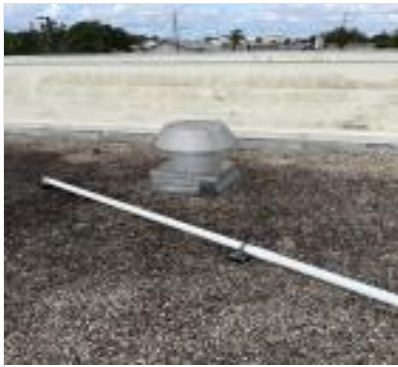
EF-1

Fan rotation is correct	Pass
Pulleys are aligned and belts are tensioned properly	NA
Speed controller installed and functional (direct drive)	YES
Fan is secured to the curb	Pass
Back draft damper is installed and functional	Pass
No exterior damage to the fan	Pass
No unusual noise or vibration	Pass
Controls are functional	Pass
Additional Comments:	EF#5 IS NOT FUNCTIONAL. (RESOLVED) EF#1 IS NOT FUNCTIONAL
